Serving the Community: St Patrick's Church Complex

**Final Report for Archaeological Investigations
at Site No. I44/539 – I44/542
Under Archaeological Authority No. 2013/61**

Report Prepared for St Patrick's Development Committee
Authors: Sheryl Cawte, Eva Forster-Garbutt, Naomi Woods, Jeremy
Moyle and Peter Mitchell
Reviewed By: Dr Hayden Cawte
05/06/2018

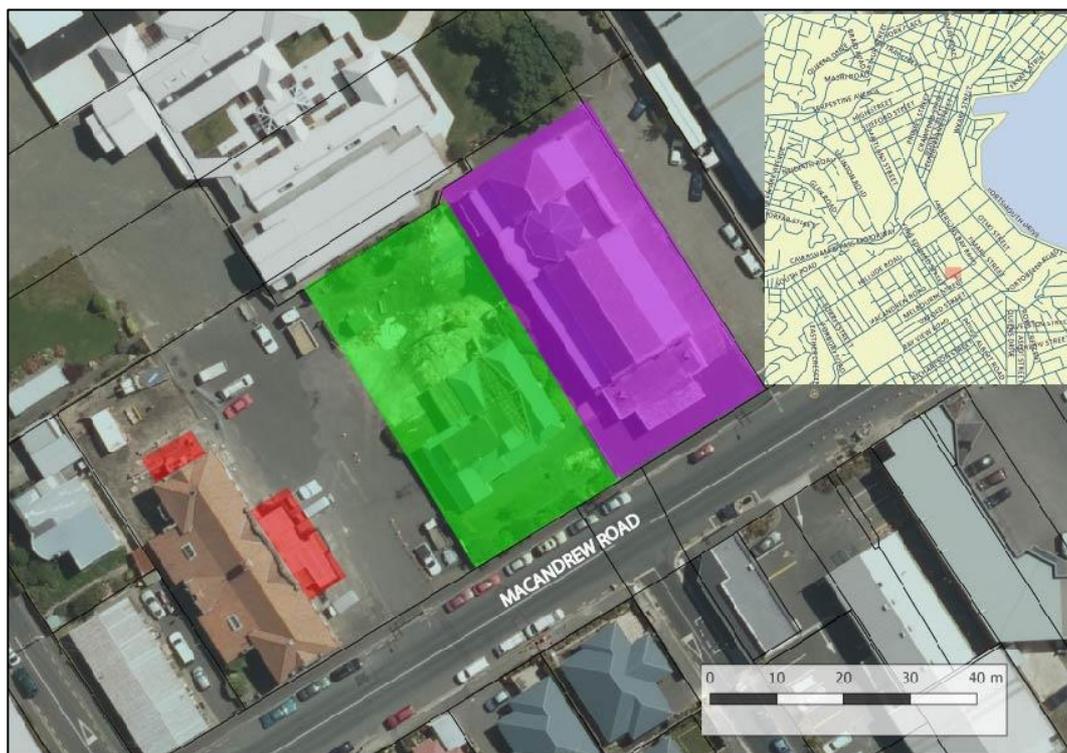
Figure 1-2 The three areas monitored during the redevelopment; stages 1, 2 and 3. Red: school excavations (EA1), green: presbytery demolition and site clearance (EA2 and EA3), purple: basilica excavations (EA4, EA5, EA6 and EA7).

Due to the extent and nature of the works, progress has been staggered over five years from 2012 until 2017 as each portion of the site was upgraded. A total of three stages of work were undertaken which encompassed seven excavation areas (Figure 1-2). The **first stage** of works related to the new St Patrick's school building and was completed in 2012 (Excavation Area 1). This included:

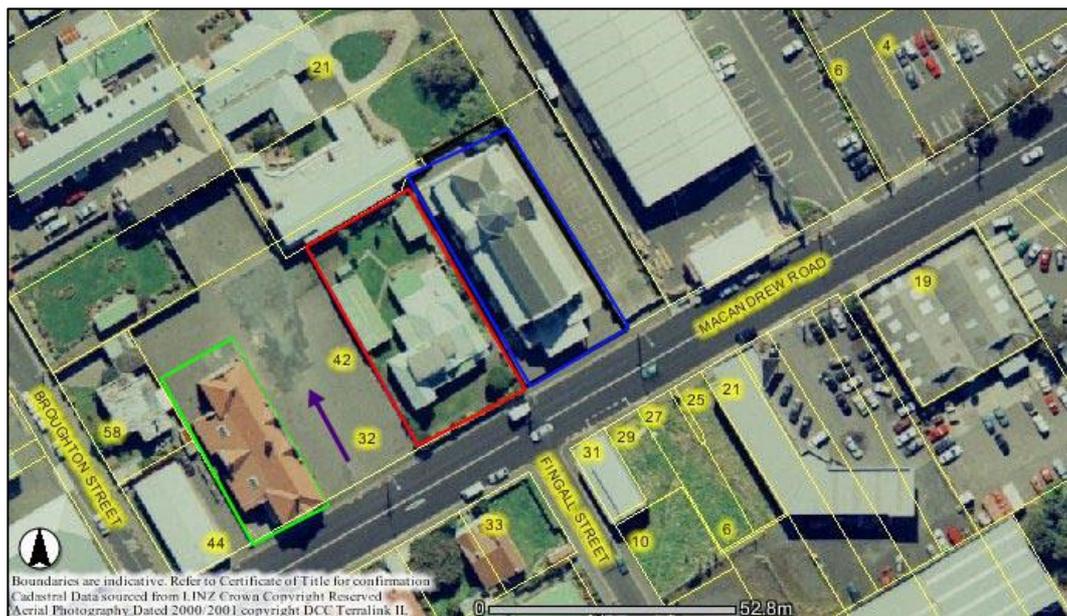
Figure 1-5 Aerial photograph of St. Patrick's Basilica (outlined in blue), new school building (outlined in green), and presbytery and associated buildings (outlined in red) at 28, 32 and 42 MacAndrew Road (Dunedin City Council Webmaps). The footprint of the old school building is indicated by the purple arrow.

As of September 2012 when the project began, the existing built features at the St Patrick's site included three buildings associated directly with the church; the St Patrick's Basilica (1898), the new St Patrick's school building (1916), and the presbytery (circa 1890s – 1970s) (Figure 1-6 to Figure 1-12). The site also included modern utilitarian garaging and several post-1900 outhouses. In Figure 1-5, the footprint of the original St Patrick's school-chapel demolished in 1986 is visible.

The building was finally demolished in 1986 (Mee, 1978). This now archaeological site (I44/542) is capped by an expanse of asphalt. Interestingly the outline/footprint of this structure can still be seen making identification of the site relatively easy (see Figure 1-5).

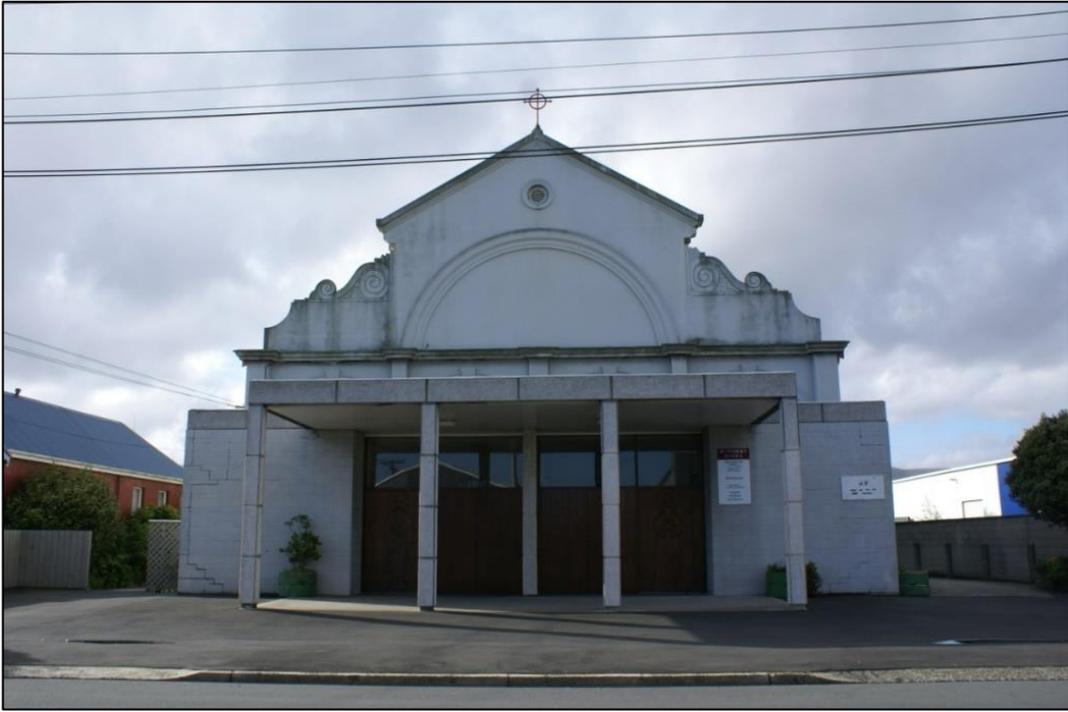
Figure 1-6 Front entrance to St Patrick's Basilica September 2012 (southeast aspect).

In 1960 the basilica was deemed complete when a front porch was added to the southeast elevation to MacAndrew Road. It was not the original design by Petre but a more simple structure designed by E.J. McCoy (see Figure 1-6). The site continued to be expanded with the establishment of St. Philomena's College, and other associated school buildings on the block (Figure 1-18). Since the image from the Otago Daily Times (ODT) in 1976 (Figure 1-19), most of these structures have been demolished including the original wooden chapel-school in 1986.

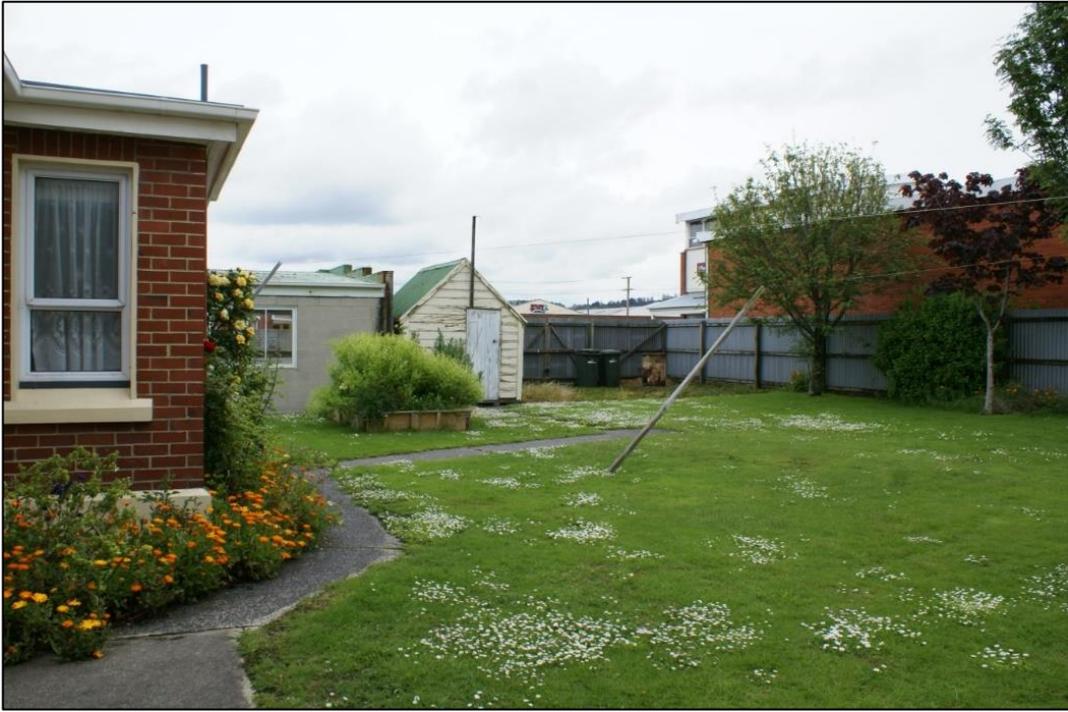
Figure 1-10 Outhouse associated with the presbytery September 2012.

The building related features (G005, G007, G010 and G011) in EA7 reflect the presence of at least one structure. Prior to works beginning there were two outhouses in the backyard of the presbytery (see Figure 1-10 and Figure 1-11). The wooden one along the western boundary of the backyard is outside the excavated area. The second outbuilding does sit within footprint of EA7 however it was constructed of wood and completely removed from the site during Stage 2. Therefore these features suggest an earlier structure or structures in the backyard area. From the minimal archaeological material uncovered in EA7, G007 suggests a structure constructed with stone foundations, and G005 and G011 indicate something constructed of brick that was demolished and materials buried on site. Whether these features represent one or multiple structures, it is not

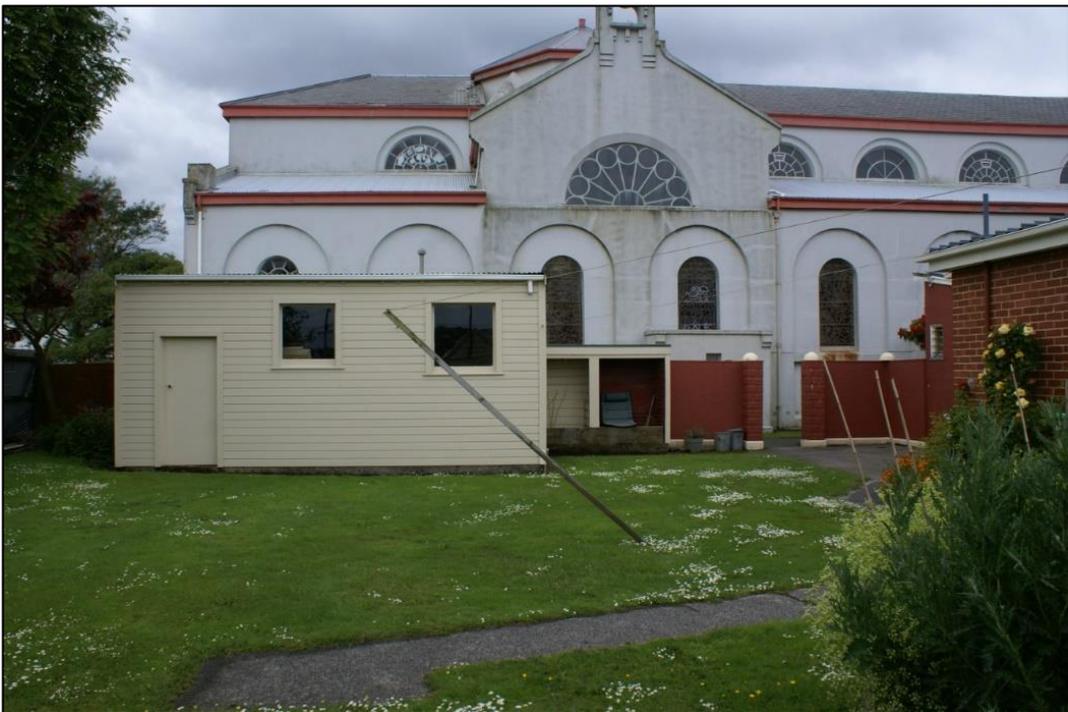
Figure 1-11 Second outhouse associated with the presbytery September 2012.

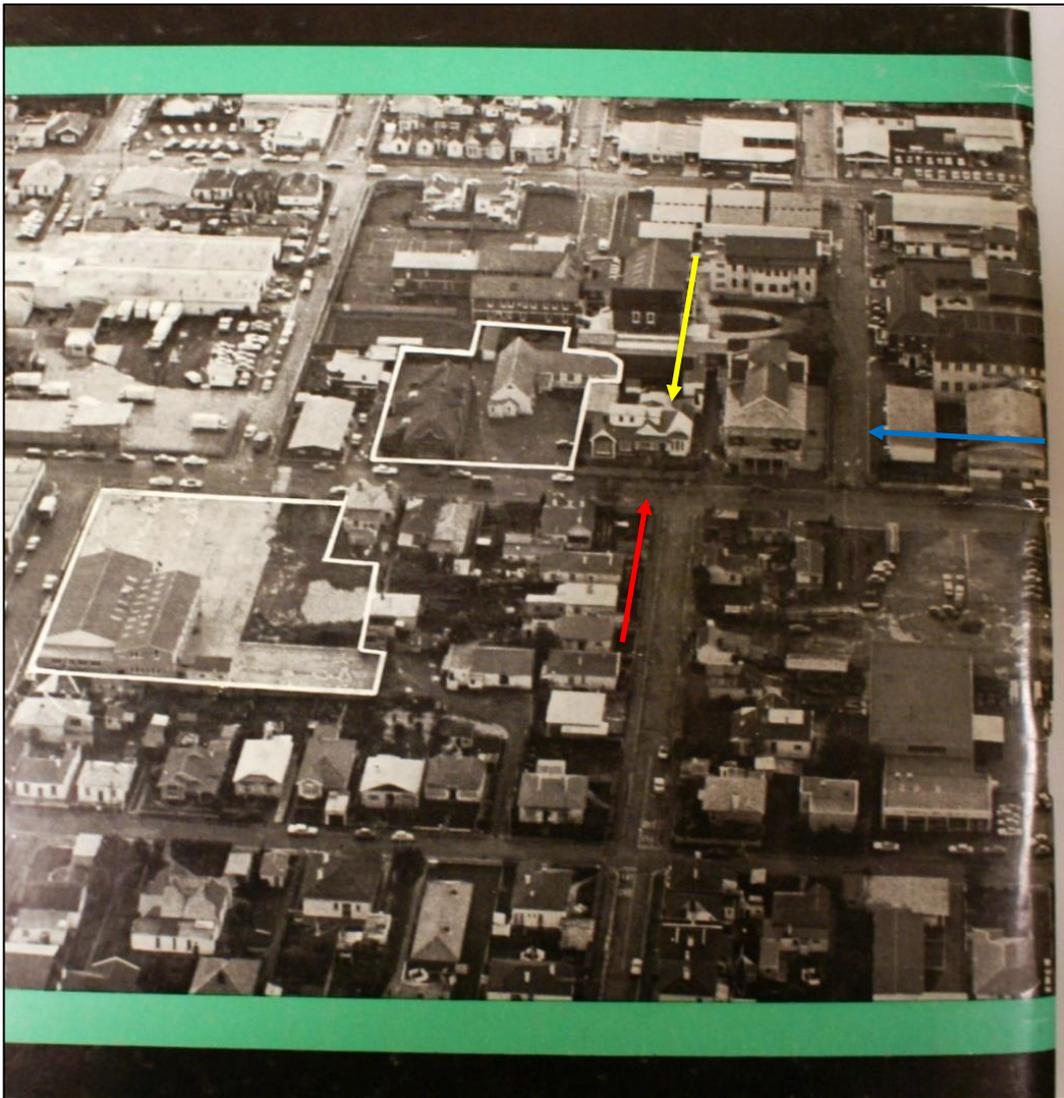
Figure 1-18 Aerial view of the site in 1978. Outlined in white are the old St Patrick's chapel-school and the new brick St Patrick's school. The red arrow points to the current presbytery on the site, the yellow arrows point to the two wooden out house structures behind it and the blue arrow points at the basilica. Note the road to the right of the basilica that is no longer there (Mee, 1994).

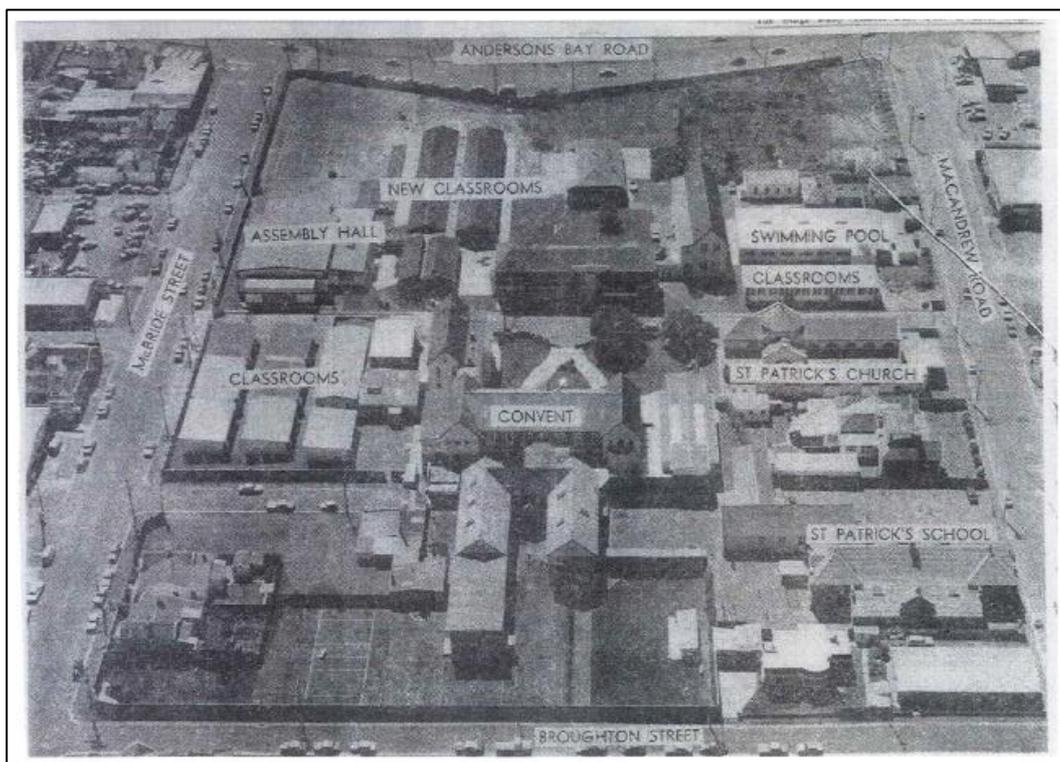
Figure 1-19 St Patrick's complex in 1976 (*Otago Daily Times*, 1976).

There are several modifications to the structure post 1956 that do not have accompanying documentation. However, based on the 1976 aerial from the ODT (Figure 1-19), an addition at the rear of the presbytery along the northeast was constructed creating a new back door entrance no longer out of Room 7, change of windows in the 1956 addition and the construction of the outbuildings at the rear of the presbytery site.

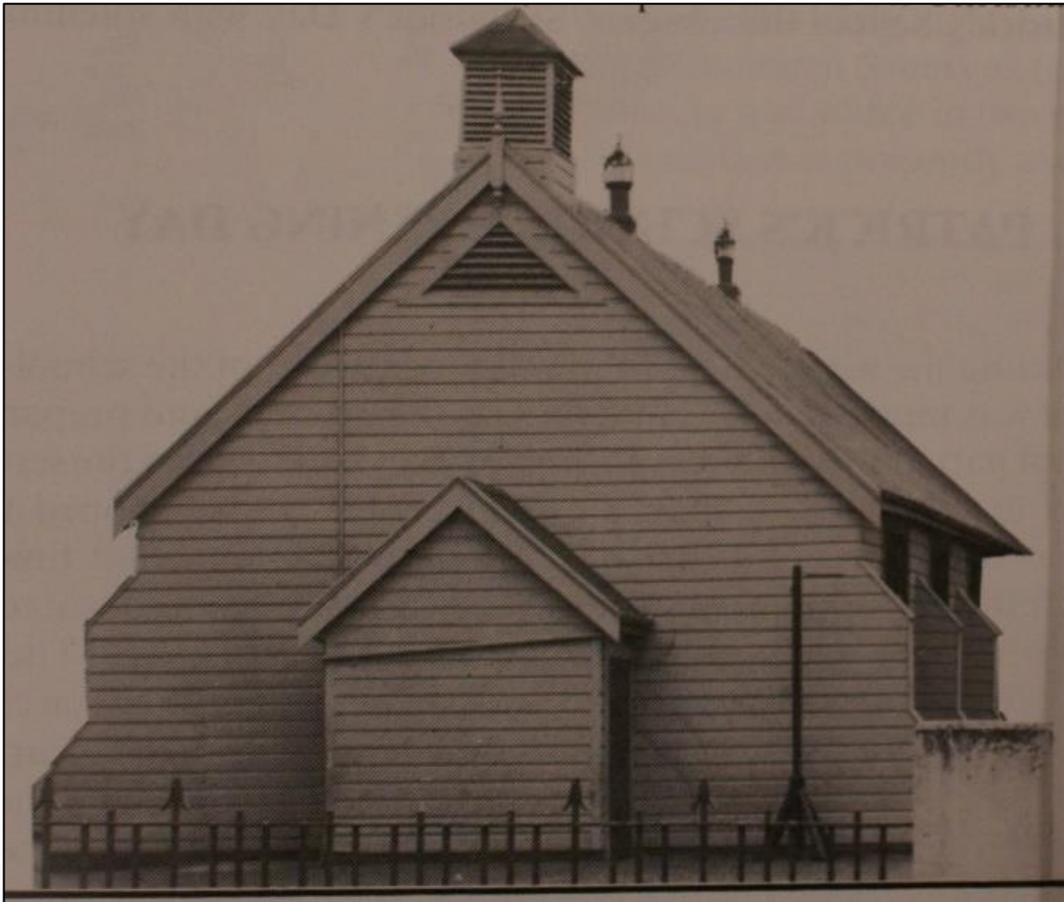
Figure 1-20 First wooden chapel-school designed by Petre and erected on the St Patricks site late 1870s. Looking at the south elevation (Mee, 1978).

The wooden St Patrick's chapel-school, designed by Frances Petre was opened free of debt on Sunday 18 August 1878, by Bishop Moran after local fundraising (Figure 1-20). An exert from the New Zealand Tablet said,

The chapel-school was a simple long room with an altar at the far end. It was humble in design and made no claim to architectural grandeur unlike many other buildings designed by Petre. It had no stained glass or marble. Father Nicolas B Moloney was consecrated as the first priest at St Patrick's school and parish (Mee, 1978). The first lay teacher at St Patrick's was Miss Katherine Hefferman from Melbourne who started on August 26 1878 teaching 60 children of various ages. During this time the school contained only the most basic amenities (Mee, 1978).

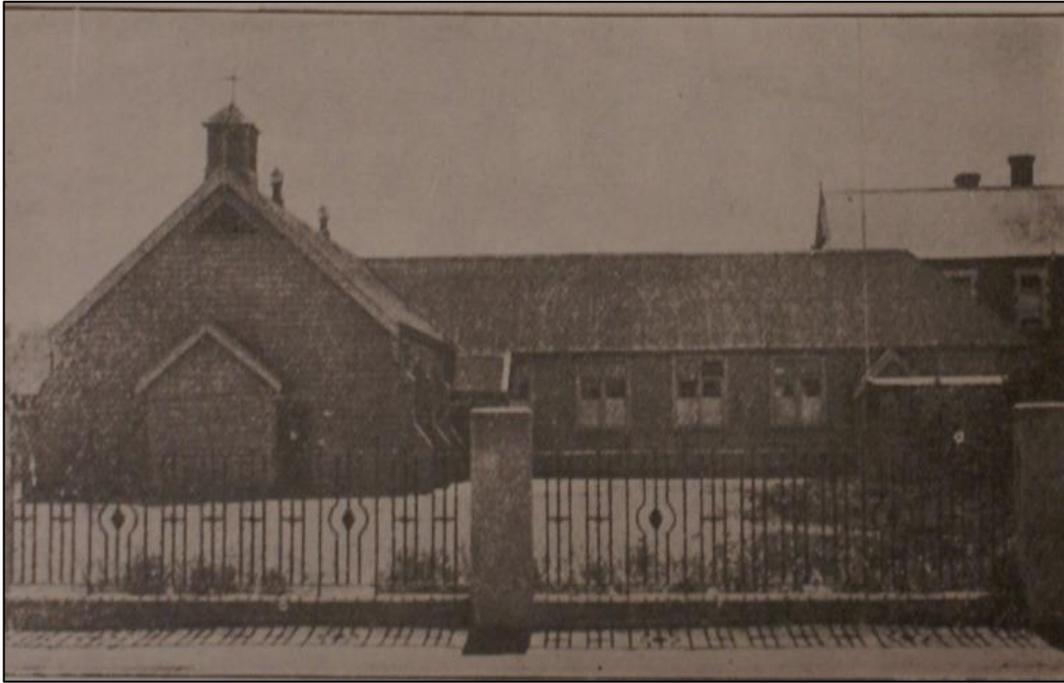
Figure 1-21 Wooden chapel-school showing the addition made in the 1880s. Photo circa 1880s (Mee, 1978)

As the population expanded in South Dunedin, so did the school role each term. The Dominican Sisters arrived September 4th 1882 to help teach at the school and began at the start of the 3rd term. Miss Hefferman remained at the school during their settling-in stage. In the 1880s a wing to the right of the original chapel-school building was added in two successive sections (Figure 1-21 and Figure 1-22).

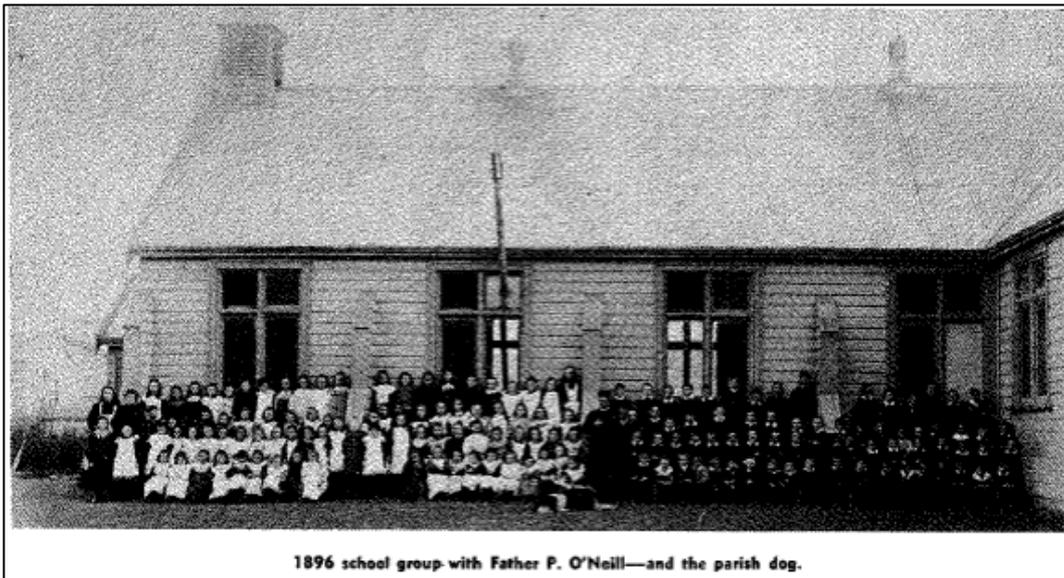
Figure 1-22 Photograph of the wooden chapel-school after its additions from another angle (Mee, 1978).

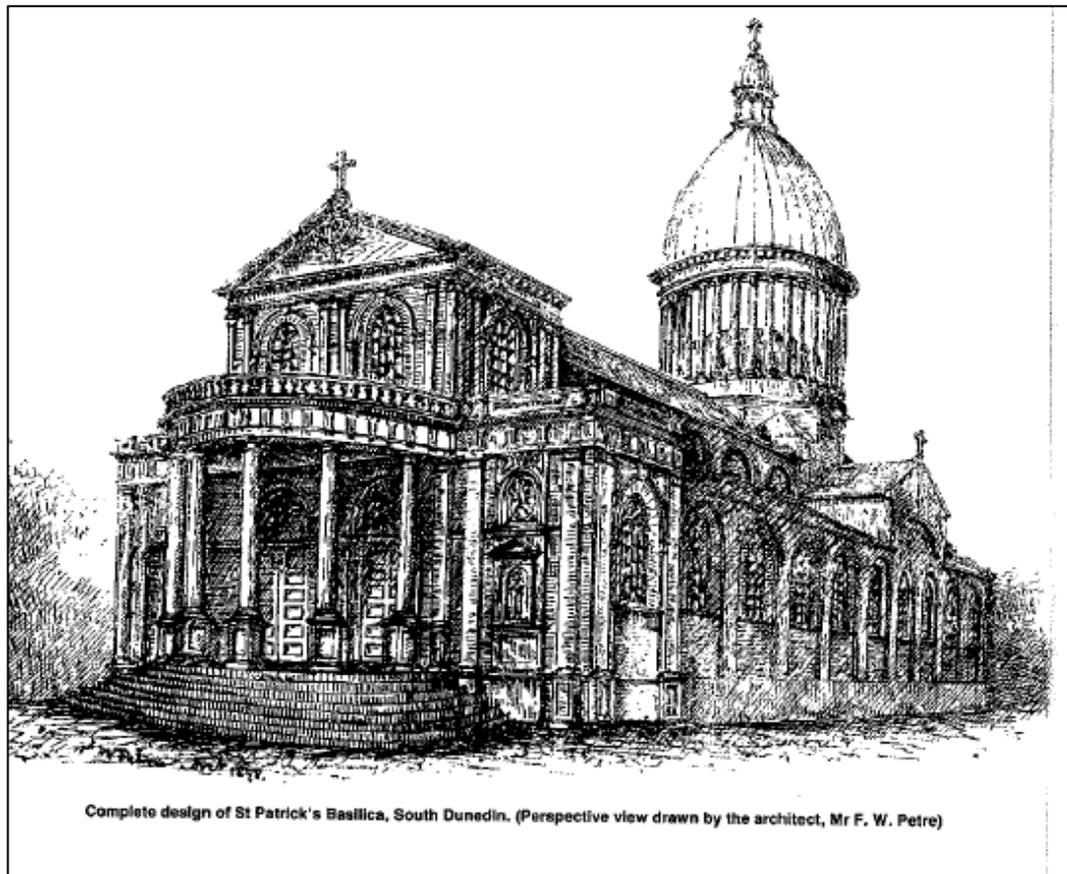
Figure 1-23 Drawing of the complete and original design Petre intended for the basilica (Mee, 1994).

The St Patrick's Basilica, a Category II historic building was designed by Frances Petre (Figure 1-23 and Figure 1-24). The building has a distinct Renaissance design and is a large roofed building used for public purposes. The building is built on concrete foundations faced with Port Chalmers bluestone with plastered brick walls and a slate roof. The building inside is richly decorated in a Classical style with moulded plaster work, religious sculptures and Wunderlien ceiling of prefabricated mass-produced zinc panels. According to architect E.J. McCoy, it was significant because it was Petre's first departure from gothic (Mee, 1994).

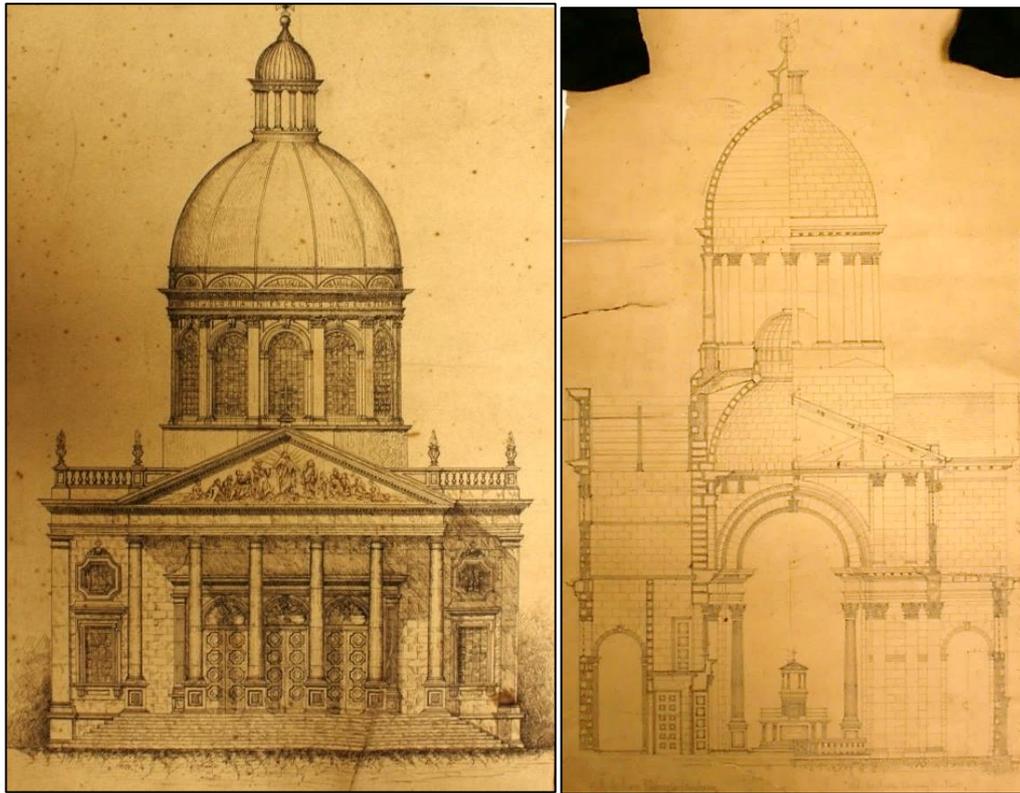
Figure 1-24 The two remaining plans of Petre's Basilica design (Petre, 1892).

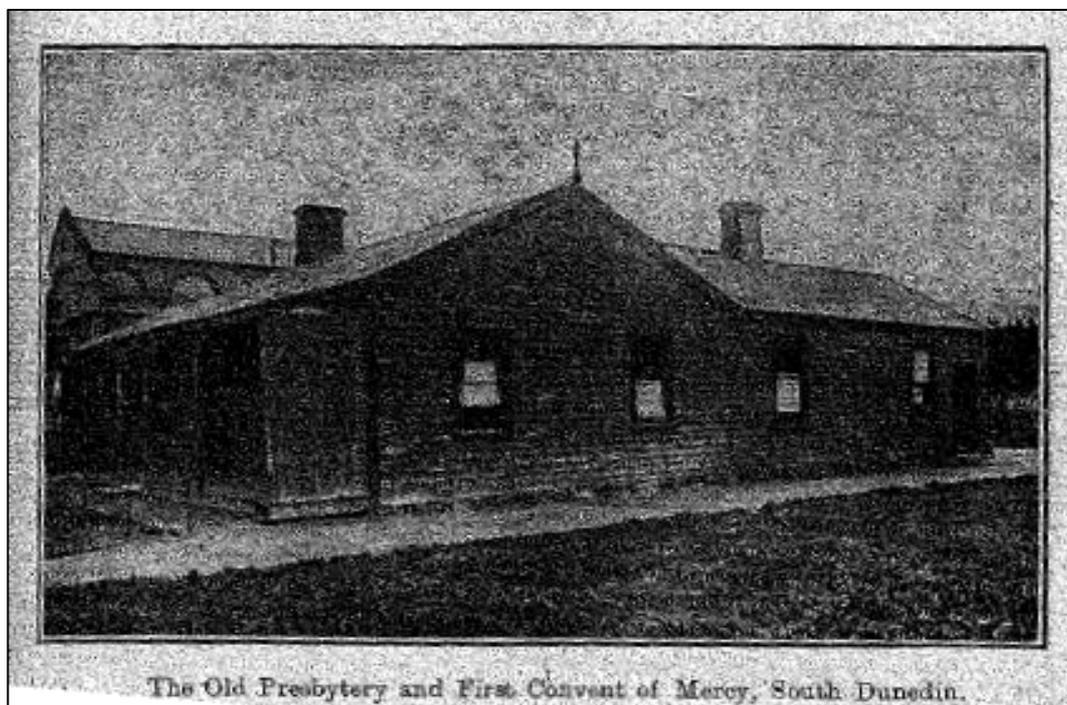
Figure 1-25 The original wooden presbytery erected on site by Father Vereker. The St Patrick's Basilica can be seen in the background in the top left-hand corner (New Zealand Tablet, 1926).

The old wooden presbytery, also known as the first 'Convent of Mercy' was built sometime during the 1880s (Figure 1-25). It was reconstructed from material from the original City Hotel at the corner of Princes Street and Moray Place when the hotel was rebuilt in the 1880s (Mee, 1978).

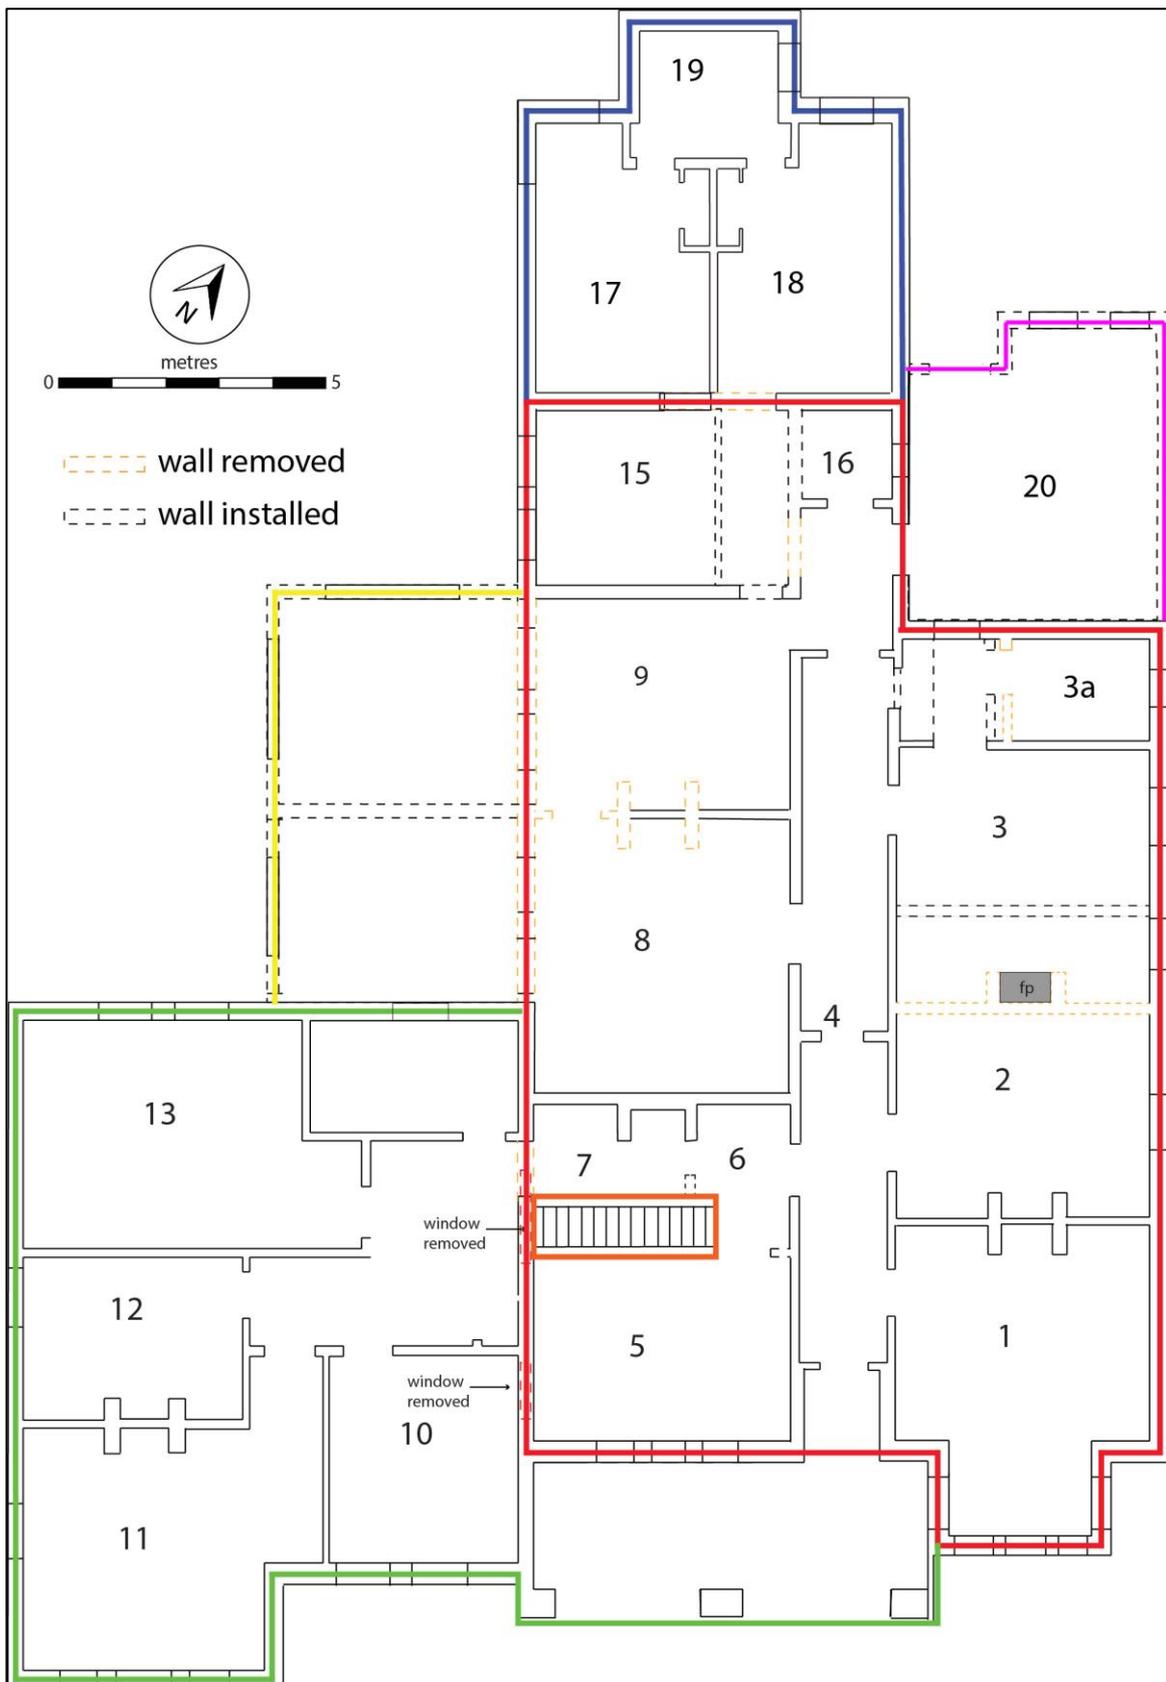
Figure 4-1 Plan of the presbytery in 2011 showing the construction phases: Phase 1 (red), Phase 2 (green), Phase 3 (blue), Phase 4 (orange) and Phase 5 (yellow), Phase 6 (purple).

Condition 5 of archaeological authority 2013/61 stipulated that the presbytery building at 32 MacAndrew Road, Dunedin be recorded to a Level III standard. This recording was undertaken between 10 and 12 December 2012 by H. Cawte, S. McPherson, D. Dyer and C. Murray. The buildings archaeology identified five phases of construction and major alterations (Figure 4-1). Additional alterations that occurred between these phases are also noted below. For ease of reference each investigated room was assigned a number. This site has been recorded on ArchSite as Site I44/539.

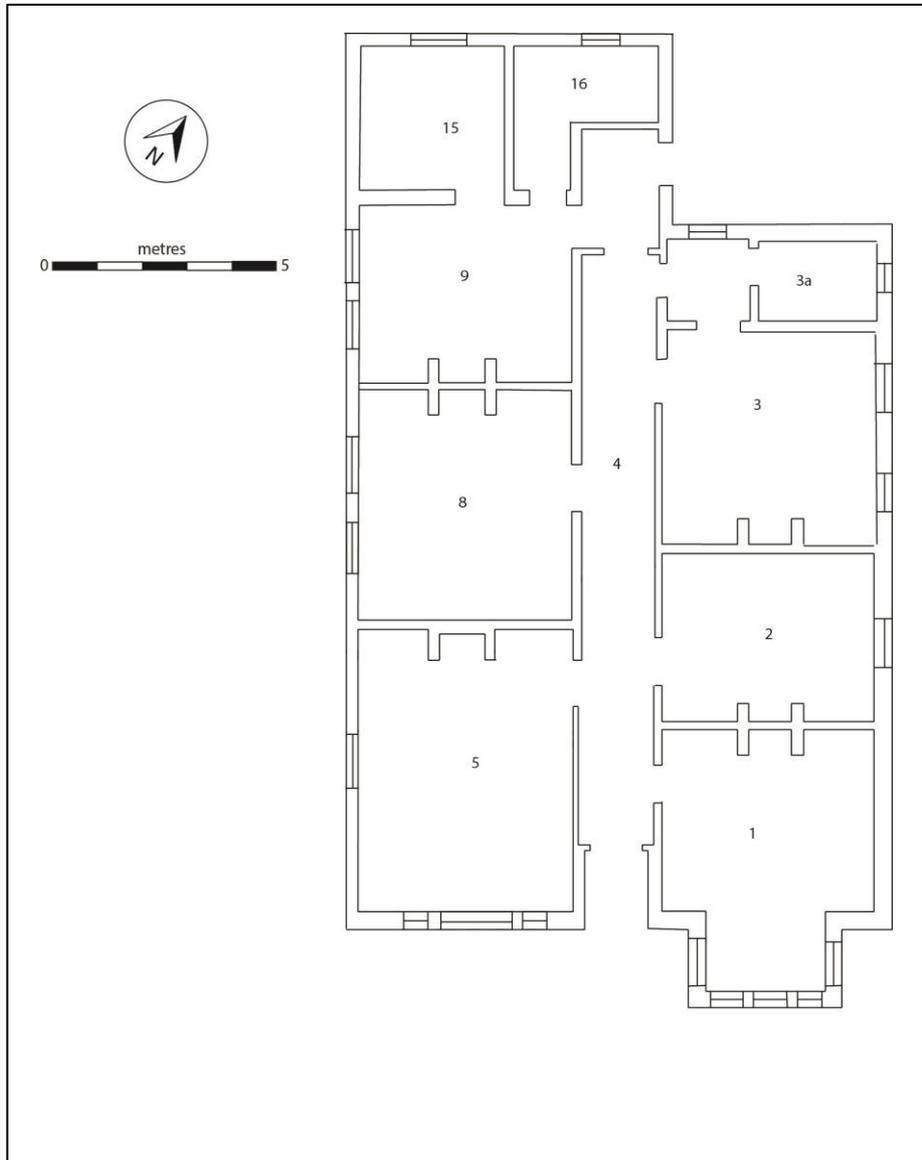
Figure 4-2 The floorplan of the presbytery during Phase 1.

Phase 1. Phase 1 includes the initial construction of the dwelling sometime in the late 1890s (Figure 4-2). The original plan of the house comprised of a two front rooms (Rooms 1 and 5), hallway (Room 4 and Room 7), two rooms off the hallway to the east (Rooms 2 and 3), one room off the hallway to the west (Room 8), a bathroom off the hallway to the west (within Room 3), a kitchen at the rear off the hallway to the west (Room 9), and a lean-to at the end of the hallway which contained the maids room (Room 15), scullery and pantry (Room 16). As seen in the 1929 addition plans (see Figure 4-4 below), the picture windows of Rooms 1 and 5 were flanked with cathedral glass.

The modern layout of the presbytery included 20 rooms from five distinct phases of construction; pre-1900, 1920s, 1940s, 1950s and post-1950s. The original (Phase 1) presbytery structure was eight room single bay brick villa with a central hallway running from the main front entrance to the rear (Rooms 1 – 5, 8, 9, 15 and 16 on Figure 4-2).

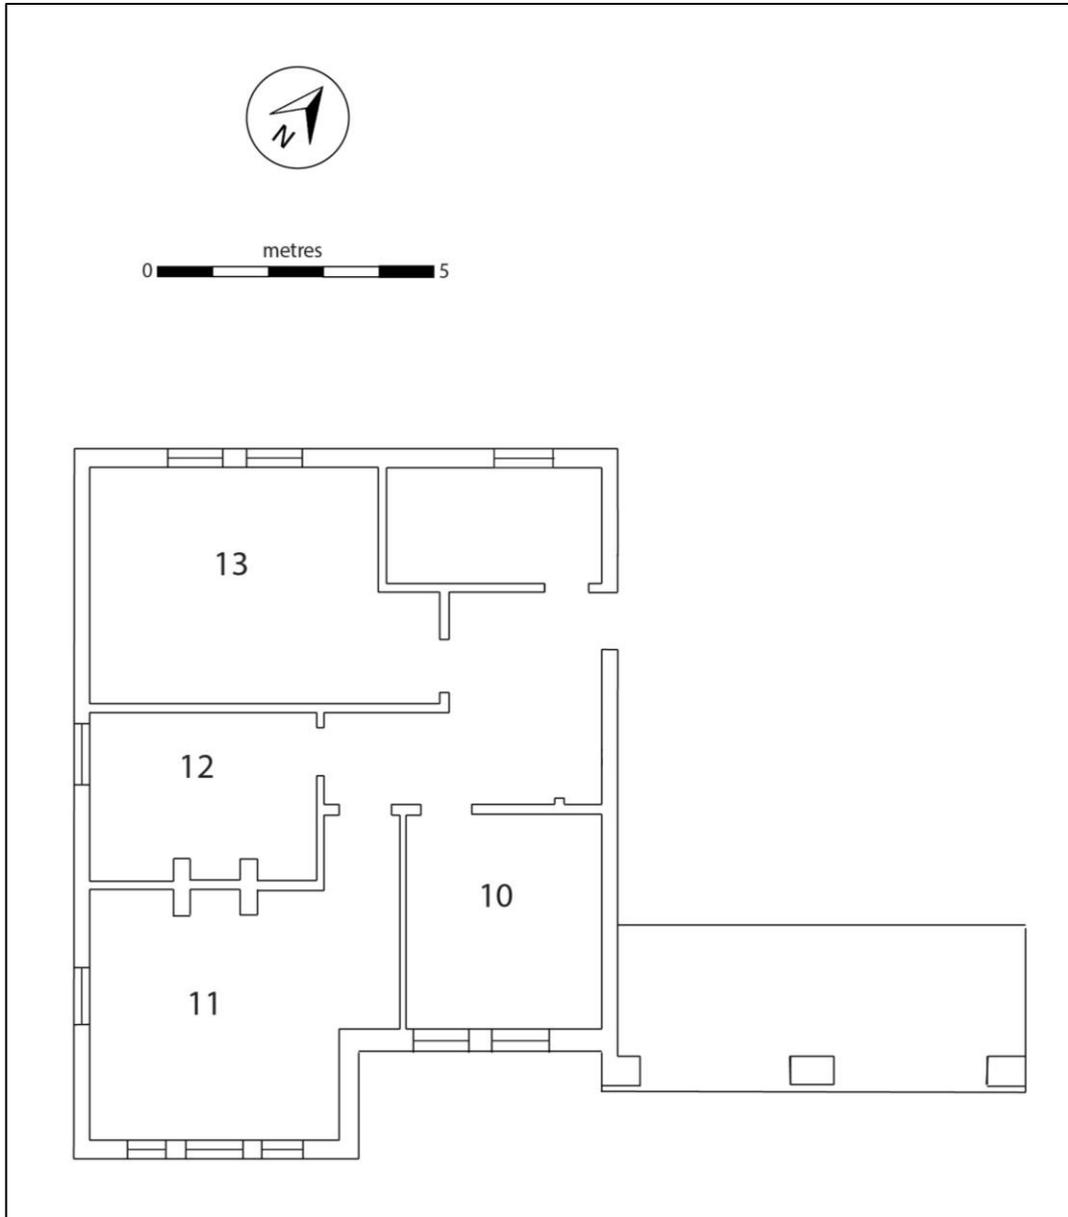
Figure 4-3 Floorplan of the Phase 2 addition. For location refer back to Figure 4-1.

Phase 2. Extensive alterations were undertaken in 1929 (DCC Property Files) (Figure 4-3). This included a new veranda, addition to the front of the structure (Figure 4-4 and Figure 4-5), an addition of five new rooms to the northwest of the existing structure and, some internal modifications to the original presbytery structure. Internal modifications relating to the new addition included a reduction in the size of Room 5 and removal of fireplace to create the hallway access into the new extension, removal of the windows on the west wall of Room 5 and the replacement of the window on the west wall of Room 8. Further internal modifications to the original structure also included a new door and frame halfway down the hallway (Room 4) and change of layout to the lean-to as follows:

- Removal of doorway into maid's room (Room 15);
- Removal of partition between Room 15 and old pantry, and installation of new partition to create smaller pantry (Room 16) at north end of the hallway (Room 4);
- Removal of the window in the south wall of the pantry (Room 16);
- New louvre on the east wall of the reduced pantry (Room 16);
- New doorway from Room 4 into Room 16.

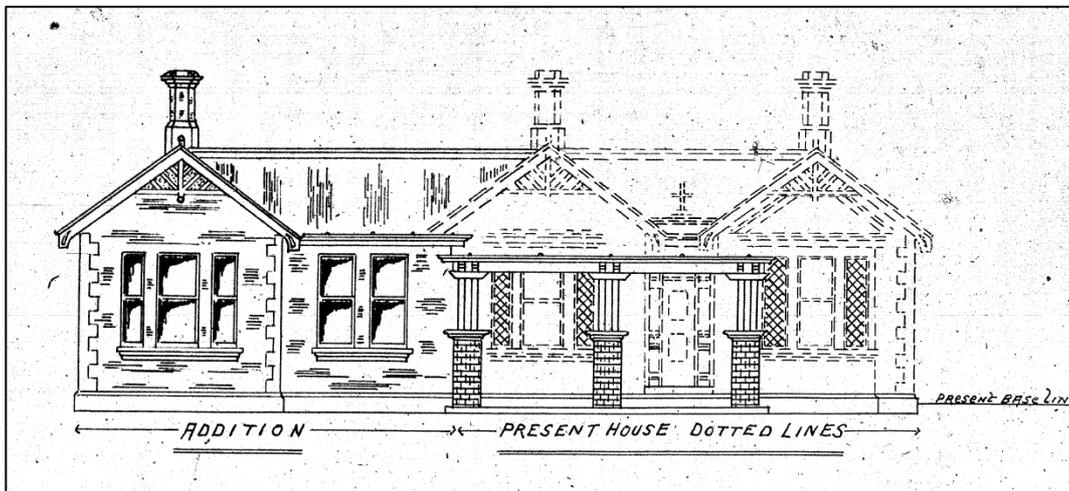
Figure 4-4 1929 Proposed addition, south elevation and original, Phase 1 design (Building Plans, DCC Archives).

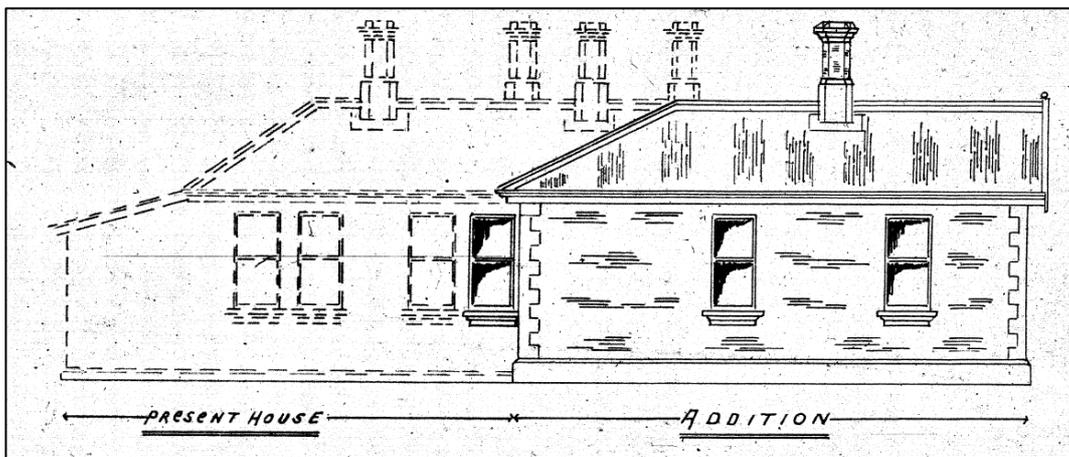
Figure 4-5 1929 Proposed addition, west elevation (Building Plans, DCC Archives).

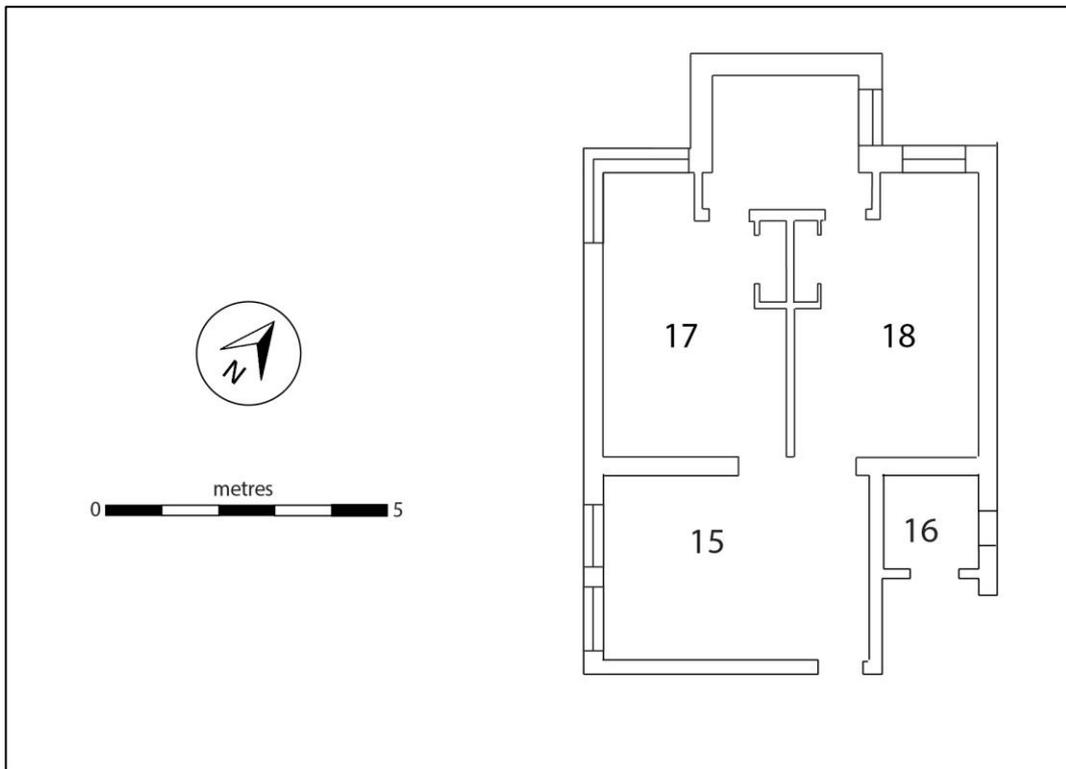
Figure 4-6 Floorplan of Phase 3 additions. For location refer back to Figure 4-1.

Phase 3. In 1940 another extension was made to the rear of the presbytery off the lean-to (Figure 4-6). This included an addition of two bedrooms and a bathroom (Figure 4-7). The window along the north wall of Room 15 was removed and two new doorways created to access the new bedrooms. Two more windows were created along the west wall of Room 15.

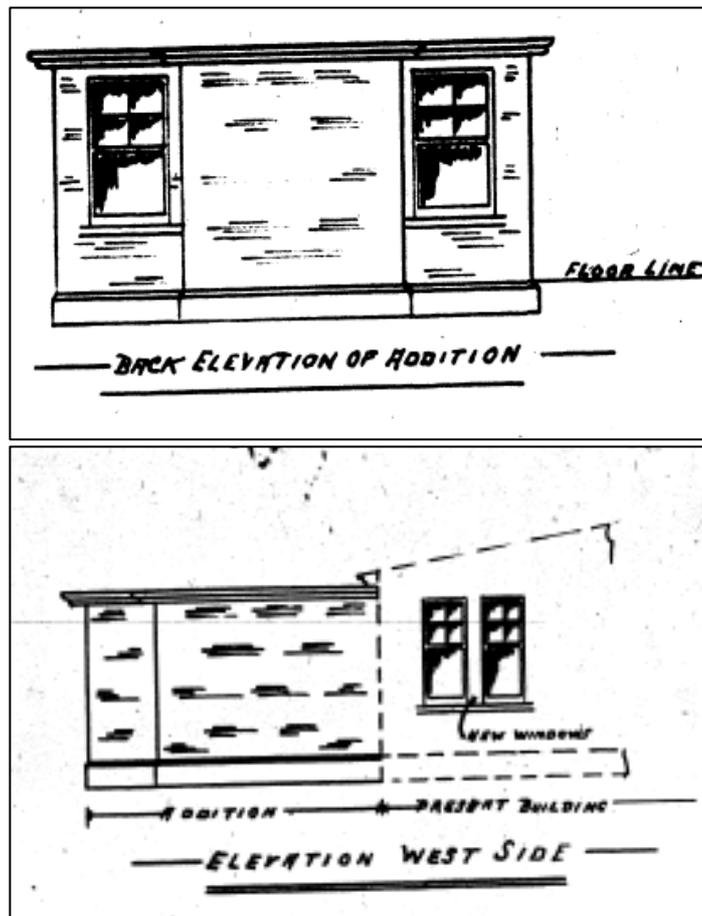
Figure 4-7 1940 Phase 3 addition. Top: west elevation (Room 17 left side and Room 18 right side). Bottom: north elevation (Building Plans, DCC Archives).

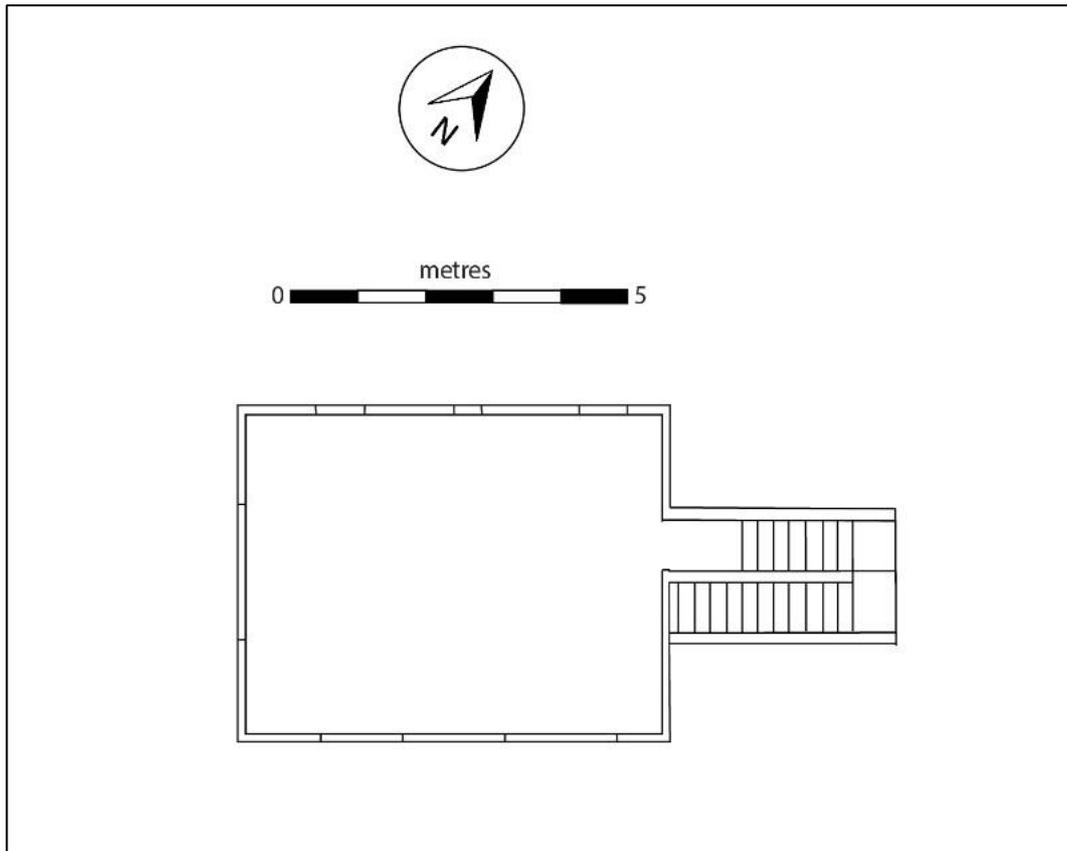
Figure 4-8 The Floor plan of the Phase 4 upstairs room.

Phase 4. In 1951 a second-storey was built on top of the 1929 extension (Figure 4-8). Internal modifications to Room 6 were made to accommodate a staircase access to the new addition (Figure 4-9).

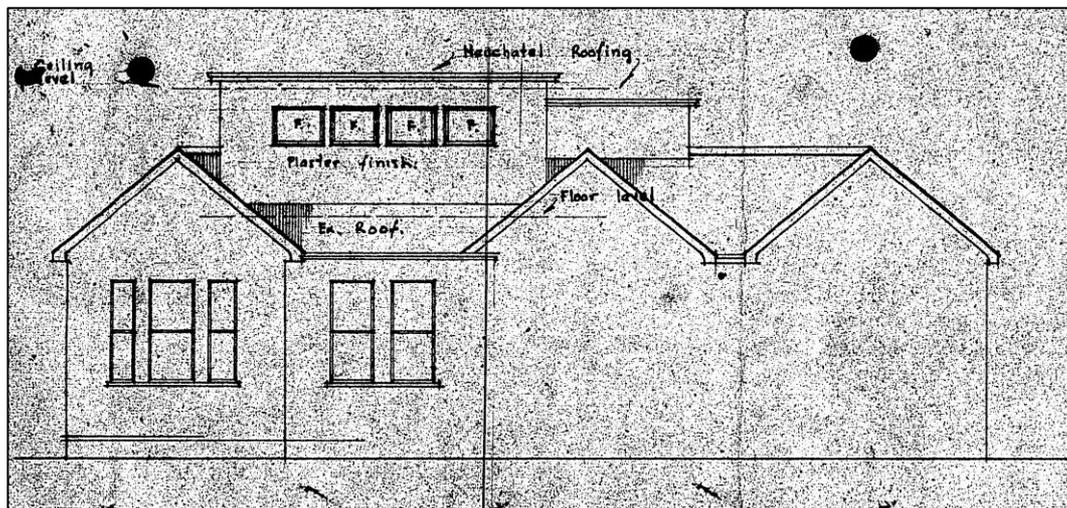
Figure 4-9 1951 Proposed addition, south elevation (Building Plans, DCC Archives).
