Serving the Community: St Patrick's Church Complex

**Final Report for Archaeological Investigations
at Site No. I44/539 – I44/542
Under Archaeological Authority No. 2013/61**

Report Prepared for St Patrick's Development Committee
Authors: Sheryl Cawte, Eva Forster-Garbutt, Naomi Woods, Jeremy
Moyle and Peter Mitchell
Reviewed By: Dr Hayden Cawte
05/06/2018

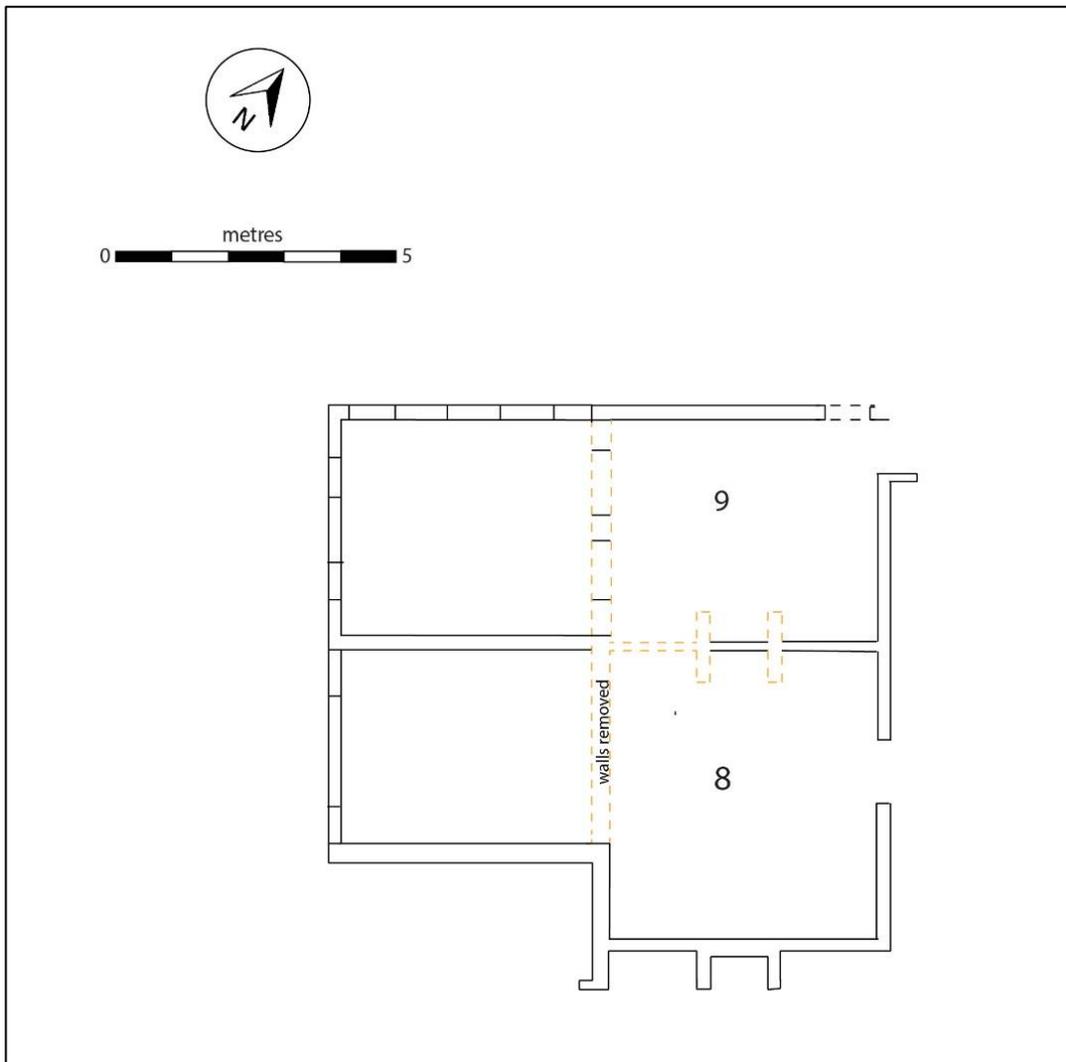
Figure 4-10 Floorplan of the Phase 5 changes to Rooms 8 and 9. For location refer back to Figure 4-1.

Phase 5. Further modifications to the presbytery based on plans submitted to the DCC were undertaken in 1956 after a fire in the kitchen (Room 9) (Figure 4-10). These modifications involved the extension of Rooms 8 and 9 to the west to increase the size of the rooms (Figure 4-11 and Figure 4-12). Internal modifications included the removal of the window in Room 8 and a doorway to provide access between Rooms 8 and 9.

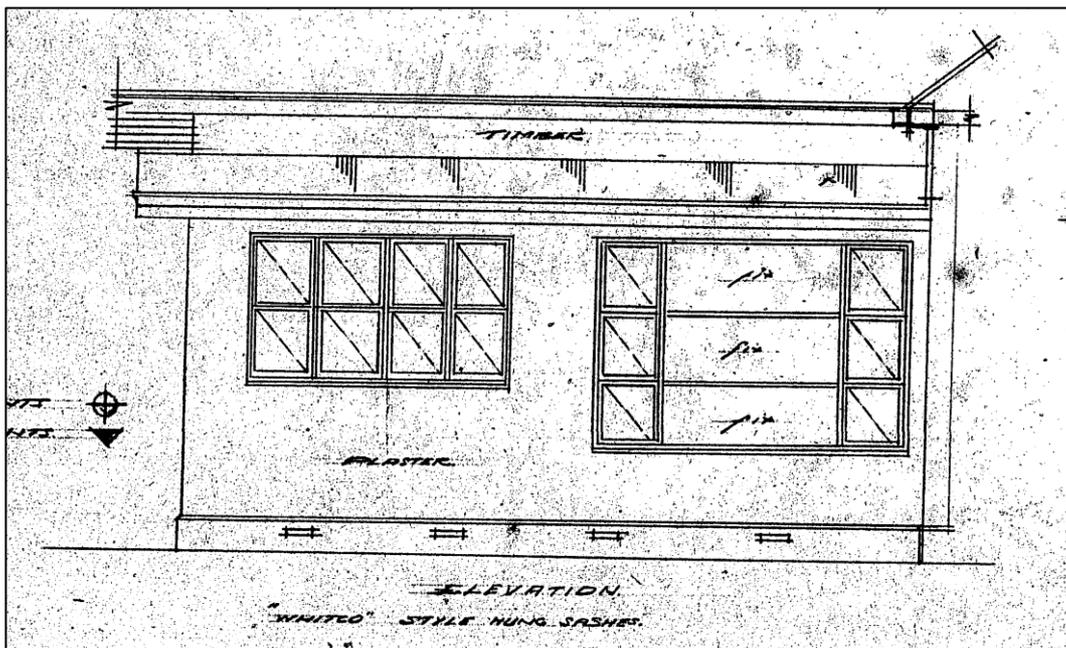
Figure 4-11 Detail from the 1956 alterations showing the proposed west elevation (Building Plans, DCC Archives).

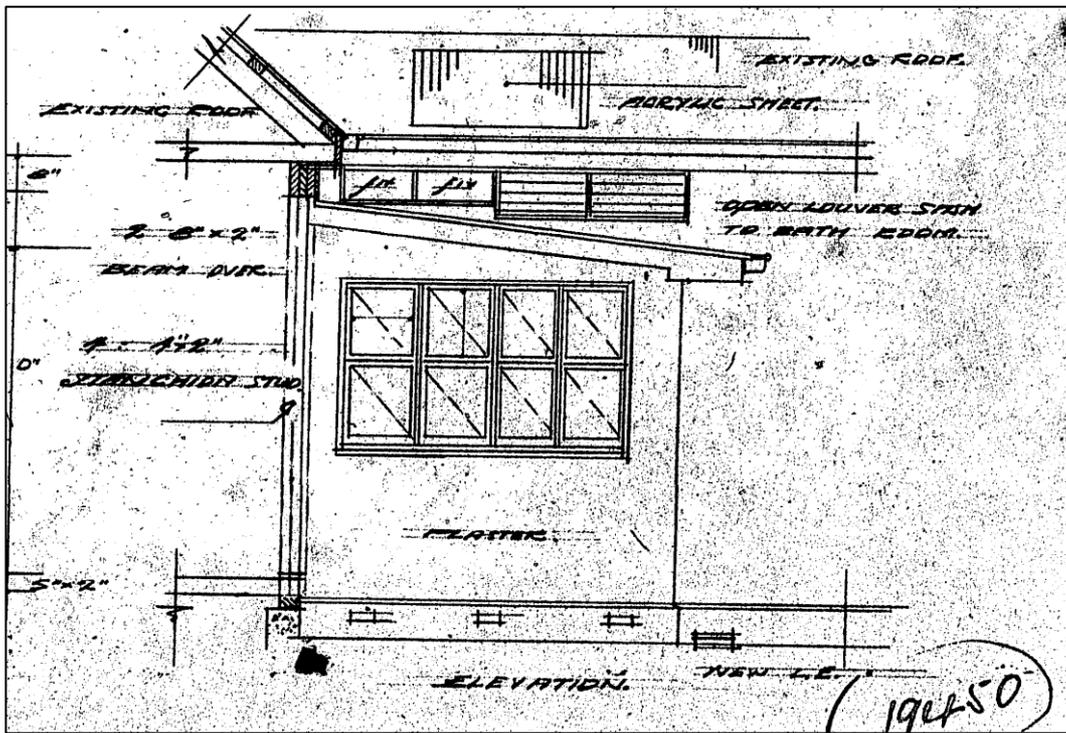
Figure 4-12 Detail from the 1956 plans showing the proposed north elevation (Building Plans, DCC Archives).

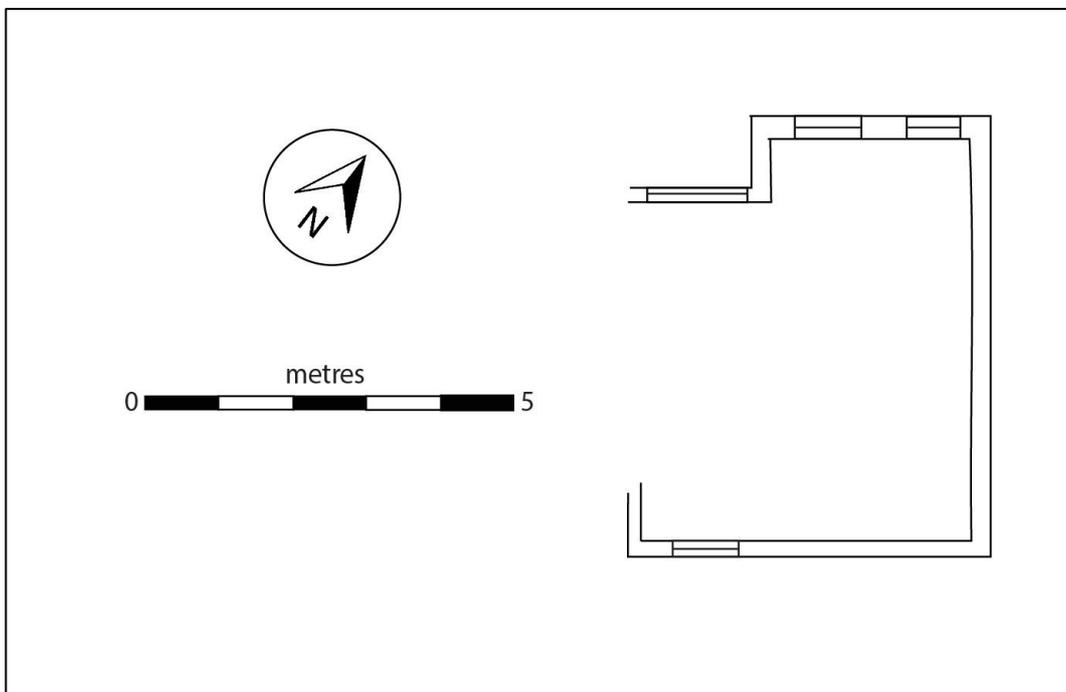
Figure 4-13 The floorplan of the Phase 6 addition. For location refer back to Figure 4-1.

There are several modifications to the structure post 1956 that do not have accompanying documentation. However, based on the 1976 aerial from the ODT (Figure 1-19), an addition at the rear of the presbytery along the northeast was constructed creating a new back door entrance no longer out of Room 7, change of windows in the 1956 addition and the construction of the outbuildings at the rear of the presbytery site.

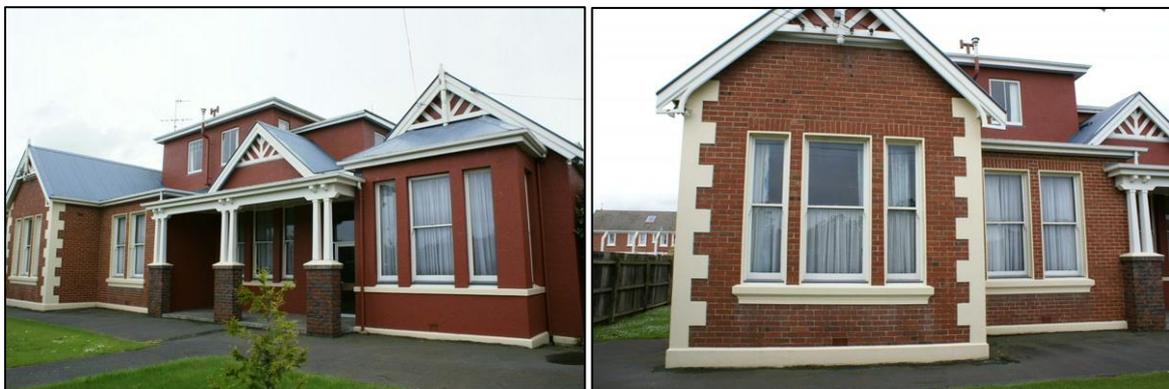
Figure 4-18 Exterior: Left – south elevation showing part of the original presbytery structure with a modern stucco and Californian bungalow veranda on the right side. Right – south elevation showing later addition constructed of brick.

The original presbytery was a single bay villa with a lean-to at the north (rear) elevation. The roof was double gabled with a single bay. After the additions, the presbytery had a much more complex form. The building was oriented northwest-southeast, fronting onto MacAndrew Road. The primary access to the building was off MacAndrew Road through the south elevation (Figure 4-18), which was comprised of two distinct phases of construction. On the right was the original presbytery structure with a roughcast finish and bay window, while the 1929 extension could be seen to the left of the California bungalow style veranda, added at the same time. The 1929 southern addition mimicked the flush open gable roof with a single flush bay (see Figure 4-4). The bargeboards on the original areas of the roof had been replicated on the post-1900 bay, as had the Chicago windows found on the right-hand bay and to the left of the entrance. The front entranceway had been replaced with a modern glass door and large plain transom window.

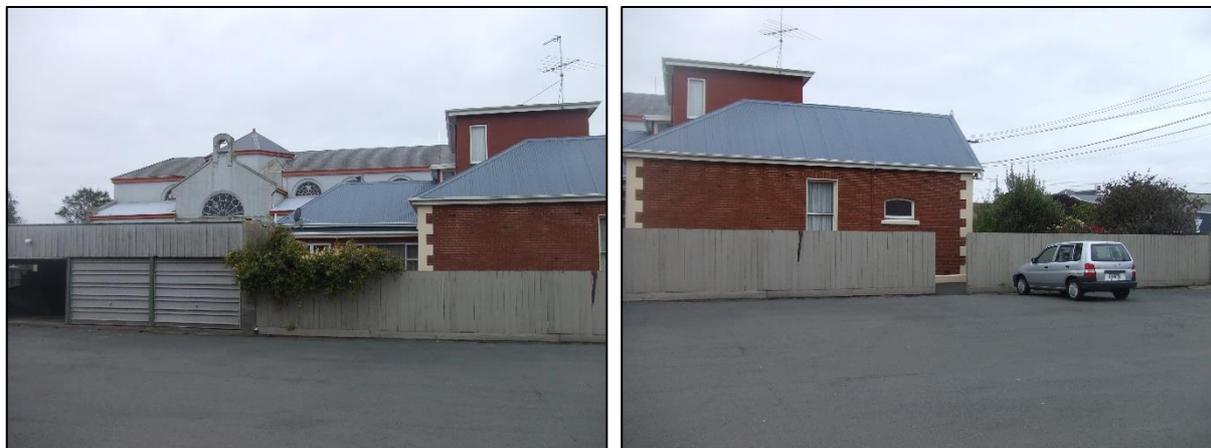
Figure 4-19 West elevation of the presbytery. Left: The 1929 brick addition can be seen in the right of the image, the 1956 extension to Rooms 8 and 9 in the centre (behind the foliage), and the 1951 extension is located behind the garage block. Right: The front addition with its fixed and sash windows.

None of the original presbytery building was visible on the west or north elevations. The proximity of the garage block and timber fence meant that it was not possible to photograph the west elevation in its entirety (Figure 4-19). There were a variety of window styles recorded along this elevation, including a small fixed window with

textured glass and a sash window on the front addition (Figure 4-19, right) and modern aluminium windows on the 1950s extension to Rooms 8 and 9 and 1940s rear extension. The north elevation was dominated by the mid-twentieth century rear extensions (Figure 4-20) and the back entrance was located along this side. The original structure also had rear, secondary access on the north elevation of the lean-to, which was part of the internal structure at the time of demolition.

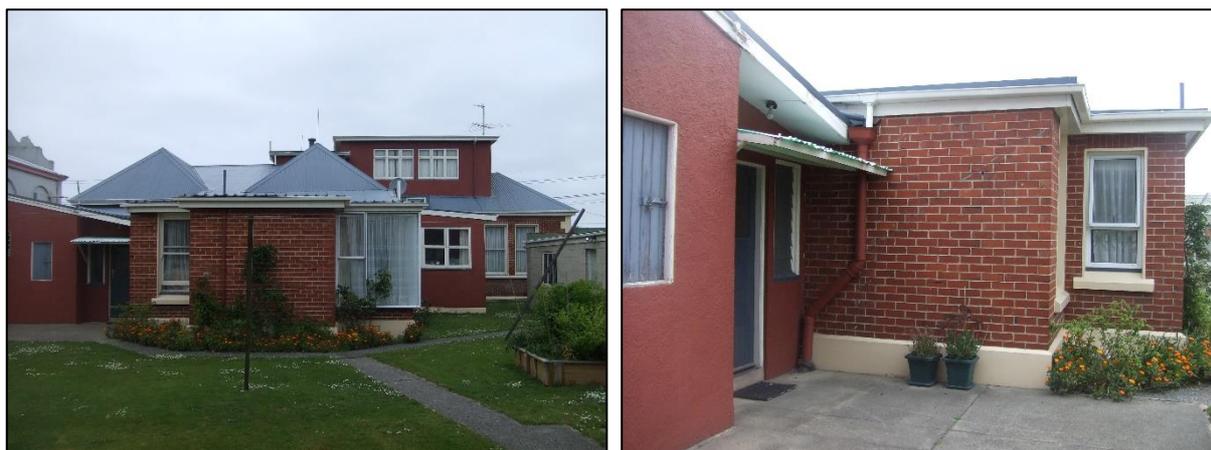
Figure 4-20 North elevation of presbytery showing 1951 rear extension in the foreground and undocumented addition to the far left of the photo, the 1956 extension in the mid-ground and the 1929 extension in the back right, partially obscured by the garage. Right: The modern rear entranceway along the north elevation.

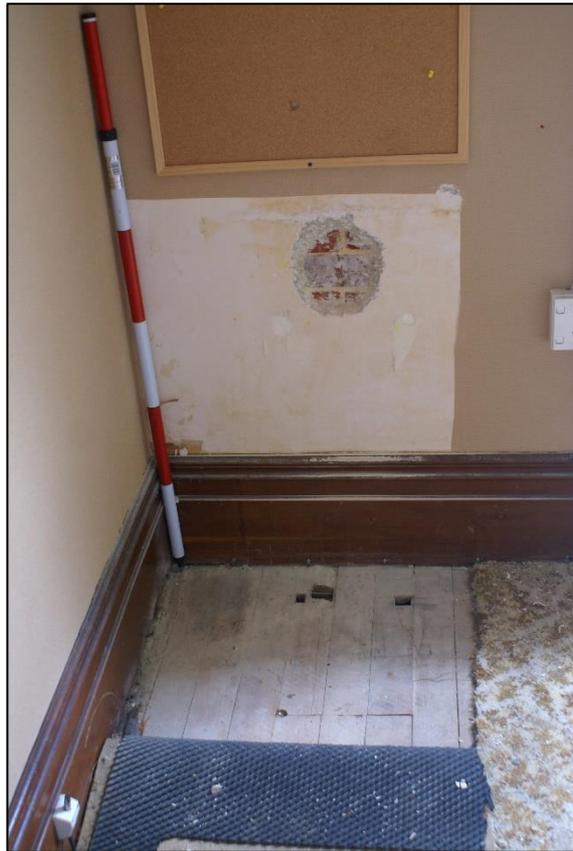
Figure 4-21 Plastered brick exterior wall of the original presbytery along the west side of Room 5 from within Room 10.

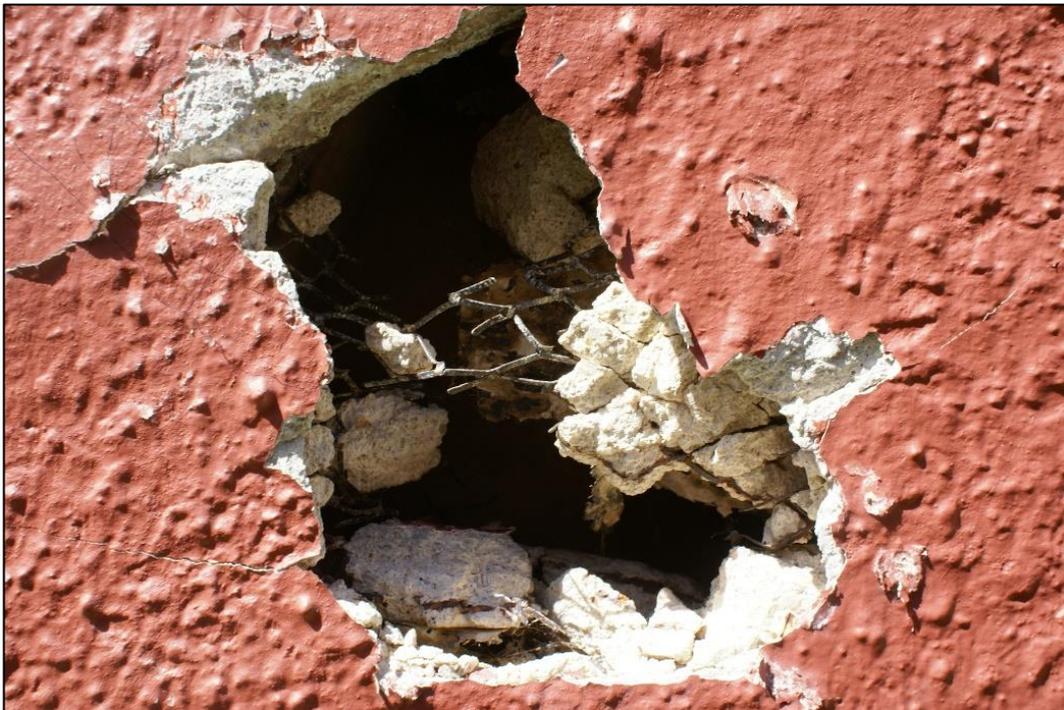
Figure 4-22 Detail of stucco over a cavity wall along the west side, outside Room 8 (the kitchen).

The pre-1900 portion of the house was constructed of brick in an English Garden Wall bond with a roughcast finish (Figure 4-22). It is believed that the roughcast was applied at the same time as the kitchen addition in 1956 which was probably undertaken as a result of the large fire that destroyed the original room. The original structure was plaster over brick (Figure 4-21). The roughcast was also used as a means of controlling moisture. The brick 1929 and 1940 additions were constructed of brick using cavity walls which created greater airflow throughout the structure and minimising the effect of the rising damp on the structure. It is likely that these portions of the structure were spared the stucco revamp as it did not need further moisture control.

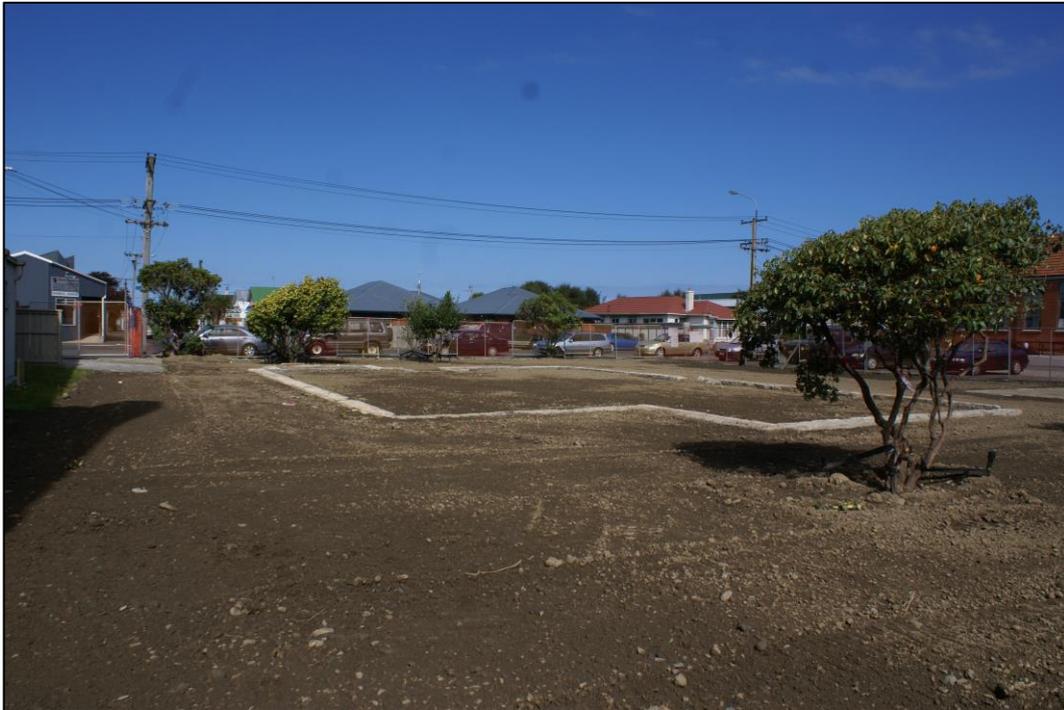
Figure 4-23 Presbytery founds left in-site at the end of Stage 2 works.

Once the building archaeology was completed, the presbytery was demolished down to its footings. The footings of the original presbytery building remain in-situ and have been incorporated into the new garden area (Figure 4-23).

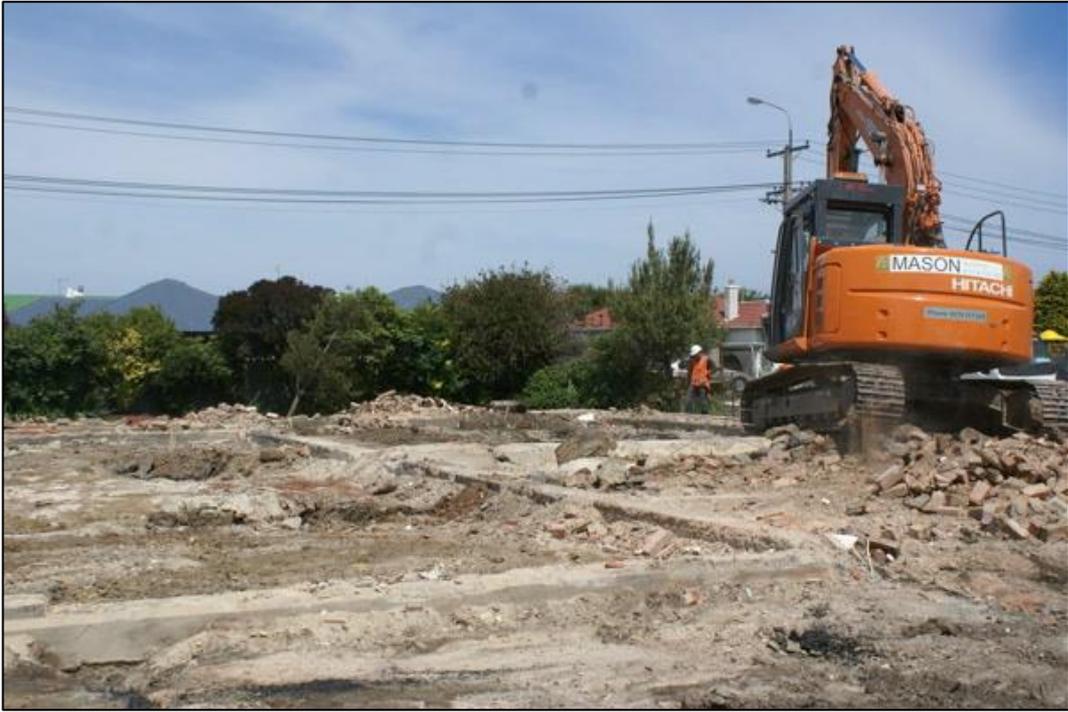
Figure 4-24 The Phase 1 concrete ring foundation at 32 MacAndrew Road.

The Phase 1 foundations at 32 MacAndrew Road consisted of an unreinforced concrete ring foundation with concrete piles within the building footprint (Figure 4-24). The concrete ring foundations were 400 x 800 mm deep and were buried to a depth of 600 mm (Figure 4-25). There was a slate damp proof course between the concrete ring foundation and the brick courses. The concrete piles within the original building footprint were 250 x 350 mm and encased in timber (Figure 4-26). They were 220 mm above the ground surface and spaced 1 m apart. The bases of the four fireplaces were concrete mixed with bluestone stone and rubble, 1400 x 1200 mm and were buried to a depth of 400 mm (Figure 4-27). The bases of the fireplaces all remained in-situ until demolition despite the one in Room 3 being removed internally.

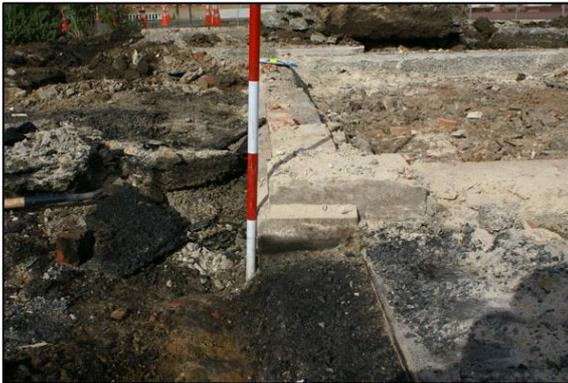
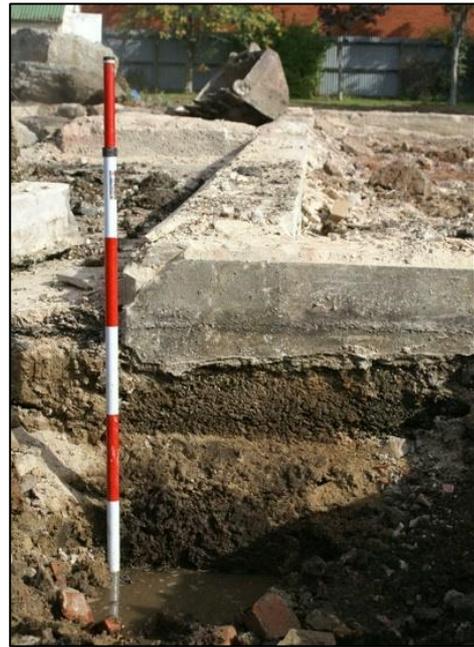
Figure 4-25 Detail of the Phase 1 concrete ring foundations.

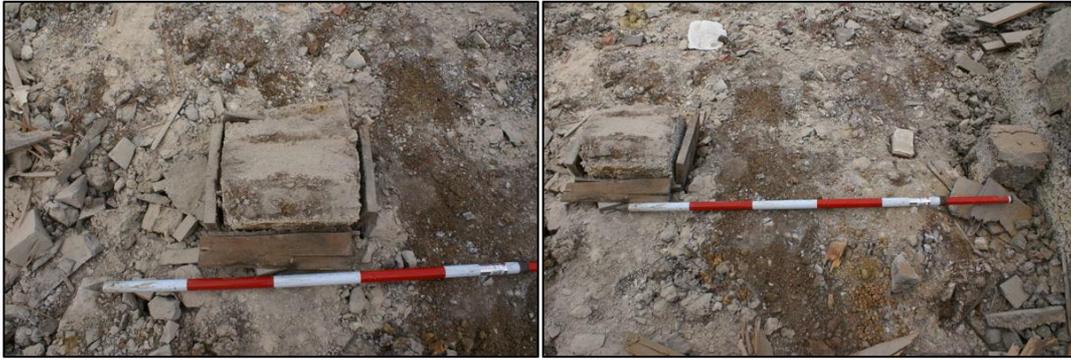
Figure 4-26 Phase 1 concrete piles within the building footprint encased in boxing.

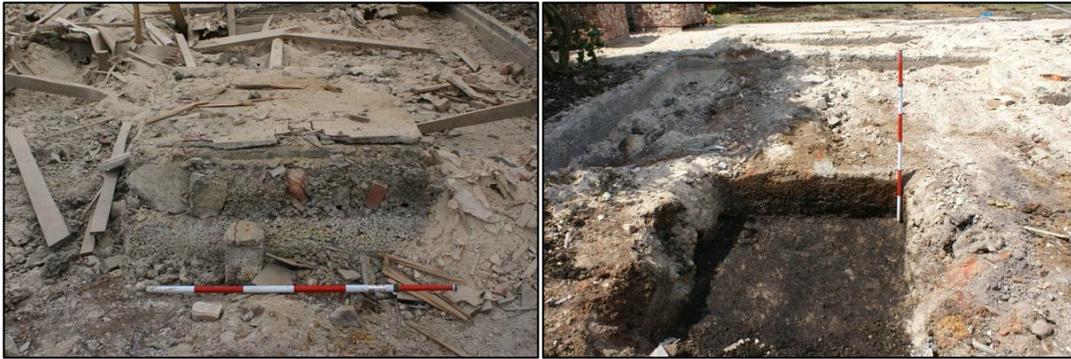
Figure 4-27 Left: Phase 1 fireplace base in-situ. Right: Fireplace base removed.

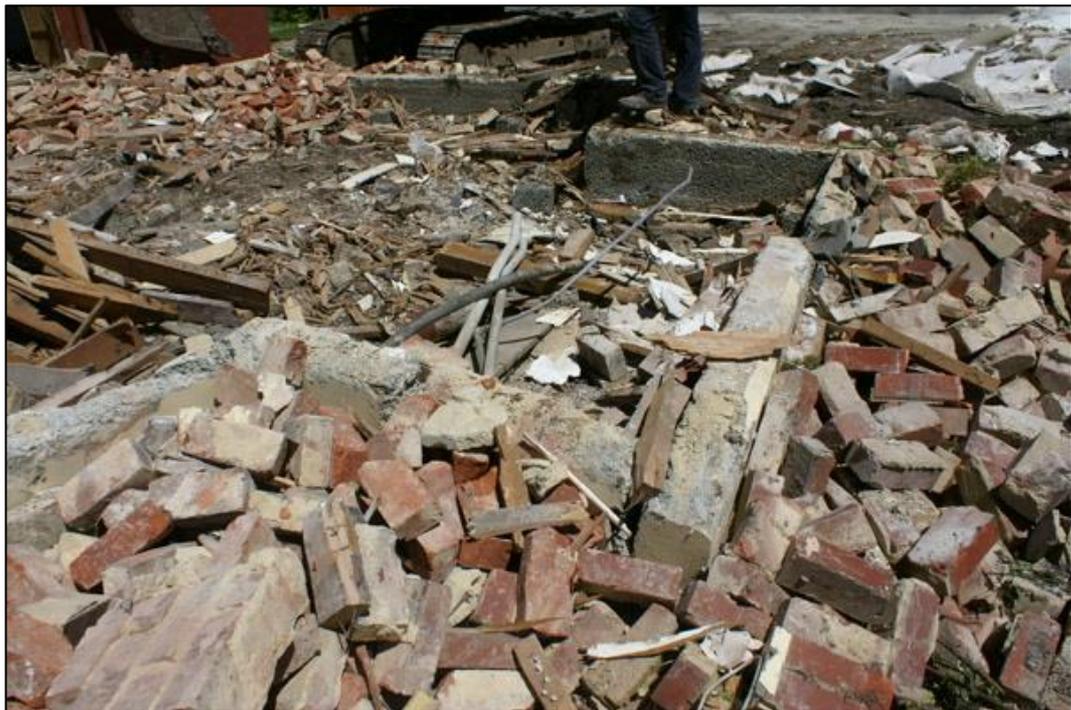
Figure 4-28 Later phase foundations at 32 MacAndrew Road.

The foundations of the later phases of construction were reinforced concrete 200 mm wide and standing 300 mm above ground level (Figure 4-28). Concrete encased in wood was also used as piles under the Phase 2 (1929) addition of the building.

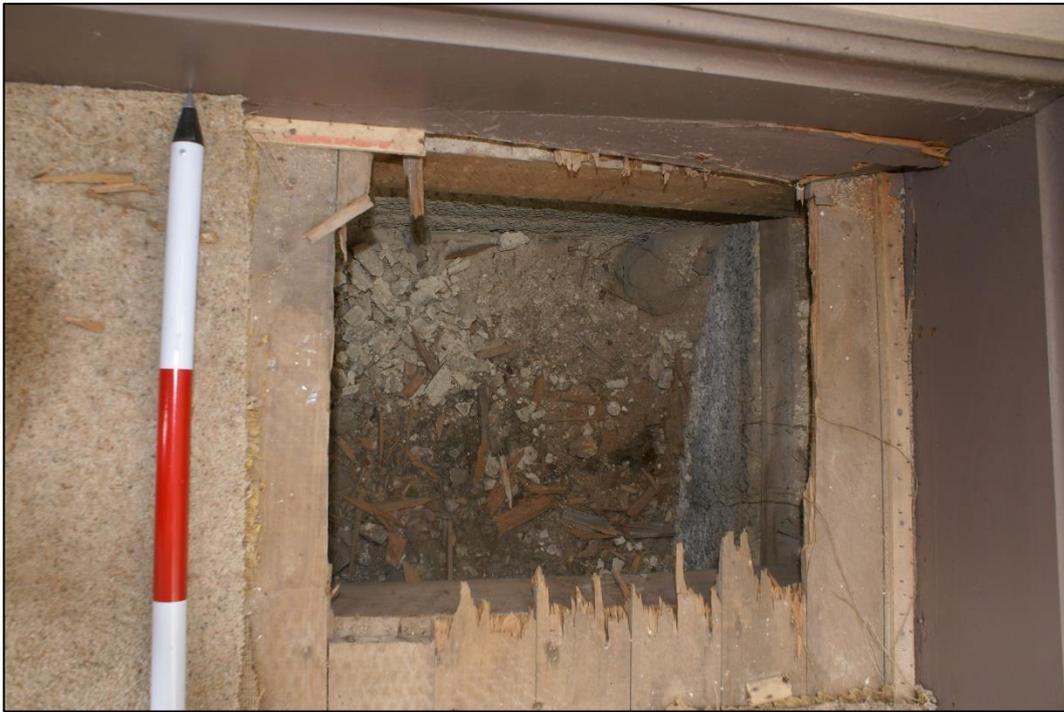
Figure 4-29 The Phase 1 floor in the northeast corner of Room 1.

The Phase 1 subfloor structure consisted of 120 x 120 mm rimu bearers that sat atop the piles and supported 150 x 50 mm rimu joists (Figure 4-29). The bearers were placed 1 m apart and the joists were 450 mm apart (Figure 4-29).

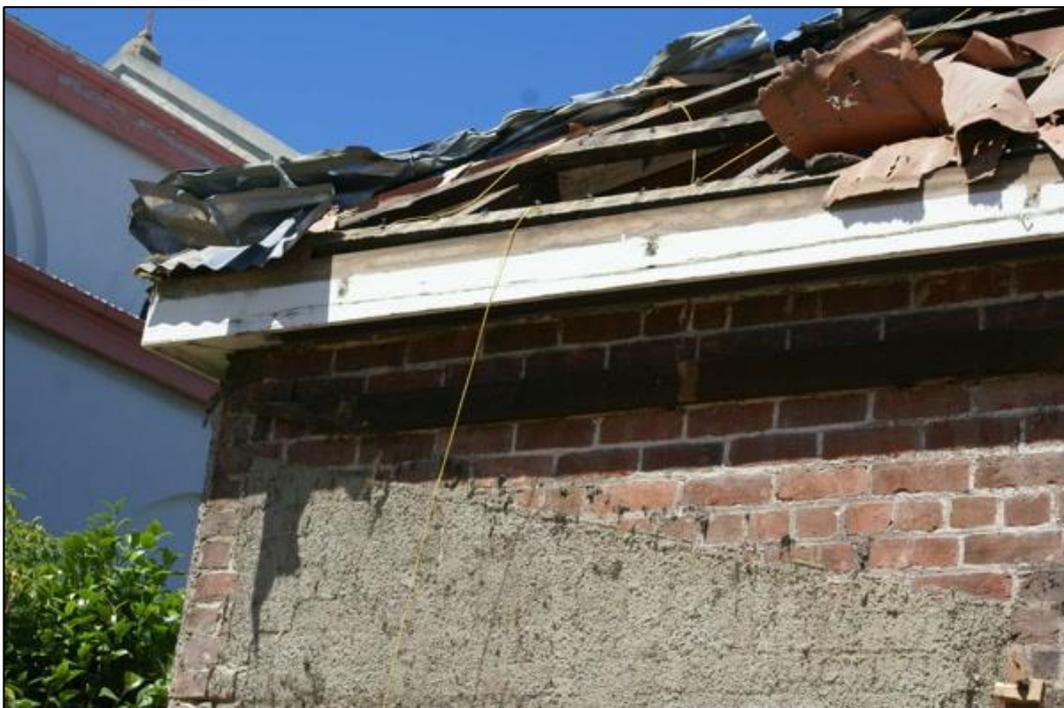
The external and load bearing Phase 1 walls were single brick laid in English Garden Wall bond (Figure 4-30). The walls were covered in plaster render on the exterior and lined with lath and plaster or beaded tongue and groove match lining on the interior (Figure 4-31). Metal strapping was used in the Phase 2 exterior brick walls (Figure 4-32).

Figure 4-30 External Phase 1 wall in English Garden Wall bond.

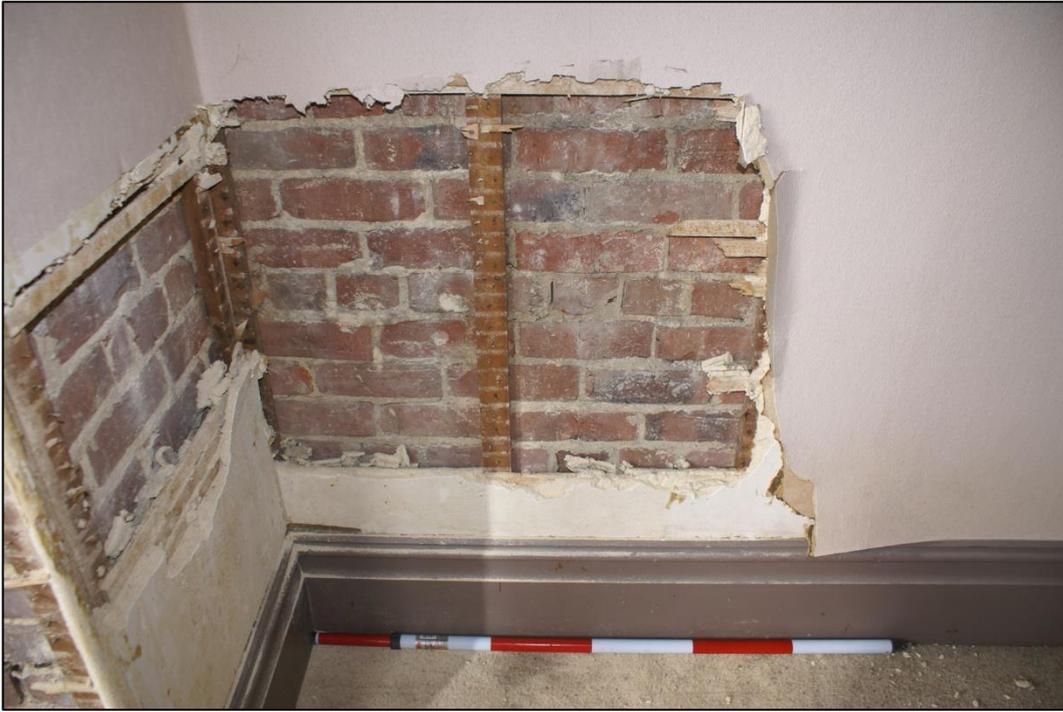
Figure 4-31 Internal load bearing wall between Room 1 and Room 4 as seen in Room 1. Note the English Garden Wall bond.

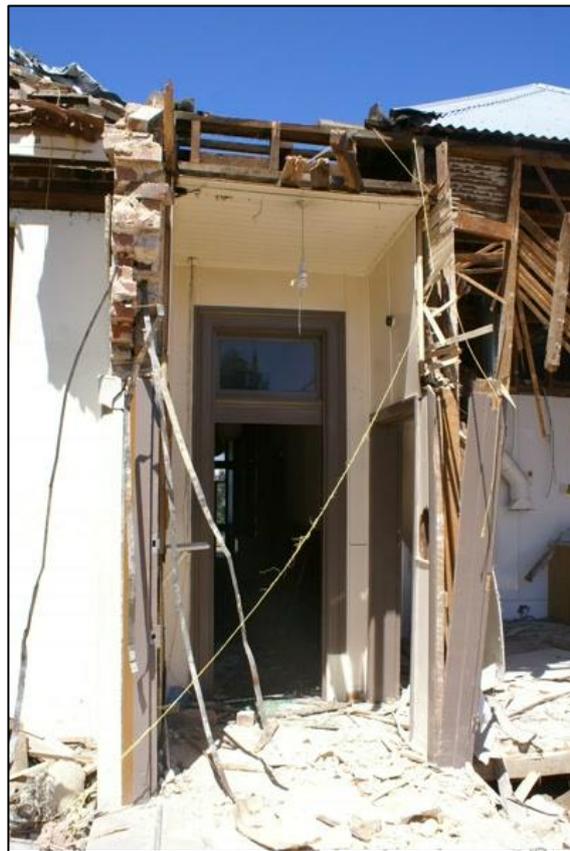
Figure 4-32 During demolition the steel strapping in the Phase 2 brick walls was visible.

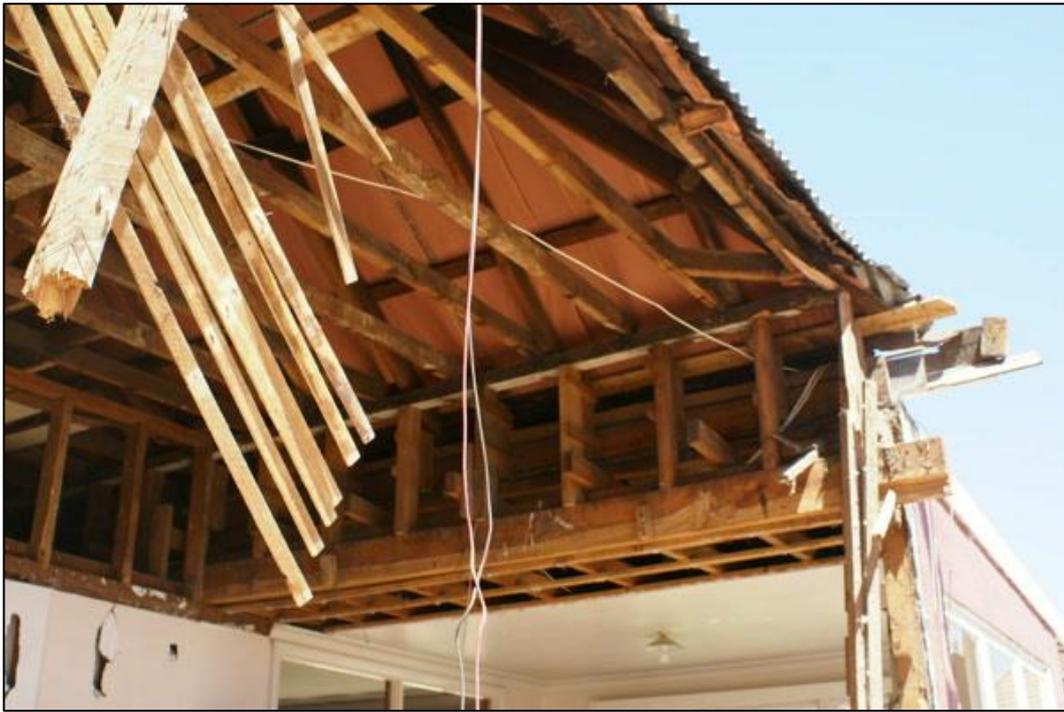
The ceilings varied room to room, but the Phase 1 ceilings were all hung on 50 x 90 rimu ceiling joists spaced 450 mm apart (Figure 4-33).

Figure 4-33 Ceiling structure of Room 9 visible during demolition.

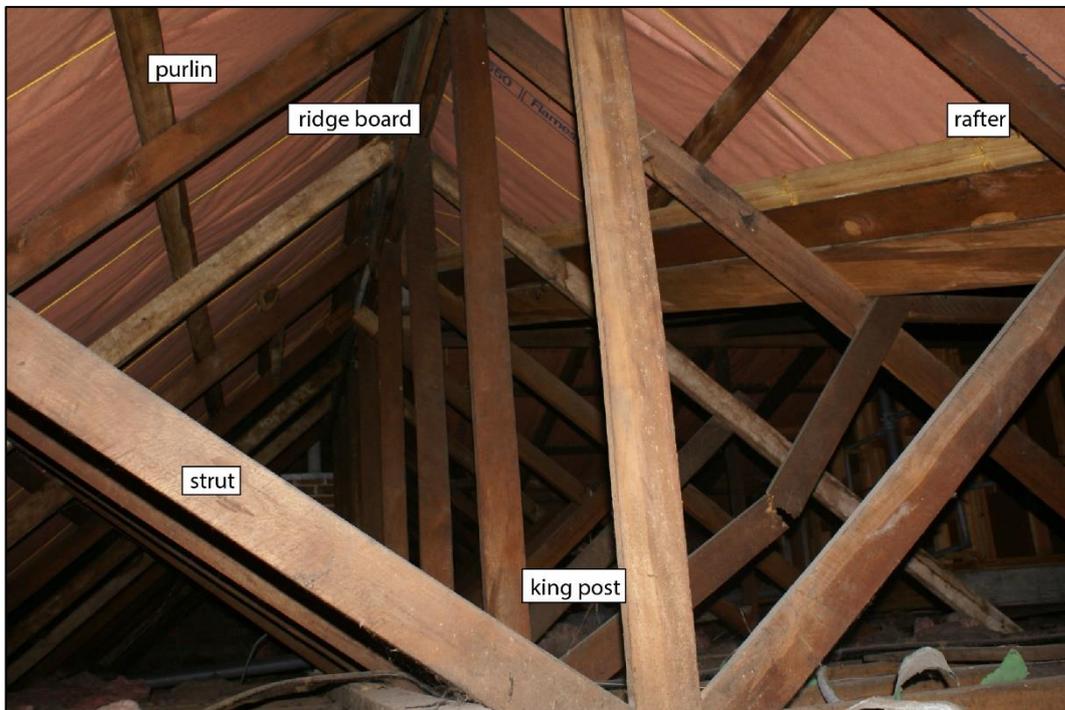
The Phase 1 roof was a timber frame king post roof (Figure 4-34). The framing consisted of 50 x 90 mm rimu king posts, struts and rafters spaced 900 mm apart and fixed to a ridge board. There were purlins fixed to the top of the rafters. There was evidence of fire in the roof structure above Room 9 (Figure 4-35). The corrugated iron had been replaced in the latter part of the twentieth century.

Figure 4-34 The Phase 1 roof structure.

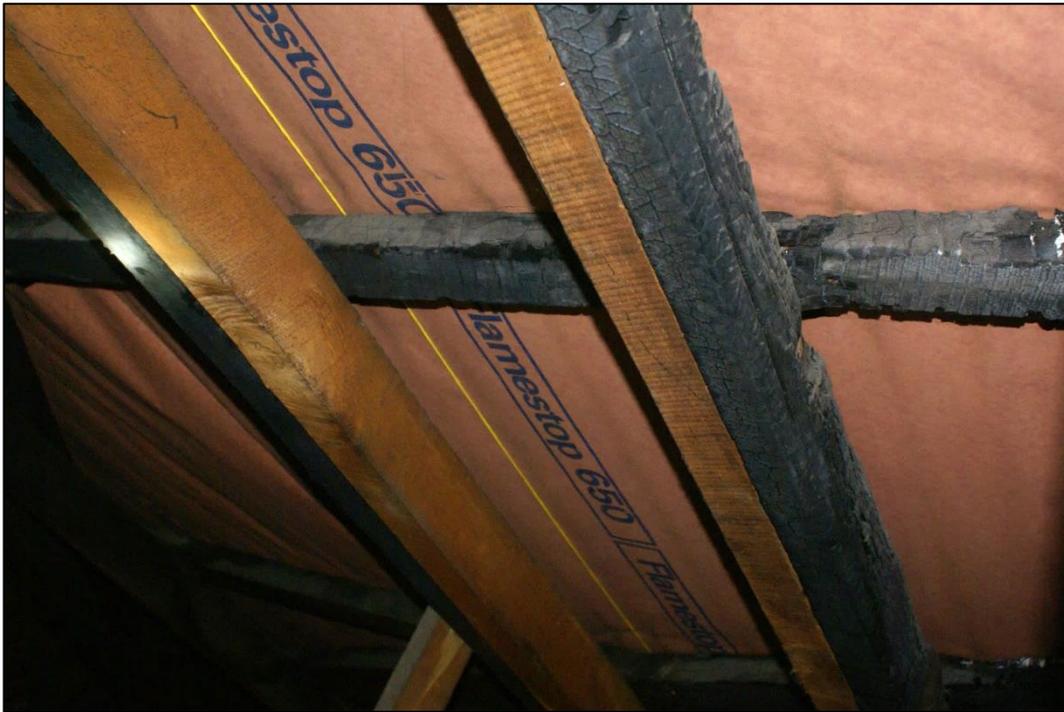
Figure 4-35 Evidence of a fire in the roof structure above Room 9.

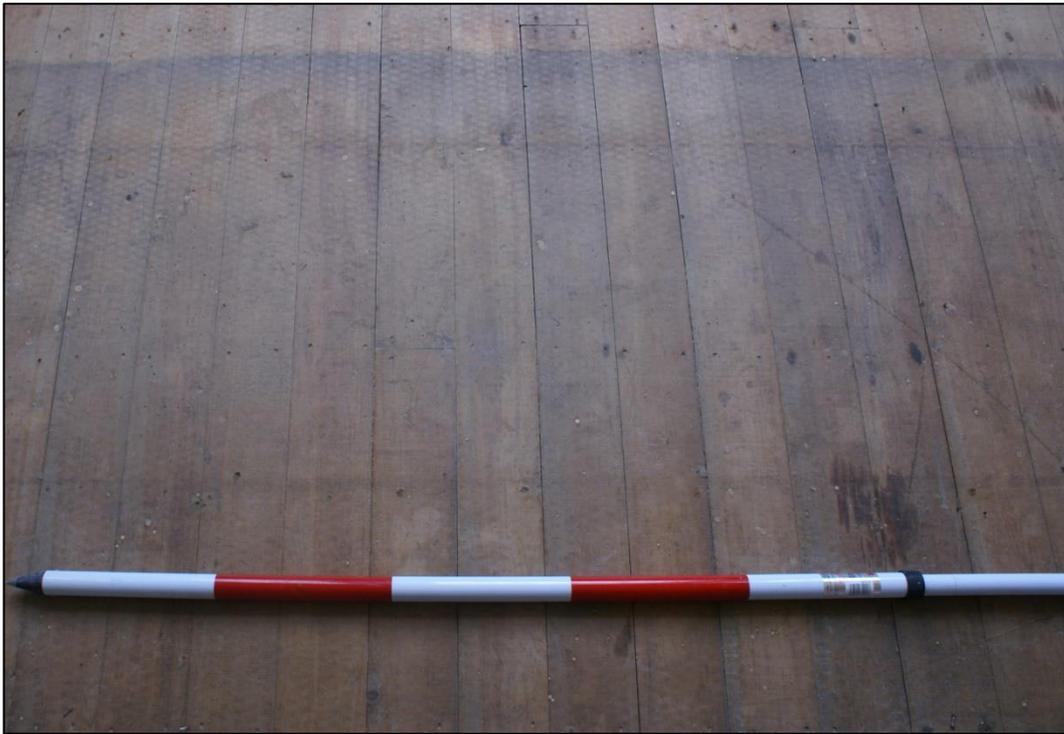
The floorboards were 100 x 20 mm tongue and groove fixed to the floor joists. The floorboards were generally aligned north to south (Figure 4-36).

Figure 4-36 Tongue and groove floorboards in Room 1.

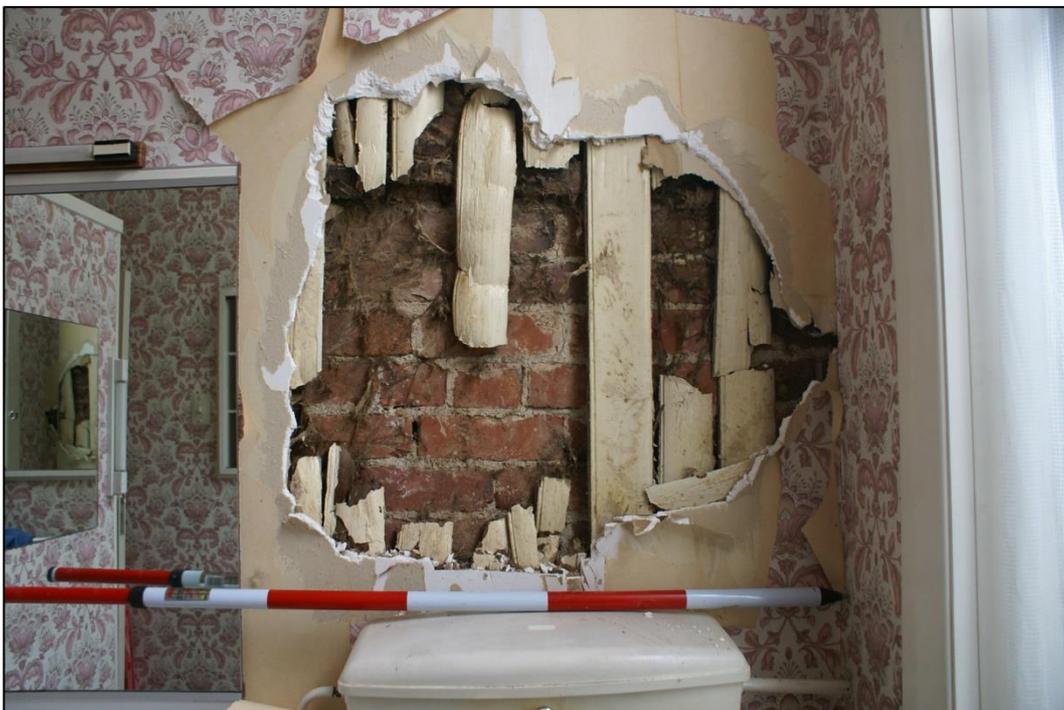
The Phase 1 internal walls were lined with a mixture of 110 x 12 mm beaded tongue and groove match lining and lath and plaster (Figure 4-37 to Figure 4-39). In some rooms twentieth century plaster board had been fixed over the original wall linings (Figure 4-40).

Figure 4-37 Beaded tongue and groove wall lining in Room 3a, north wall.

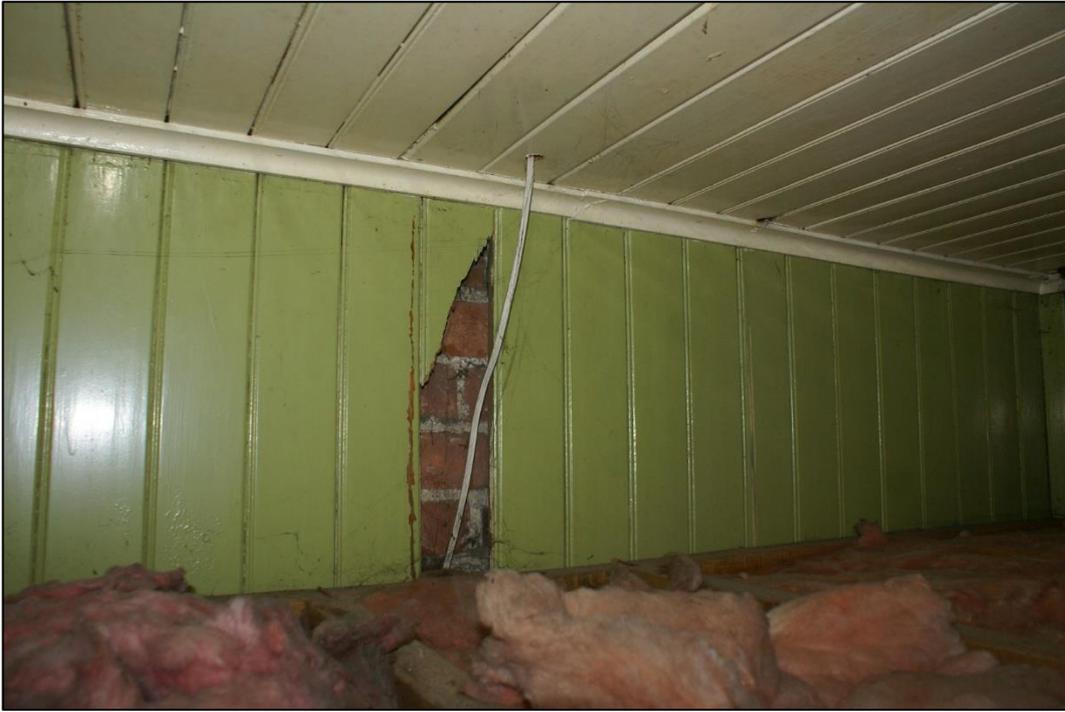
Figure 4-38 Beaded tongue and groove match lining over brick, above false ceiling in Room 3a, north wall. Note the match lining on the original ceiling

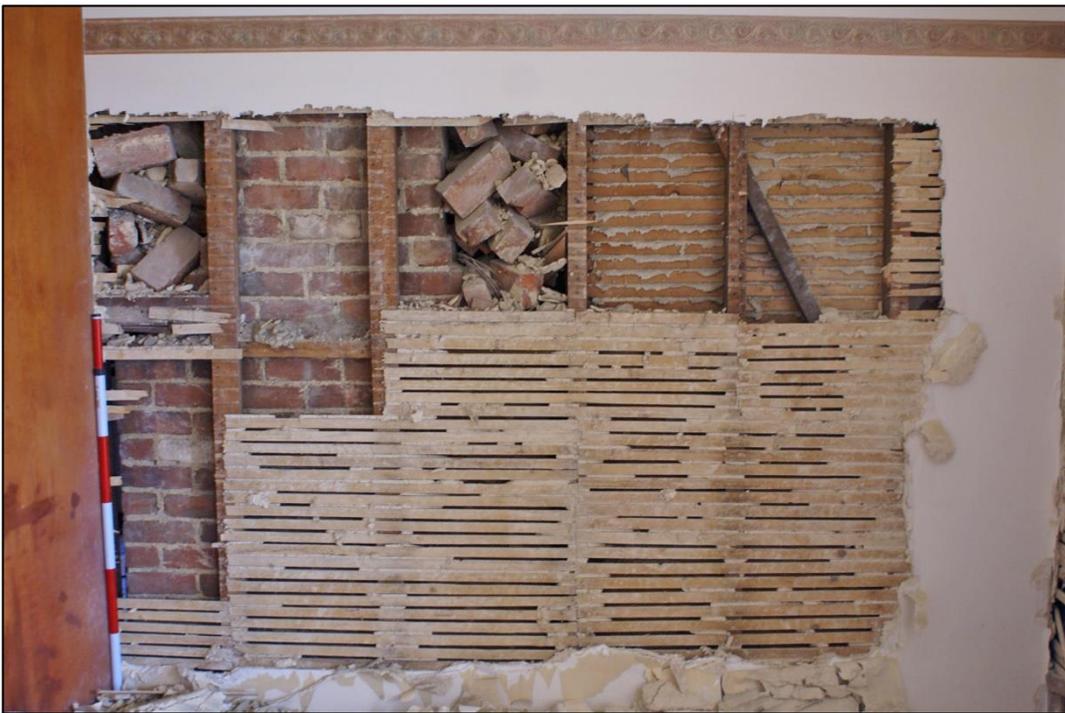
Figure 4-39 Lath and plaster wall lining in Room 8, south wall. Note the chimney bust of Room 5 in the wall and fallen bricks from the deconstructed chimney stack in the wall cavity.

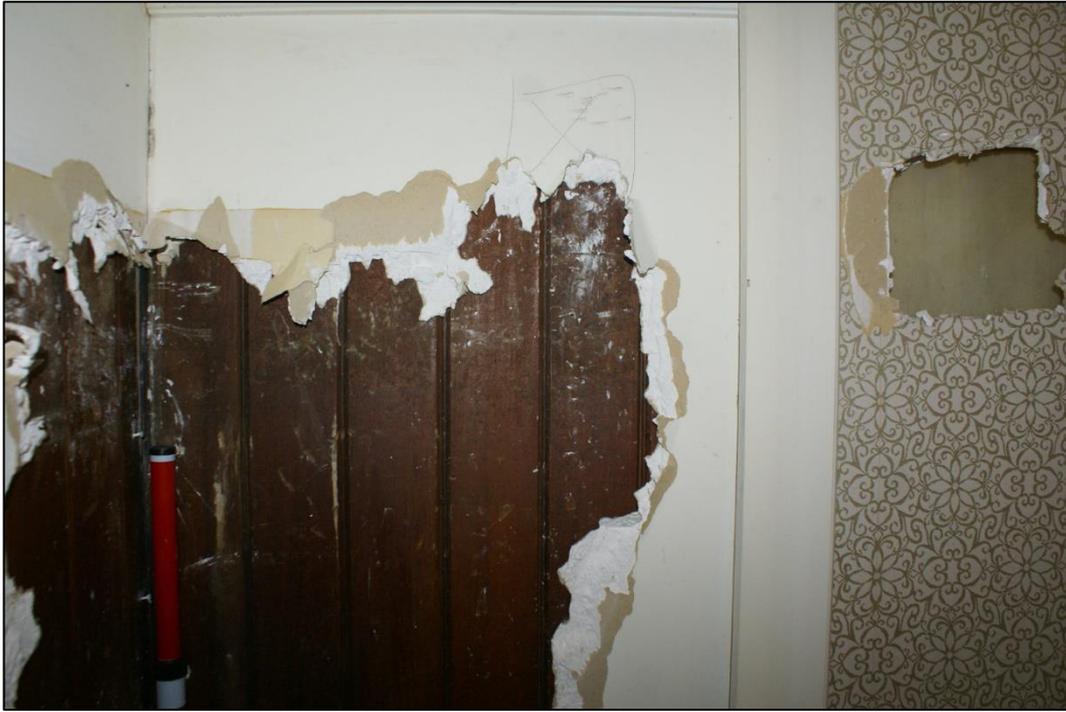
Figure 4-40 Late twentieth century plasterboard over beaded tongue and groove match lining in the Room 3 wardrobe (north wall).

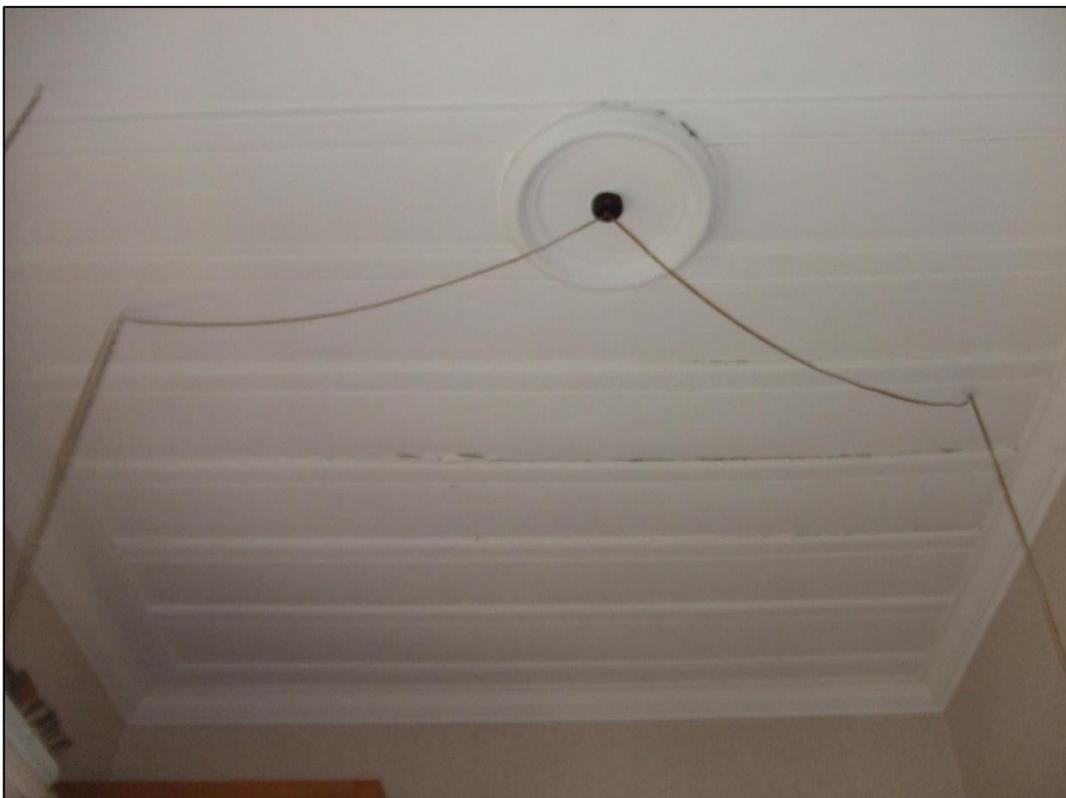
The Phase 1 section of the building had 3.4 m high ceilings, although many rooms had lowered ceilings when alterations had been undertaken in the twentieth century. The Phase 1 ceilings were either board and baton or beaded tongue and groove match lining (Figure 4-41 and Figure 4-42). Ceiling roses were identified in Rooms 1 and 5.

Figure 4-41 The Phase 1 board and baton ceiling in Room 5 with ceiling rose.

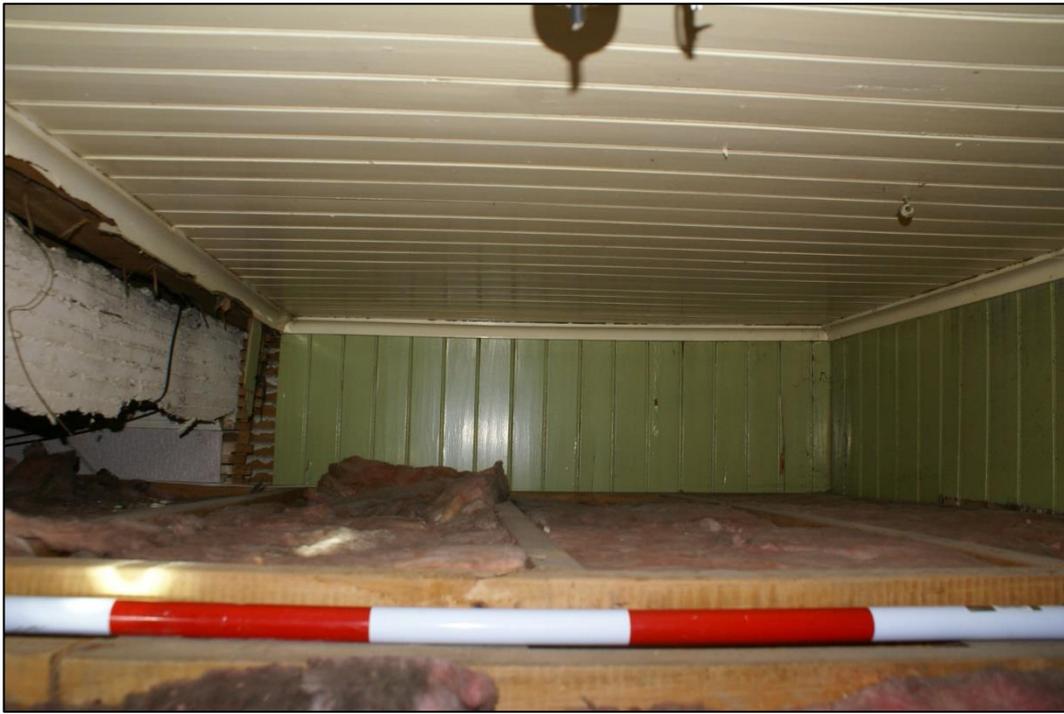
Figure 4-42 The Phase 1 beaded tongue and groove match lining ceiling in Room 3a, west and north wall.
