Serving the Community: St Patrick's Church Complex

**Final Report for Archaeological Investigations
at Site No. I44/539 – I44/542
Under Archaeological Authority No. 2013/61**

Report Prepared for St Patrick's Development Committee
Authors: Sheryl Cawte, Eva Forster-Garbutt, Naomi Woods, Jeremy
Moyle and Peter Mitchell
Reviewed By: Dr Hayden Cawte
05/06/2018

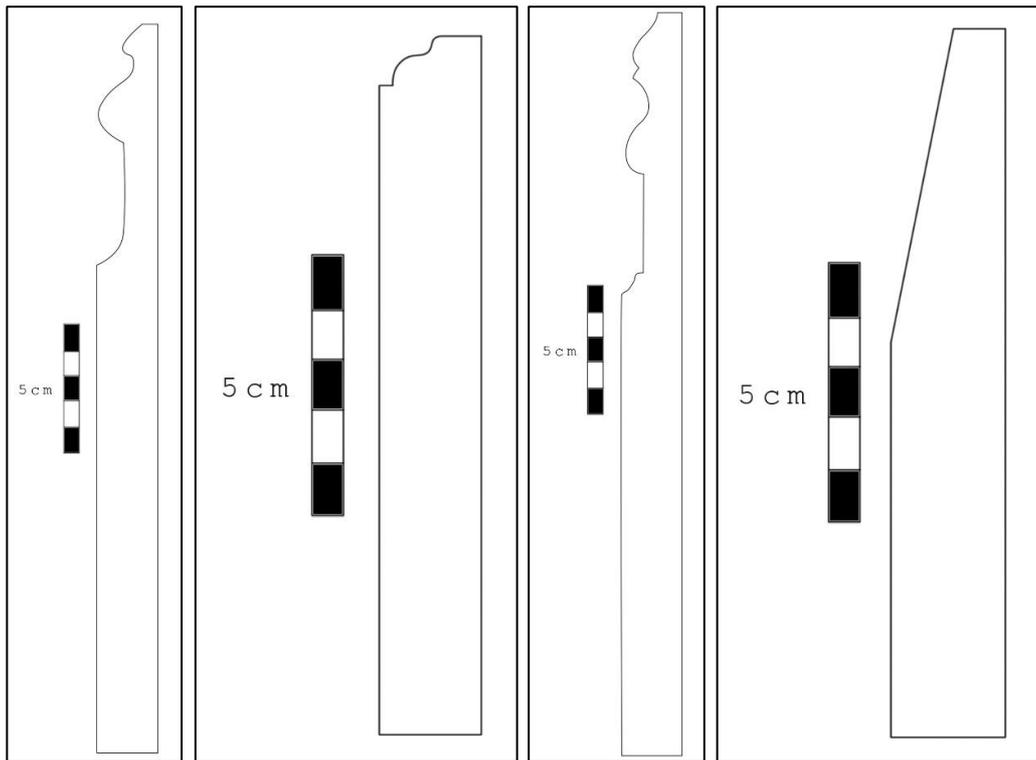
Skirting samples were taken from Rooms 1, 2, 5, 10, 11, 12, 13 and 16. Original moulded skirting boards are 188 mm wide (7.4 inches), with decorative elements being restricted to the upper portion (Figure 4-7, right). These were found in Room 1 and 4. Rooms 5, 10, 11, 12, and 13 were identical and a slightly different moulding design relating to Phase 2 modifications (Figure 4-43).

Figure 4-43 Profiles of skirting boards from (left to right): Rooms 1, 2, Rooms 5/10/11/12/13, and 16.

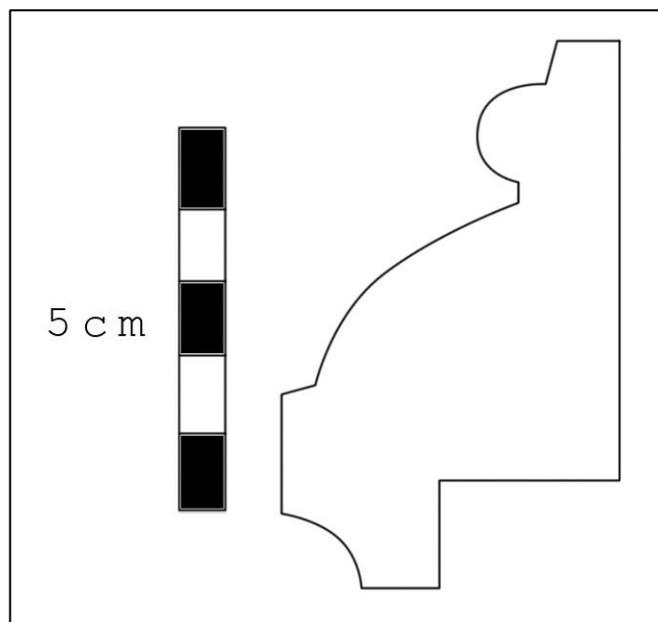
The cornices throughout the villa were decorative and are comprised of several applied mouldings (Figure 4-44).

Figure 4-44 Profile of decorative moulding from Room 4 (Hallway).

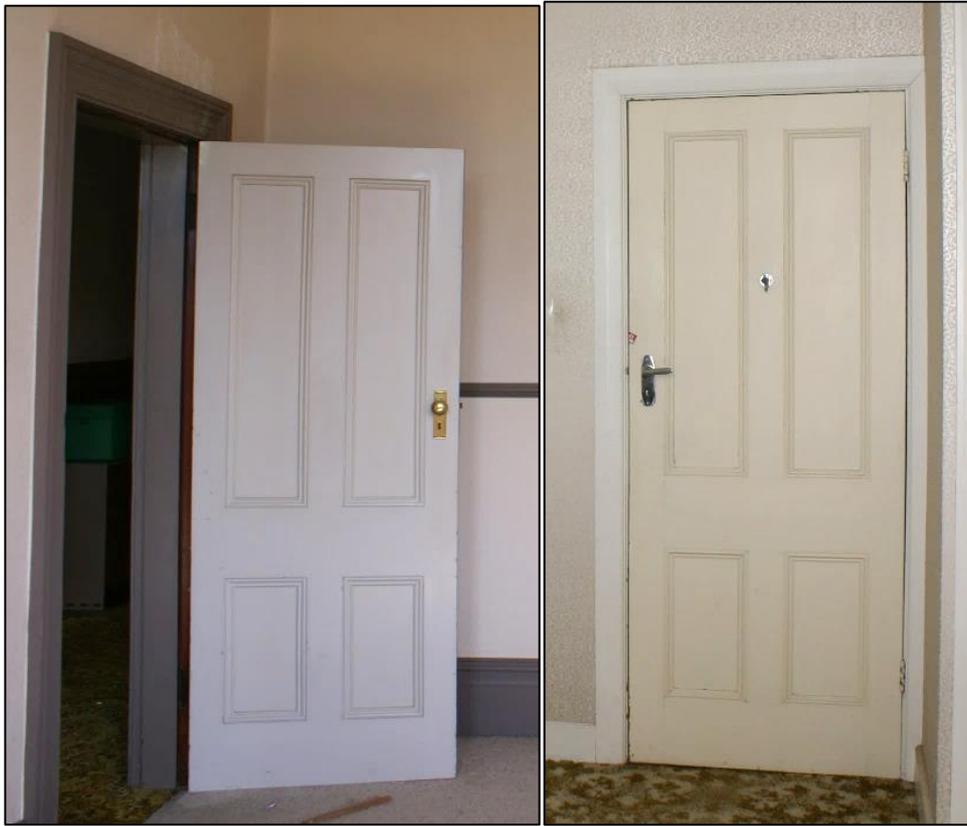
The majority of doors in the Phase 1 presbytery structure were timber four-panel low lock rail doors that dated to Phase 1. It is interesting to note that all the Phase 1 doors had had their handles and locks moved (Figure 4-45).

Figure 4-45 Phase 1 timber four panel low lock rail doors with moved locks and handles. Room 1 (left) and Room 3 (right).

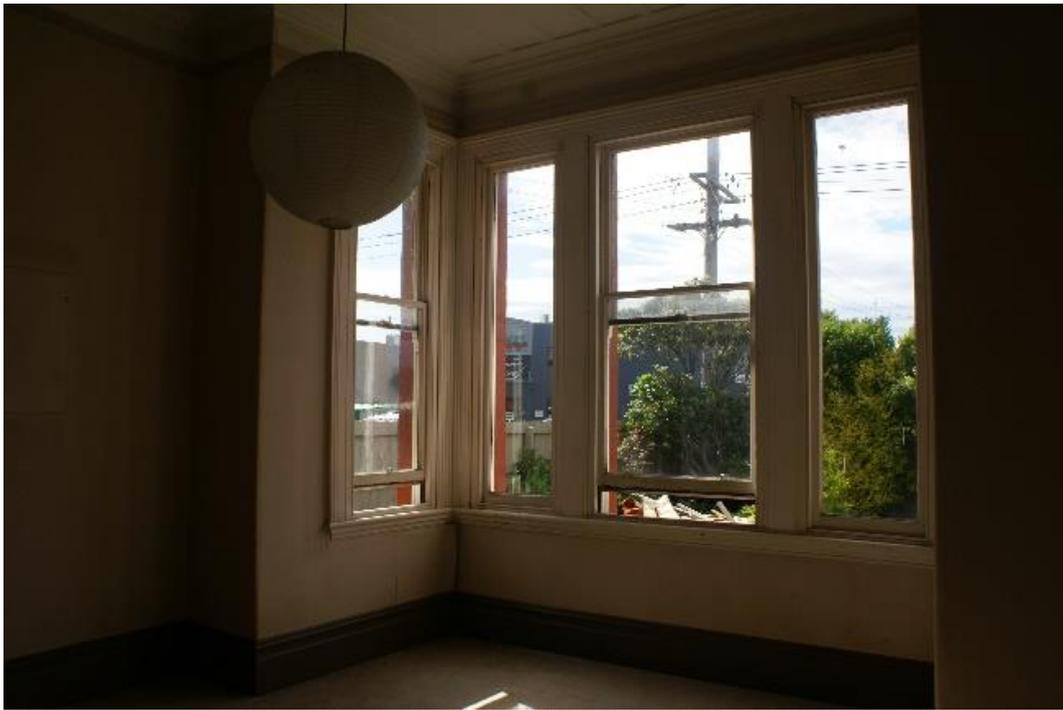
Figure 4-46 Bay window Room 1, looking south. Note the original joinery.

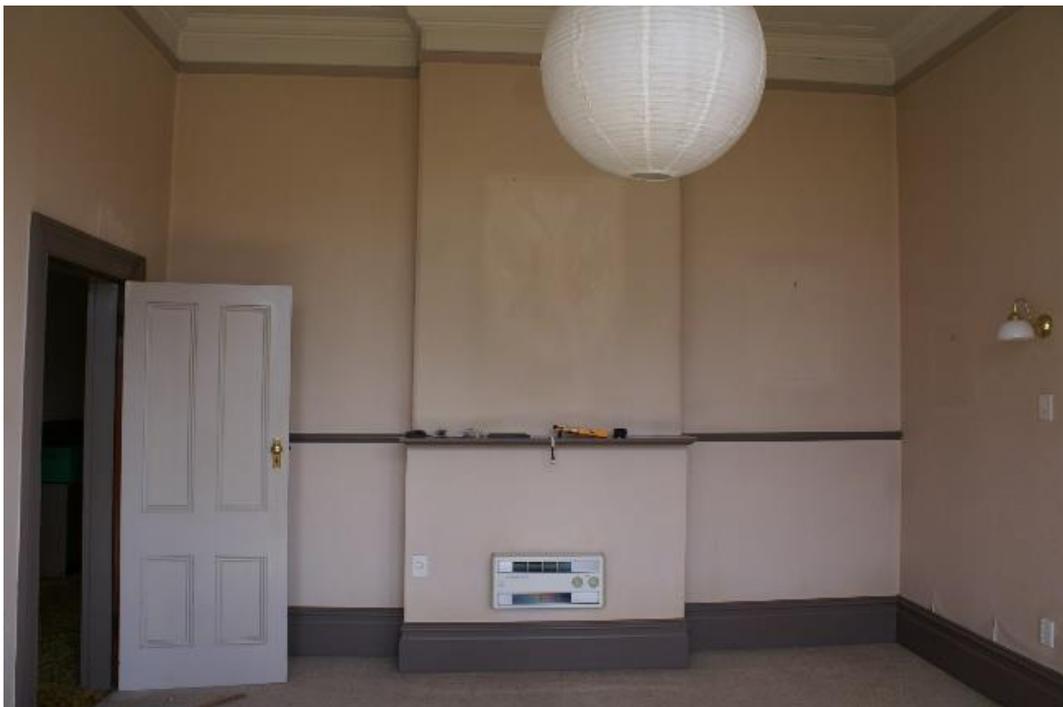
Room 1 was located on the east side of the building and was accessed through a hallway (west; Room 4). It formed part of the original pre-1900 presbytery structure. The maximum dimensions of the room were 4.259 m wide and 5.106 m long (including the bay window). There were original lath and plaster wall linings and moulded joinery throughout the room, as well as five sash windows within the bay window (Figure 4-46). The bust of a fireplace was positioned in the middle of the northern wall forming a double-back with the fireplace in Room 2 (Figure 4-47).

Figure 4-47 North wall Room 1 showing in-situ fireplace and four-panelled door into Room 4.

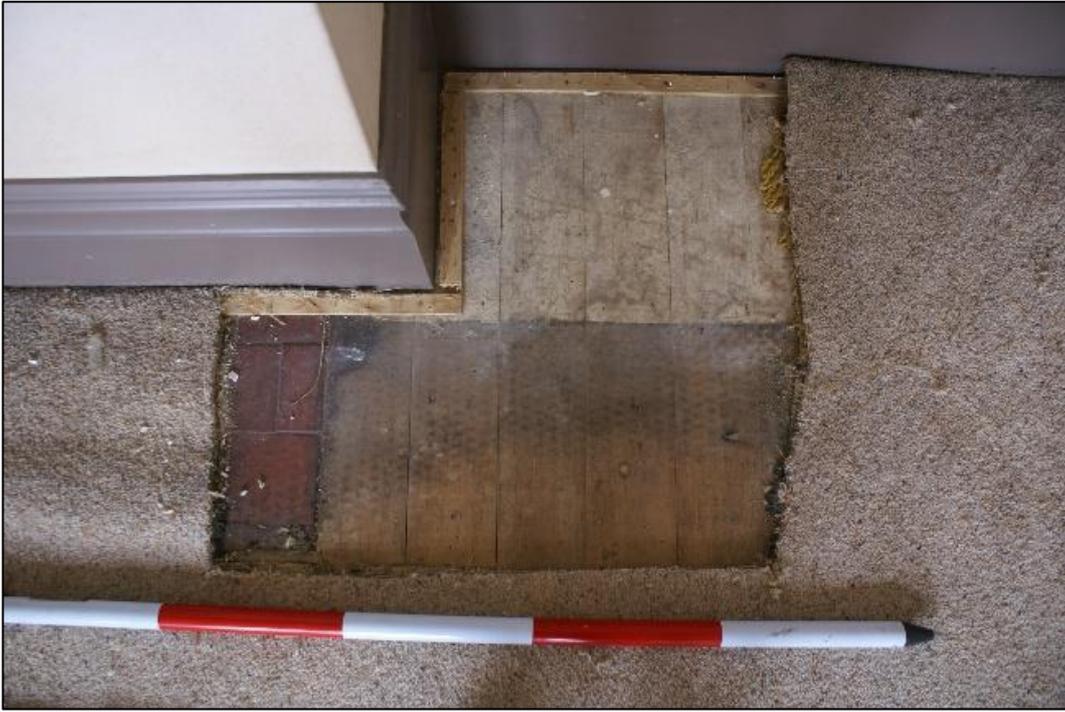
The tongue and groove timber floorboards were orientated north-south and the concrete hearth of the fireplace was tiled (Figure 4-48). Differences in the finishes of the floor demonstrated that the room once had a large rug. The walls throughout the room were comprised of several layers of wallpaper over lath and plaster and English Garden Wall bond brick walls (Figure 4-49). The bust of the fireplace was also constructed of brick. The window and door architraves, skirting, and cornices were all original ornate moulded pieces. The ceiling was board and baton with a ceiling rose in the centre of the ceiling (Figure 4-50). The door was an original four panel design.

Figure 4-48 Tongue and groove floorboards orientated north-south.

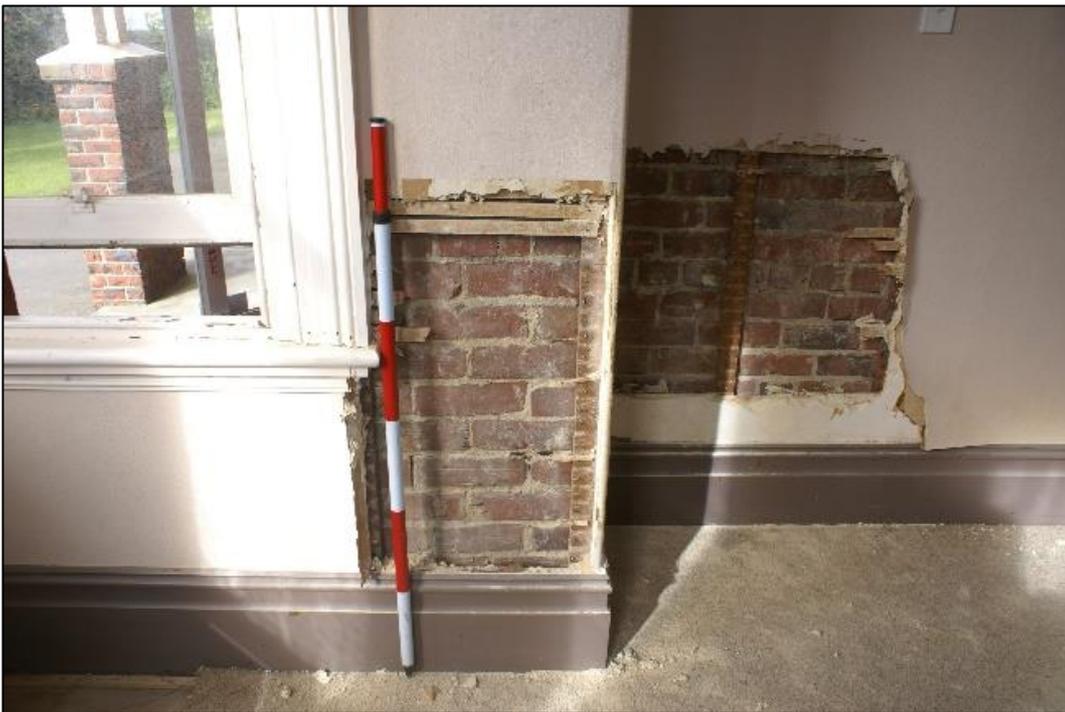
Figure 4-49 West internal wall showing wall linings in Room 1.

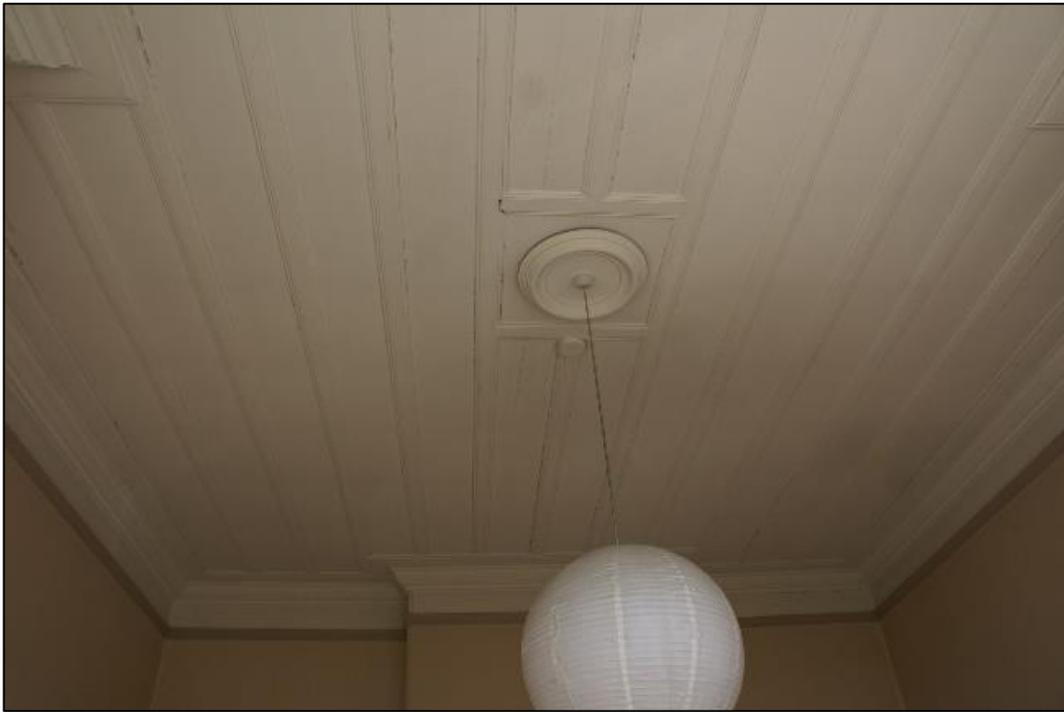
Figure 4-50 Board and baton ceiling and ceiling rose in Room 1.

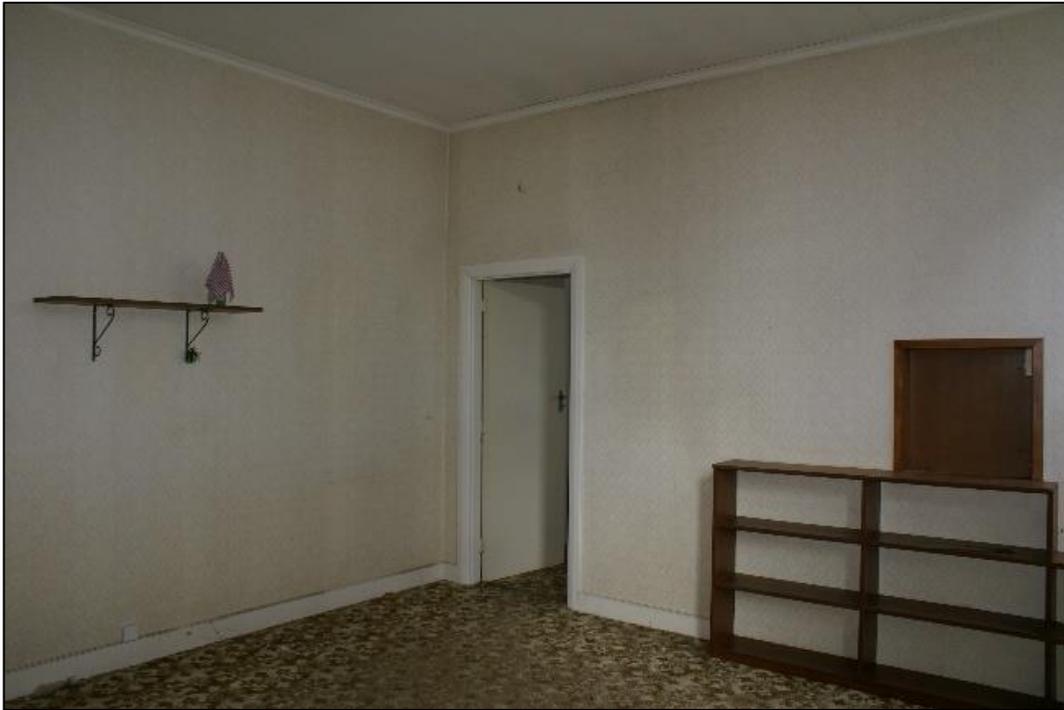
Room 2 was located on the east side of the building and was accessed through a hallway (west; Room 4) and Room 3 (north) (Figure 4-52). It formed part of the original pre-1900 presbytery structure. The maximum dimensions of the room are 4.332 m wide and 5.320 m long and had been modified from its original size and shape. There were modern ceiling and wall linings and joinery throughout the room, with as two sash windows along the eastern wall (Figure 4-53). The bust of a fireplace was positioned in the middle of the southern wall forming a double-back with the fireplace in Room 1 (Figure 4-54).

Figure 4-52 North-west corner of Room 2 showing door through to Room 3. Note the modern joinery and door into Room3 and the dropped modern ceiling.

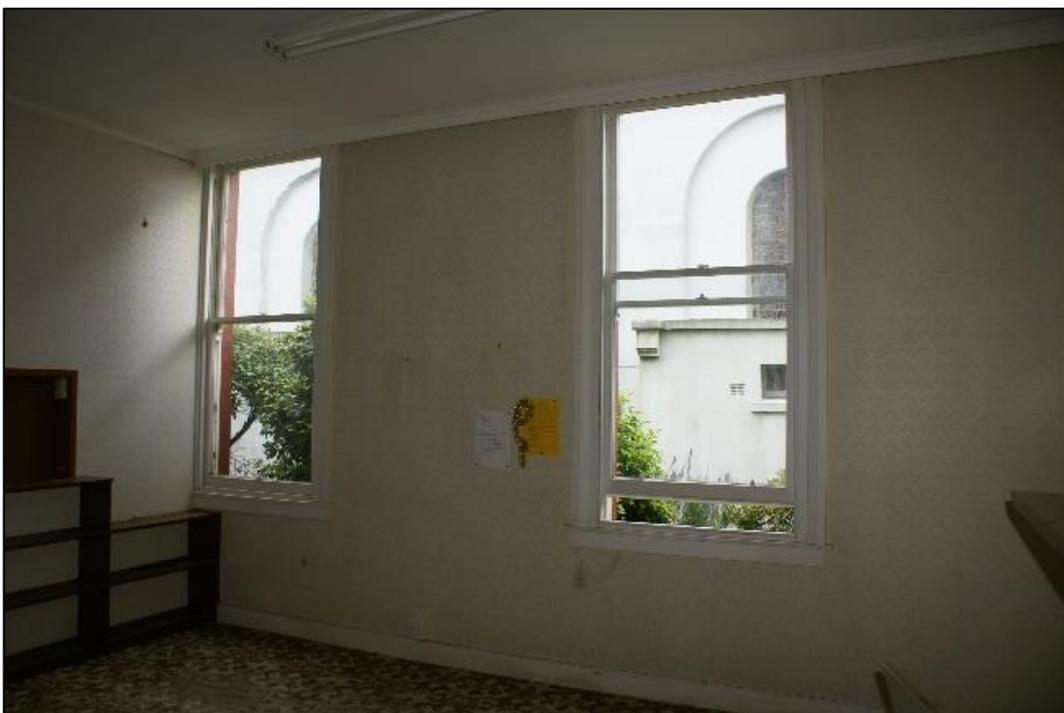
Figure 4-53 Sash windows in Room 2 along eastern exterior wall.

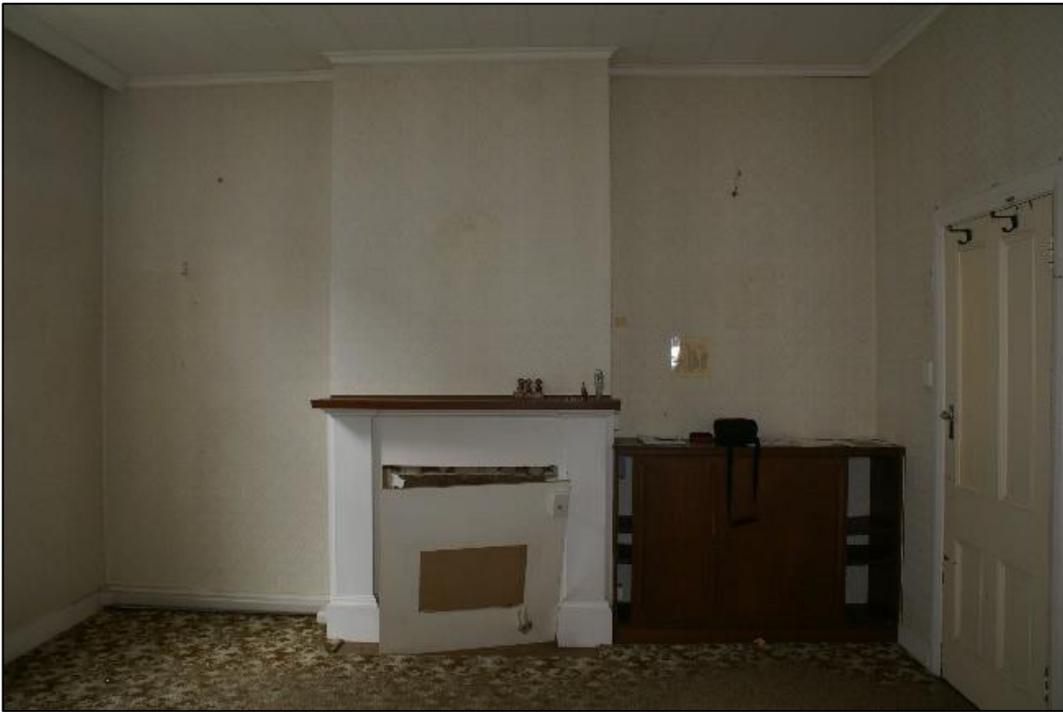
Figure 4-54 The north wall of Room 2 and double-back fireplace shared with Room 1.

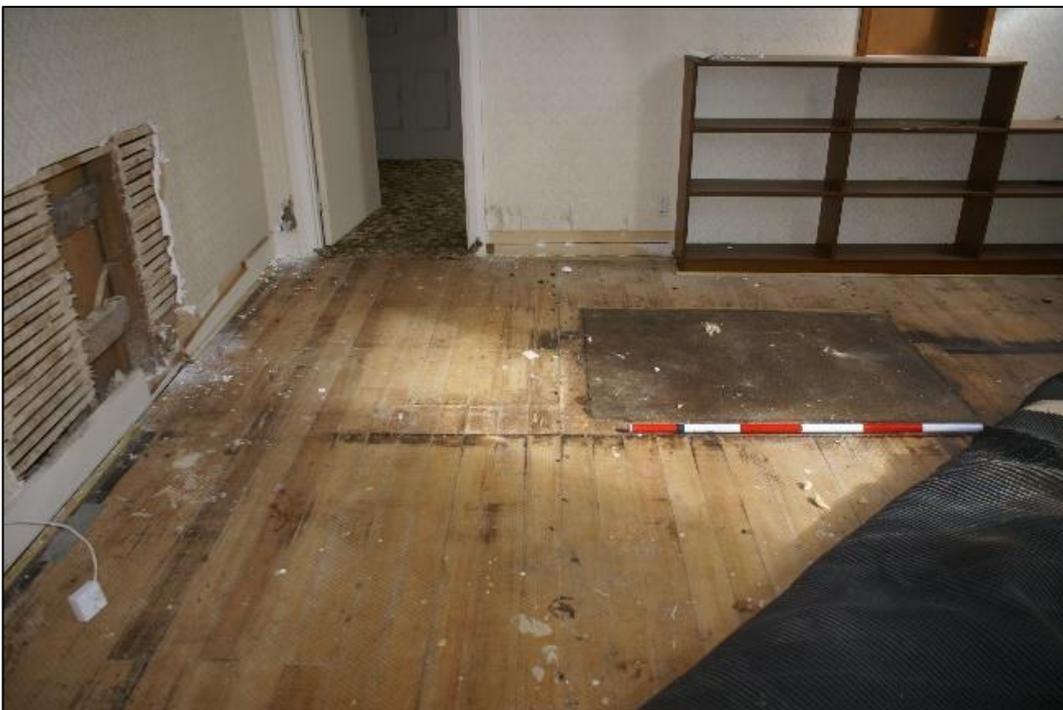
The tongue and groove timber floorboards were orientated north-south and there was the concrete hearth of the fireplace along the southern wall. A second fireplace concrete base was uncovered beneath the carpet in the centre of the room (Figure 4-55). Differences in the finishes of the floor extending out from the fireplace concrete base denoted the original location of the wall dividing Rooms 2 and 3 and the location of a doorway between the two on the west side of the fireplace. Discolouration also indicated that this second fireplace would have been entirely part of Room 3 along the southern wall of the room.

Figure 4-55 Looking north in Room 2 showing the original wall and doorway between Room 2 and 3 and the deconstructed fireplace along the original south wall of Room 3.

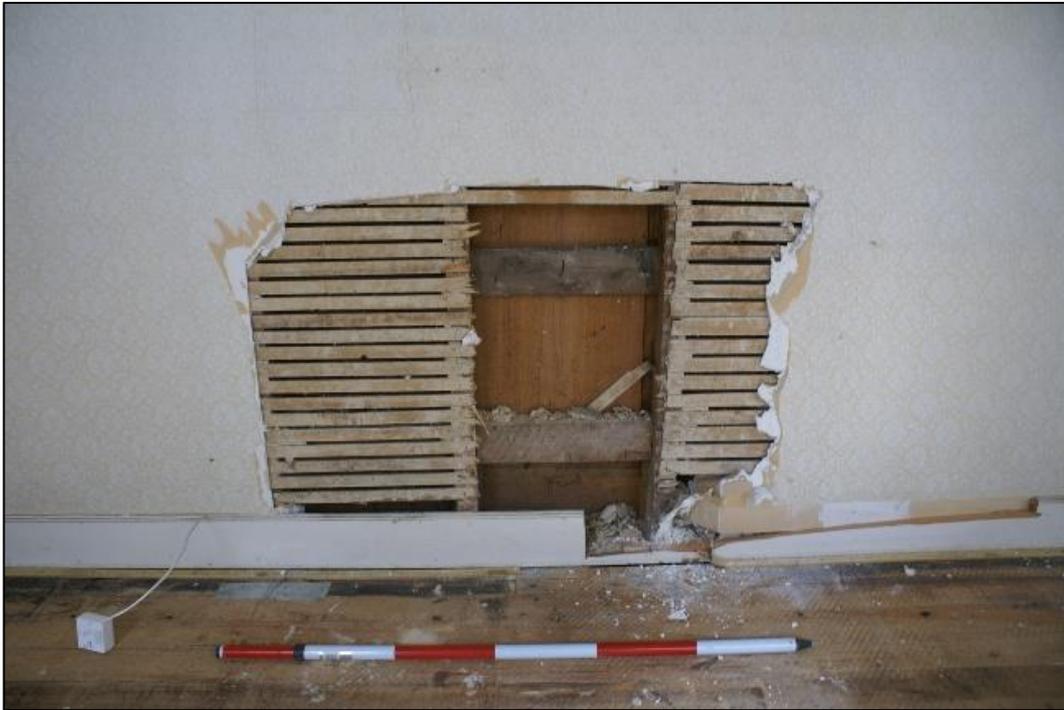
The wall linings throughout the room varied, depending on whether they are internal or external, original or late modifications. The west and south walls in the room were lined with wallpaper over Gib, lath and plaster and studs (Figure 4-56). Along the external (east) wall and north wall, the lath and plaster overlay an English Garden Wall bond brick wall. The window and door architraves, skirting and cornices were modern upgrades. The door into the hallway (Room 4) was an original four panel design while the door into Room 3 was modern. The ceiling was dropped and lined with plasterboard tiles (Figure 4-57).

Figure 4-56 East internal wall with Room 4 showing wall linings in Room 2.

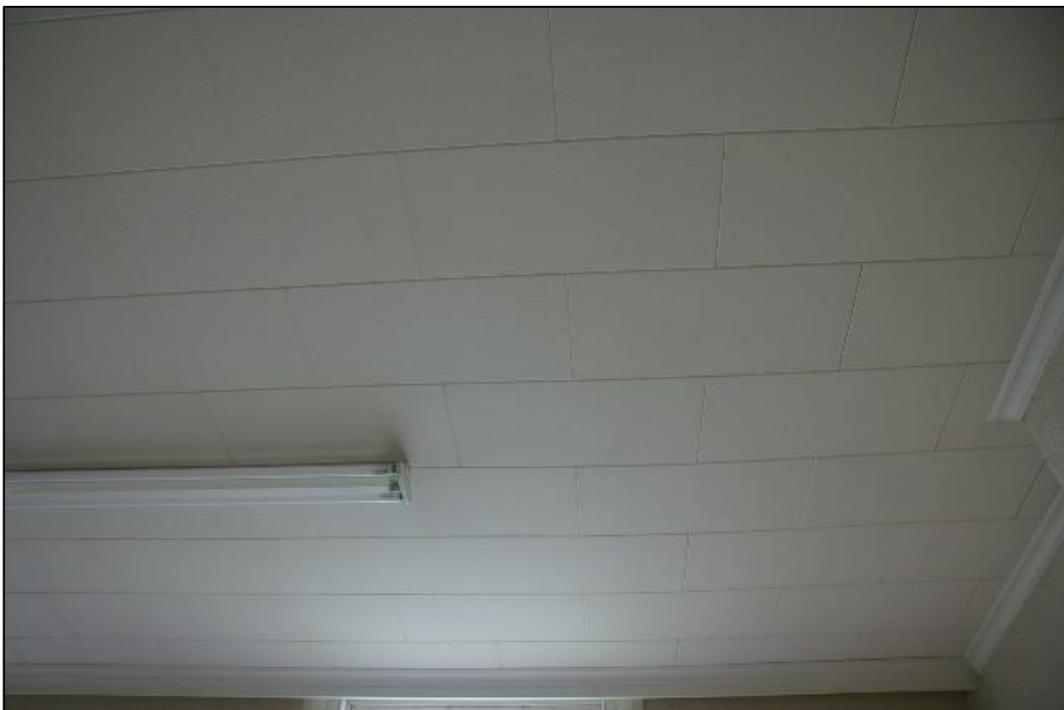
Figure 4-57 Dropped modern plasterboard tile ceiling in Room 2.

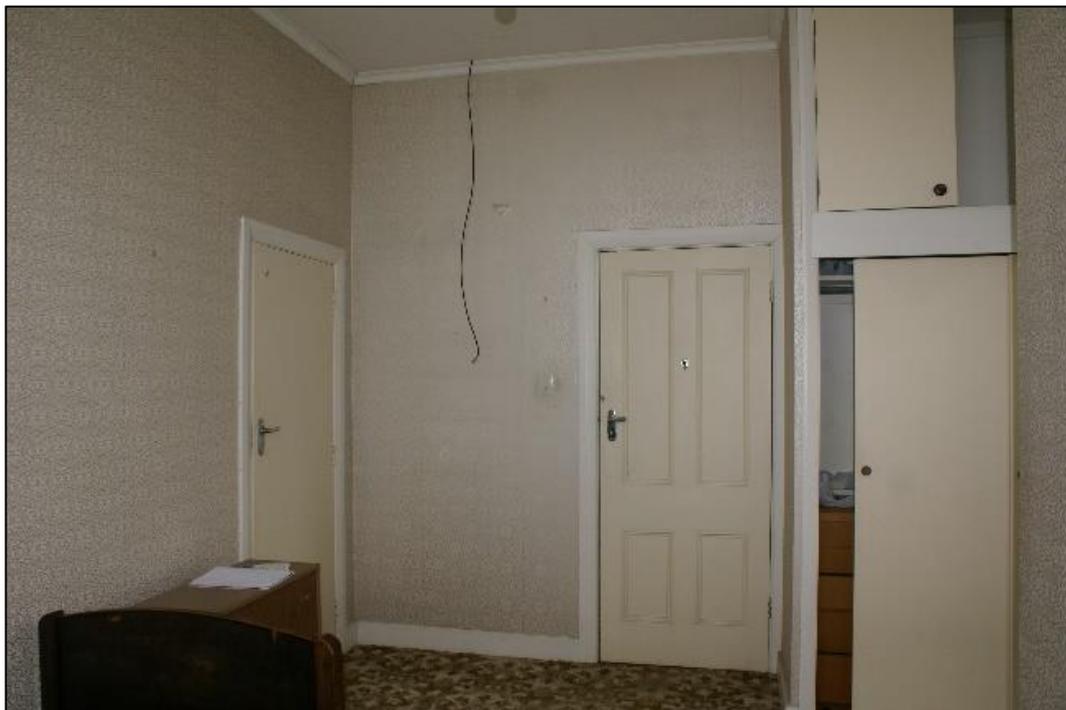
Figure 4-58 Southwest corner of Room 3 showing door through to Room 3 (modern) and Room 4 (four-panelled). Note the modern joinery.

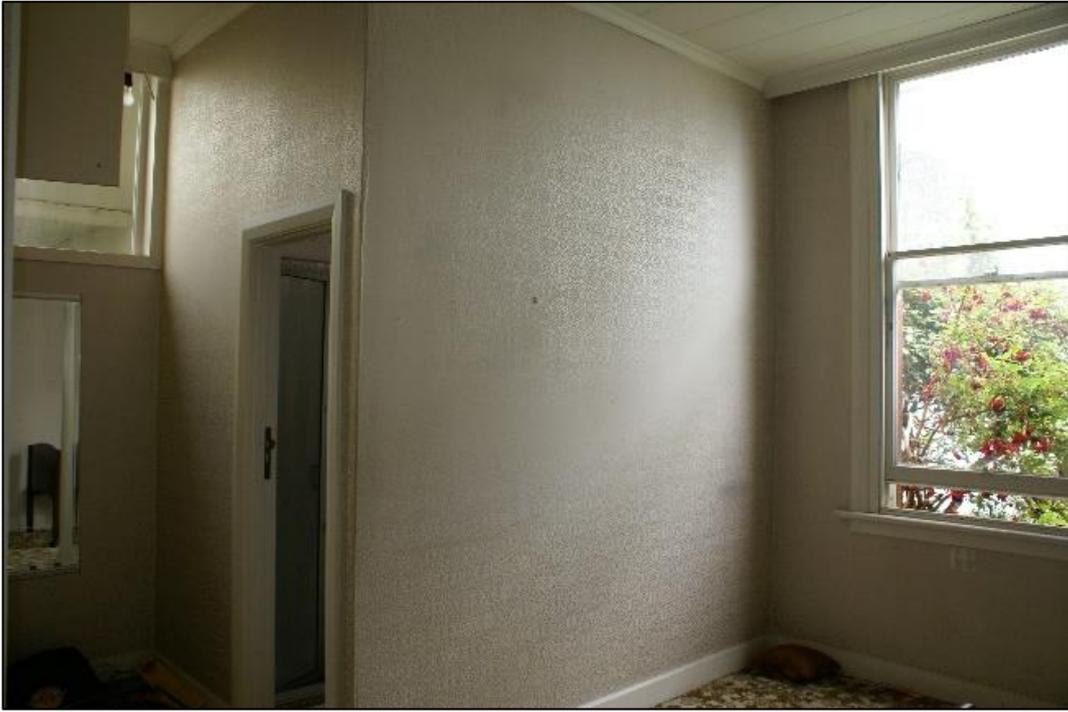
Room 3 was located on the east side of the building and was accessed through a hallway (west; Room 4) and Room 2 (south) (Figure 4-59). It formed part of the original pre-1900 presbytery structure. The maximum dimensions of the room were 4.418 m wide and 4.315 m long and had been modified from its original size and shape when the south wall was moved. Within the room, a small bathroom was constructed in the north-east corner and a wardrobe in the north-west corner (Room 3a) (Figure 4-59). This room formed part of the original presbytery structure. The bathroom measured 2.573 m wide and 1.641 m long and the wardrobe measured 632 mm wide and 2.260 m long. Within the bathroom there was access into the roof space through the modern dropped ceiling, lining up with the original ceiling manhole above (Figure 4-60). There were modern ceiling and wall linings and joinery throughout the room. A small portion of an original external window remained open and sat between the wardrobe and the entrance into the bathroom along the northern wall looking into an undocumented post-1956 addition to the rear of the building (Figure 4-61). The transom is a small portion of the original sash window still in-situ that has been covered up by the north wall (Figure 4-62). There was one sash window in the larger room and an aluminium retrofitted sash window in the bathroom along the eastern wall (Figure 4-63).

Figure 4-59 North-east corner of Room 3 showing bathroom built within the room.

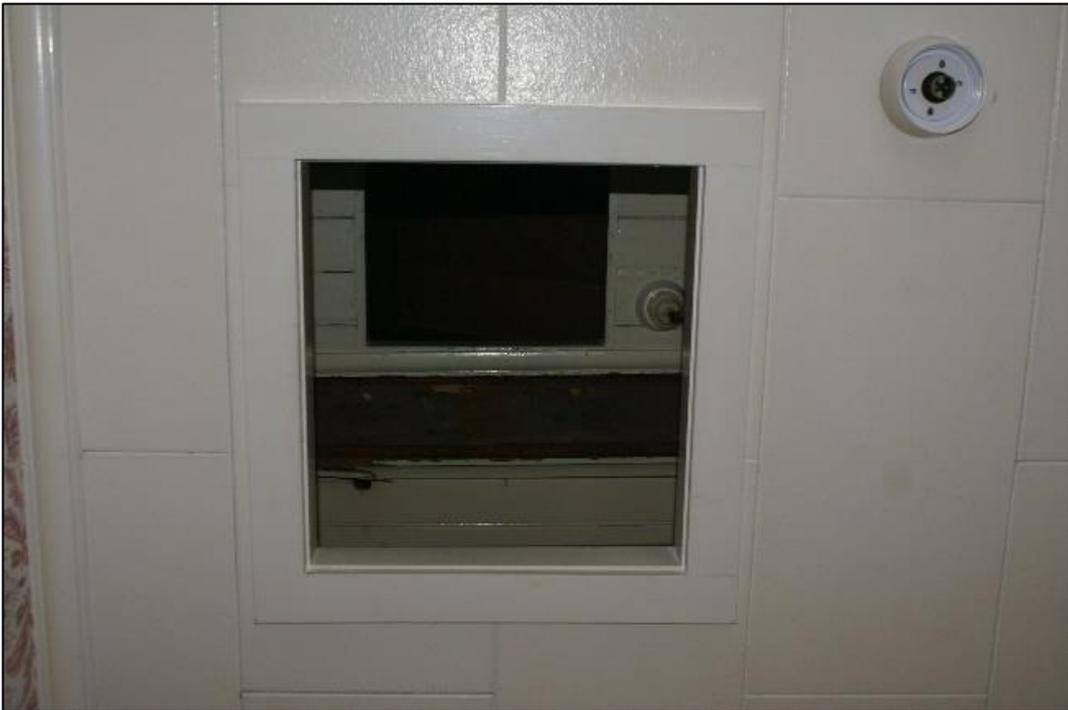
Figure 4-60 Manhole through the modern plasterboard ceiling that lines up with the original ceiling manhole into the roof cavity in Room 3a.

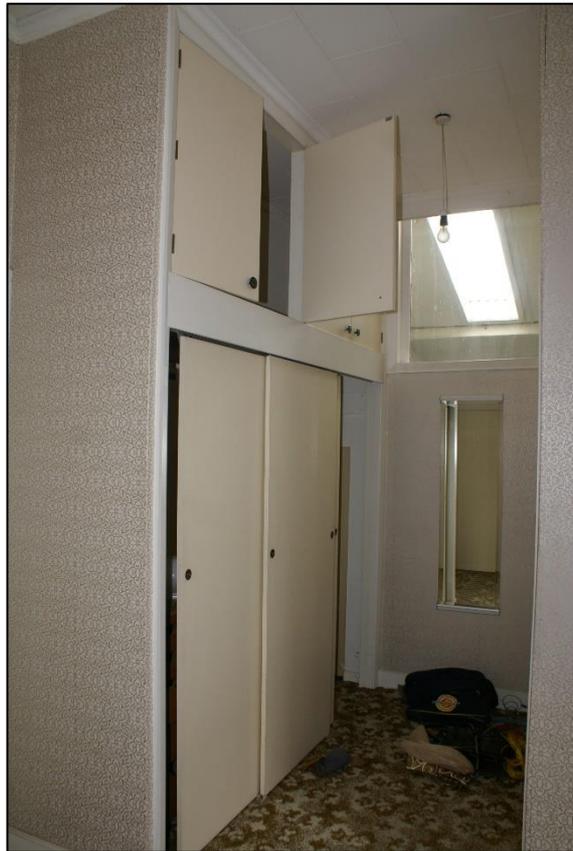
Figure 4-61 Transom window between the wardrobe and bathroom along the north wall of Room 3. This is a portion of the original sash window not obscured by modern wall linings

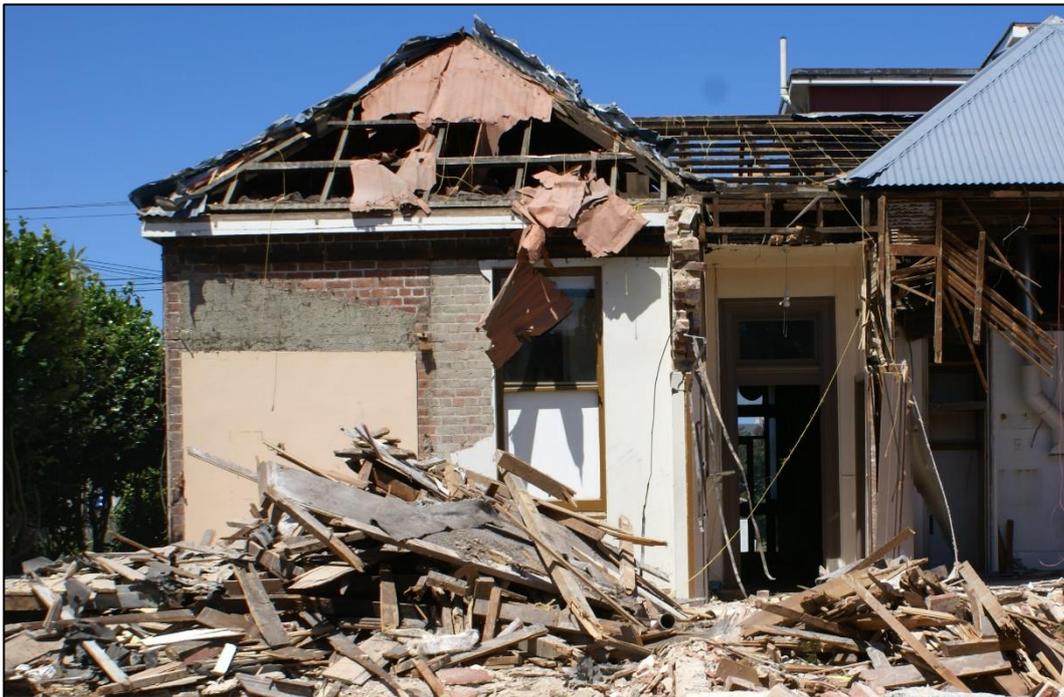
Figure 4-62 Original external north wall of the presbytery (Room 3).

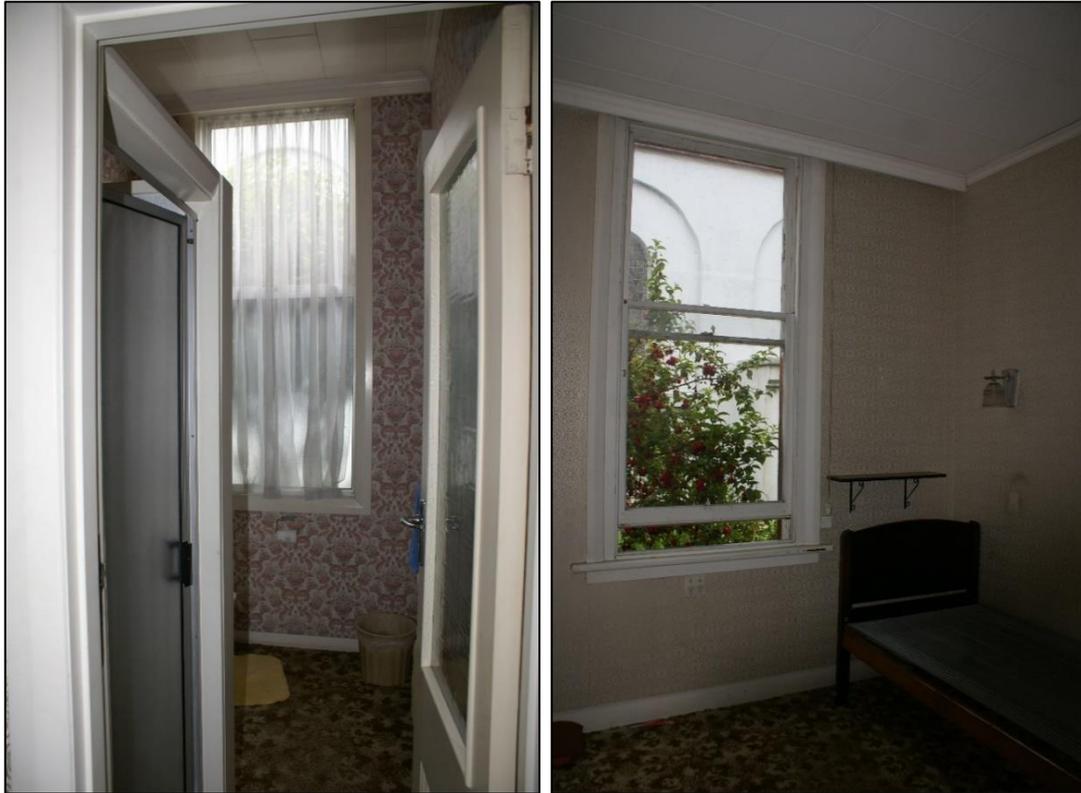
Figure 4-63 Left: Retrofitted sash window in the bathroom which is now aluminium. Right: Sash window in the main portion of Room 3.

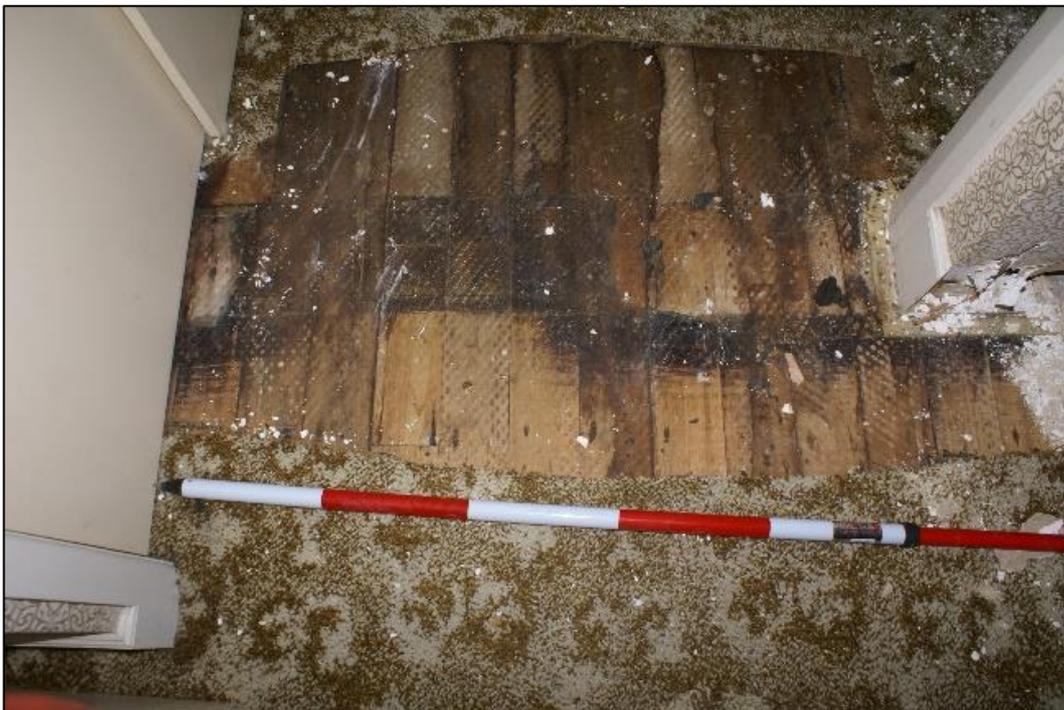
Room 3 and Room3a had tongue and groove timber floorboards orientated north-south. Differences in finishes of the floor demonstrated the original location and dimensions of Room 3a in the northeast corner of the room approximately where the bathroom currently is (Figure 4-64).

Figure 4-64 Discolouration of the flooring where a wall once was at the northern end of Room 3 dividing it with Room 3a.

lined with wall paper over Gib, lath and plaster and studs (Figure 4-64). Along the external (east) wall the lath and plaster overlay an English Garden Wall bond brick wall on studs. In Room 3a and in the Room 3 wardrobe (which would have been one room), the walls were lined with Gib over tongue and groove and also overlay an English Garden Wall bond brick wall (Figure 4-66 and Figure 4-67). The window and door architraves, skirting, and cornices throughout the rooms were all modern upgrades. The door into the hallway (Room 4) was an original four panel design while the door into Room 2 and bathroom was modern (Figure 4-68). Within Room 3, the original door into Room 3a is covered over with Gib in the wardrobe while the original architrave for the doorway remains present in Room 4.

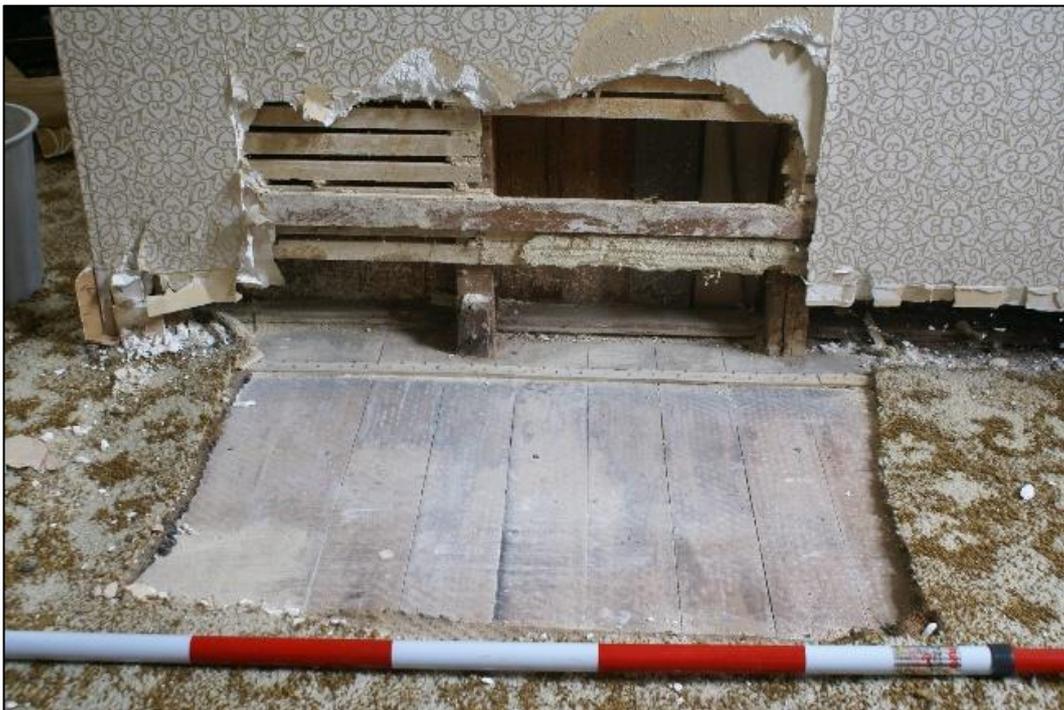
Figure 4-65 North internal wall with the bathroom showing the internal wall linings in Room 3.

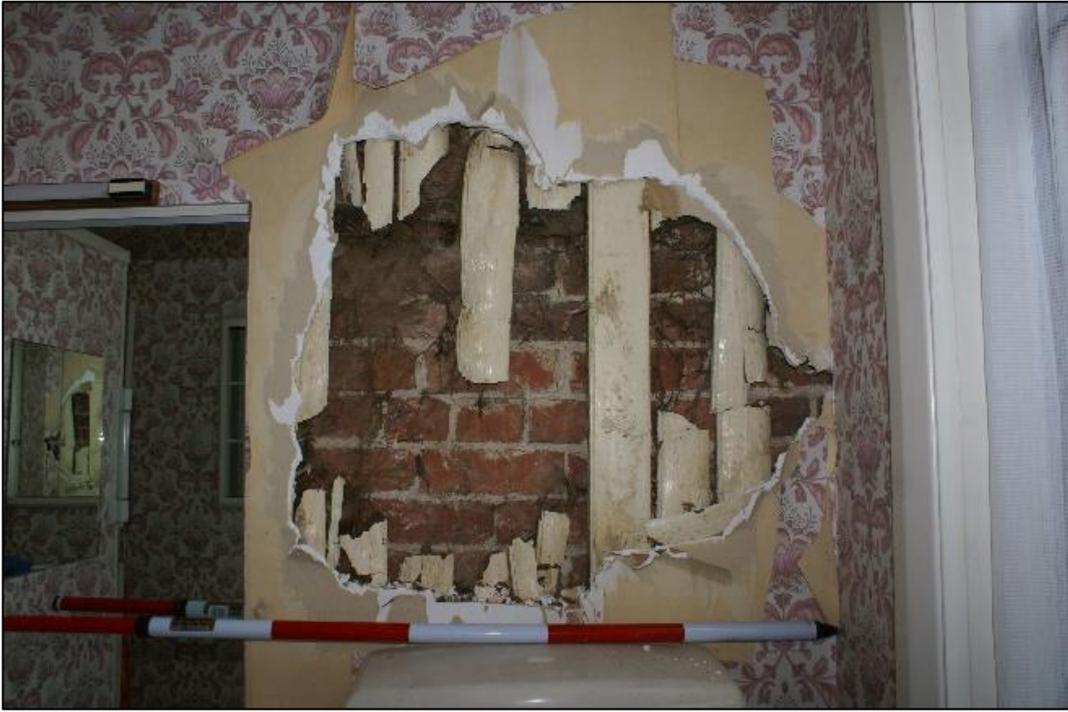
Figure 4-66 North external wall in bathroom showing wall linings.

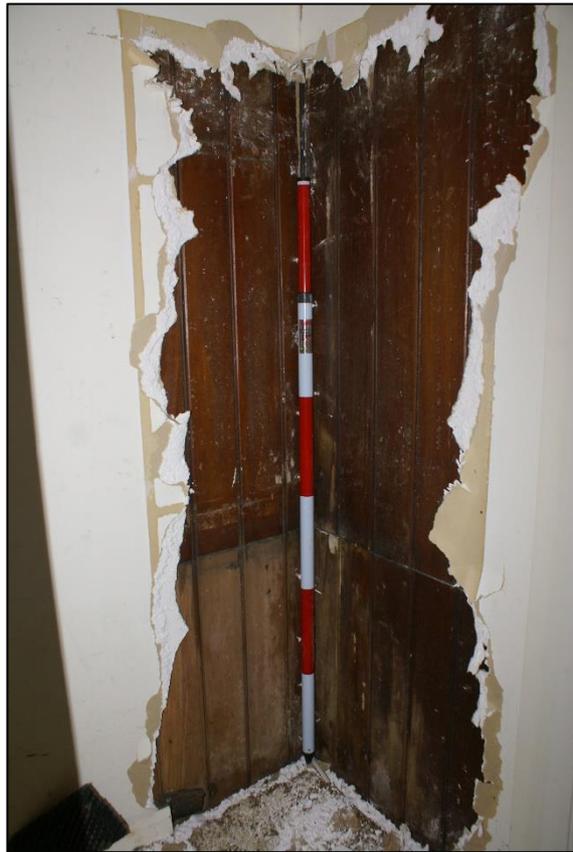
Figure 4-67 North-east internal/external wall within the wardrobe showing wall linings.

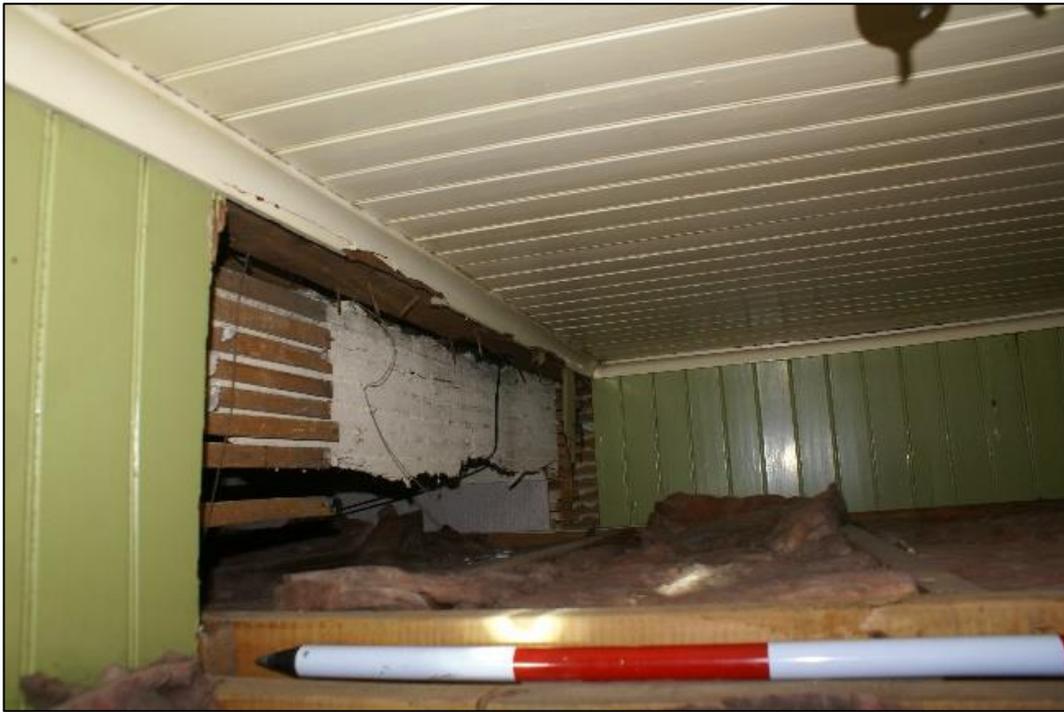
The ceiling in Room 3 and bathroom was dropped and lined with plasterboard tiles. Through the manhole in the bathroom, the dimensions of the room where the bathroom is now located was clearly evident, and the Phase 1 ceiling of this room was cream painted tongue and groove beaded match lining (Figure 4-68). The original ceiling of the rest of the room was board and baton.

Figure 4-68 Ceiling space between the original and modern dropped ceiling looking east towards Room 4. The lath and plaster forms the internal north wall shared with Room 3.

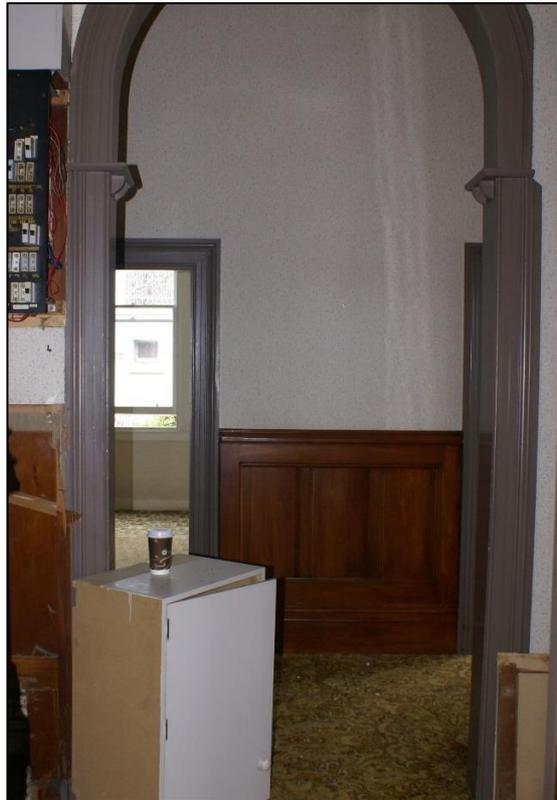
The carpet throughout the room was pulled back, revealing tongue and groove timber floorboards orientated north-south. The wall linings throughout the room varied before and after the doorway at the northern end of the hallway where the scullery was. In the main portion of the hallway south of the doorway (front section), the walls are lined with wallpaper over Gib, lath and plaster and studs. The lower half of the walls are lined with

wooden wainscoting (Figure 4-69). North of the rear doorway, the walls were lined with cream painted vertical tongue and groove sarking, studs and overlay an English Garden Wall bond brick wall brick as seen in Room 3a (Figure 4-70).

Figure 4-69 Looking east into Room 4 showing the wooden wainscoting.

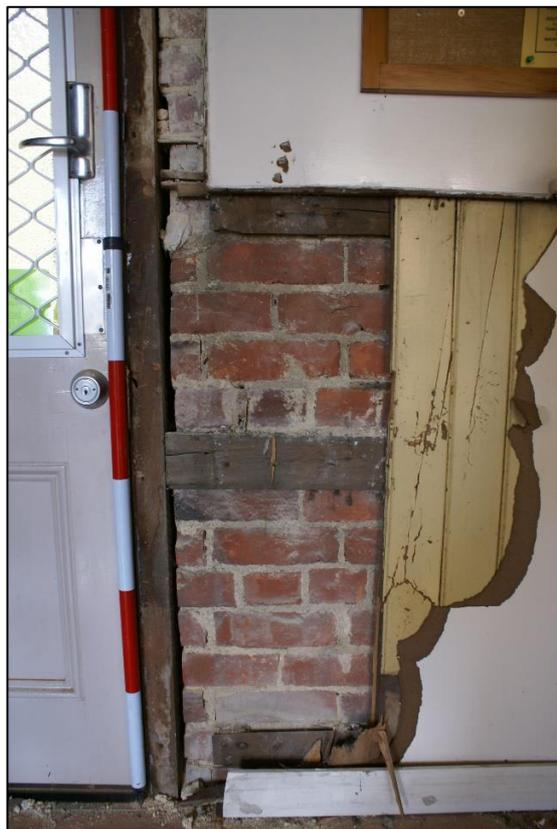
Figure 4-70 Rear section of Room 4 showing the tongue and groove match lining.

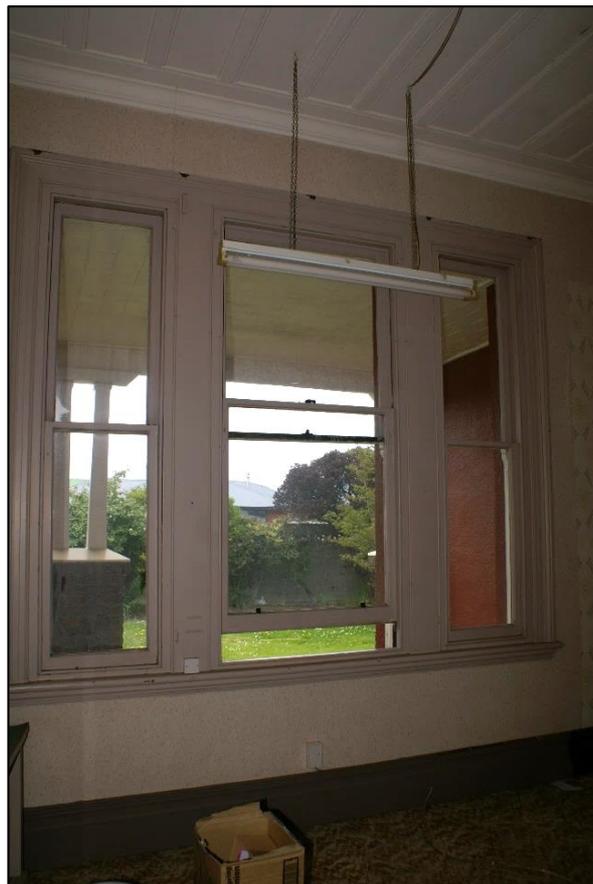
Figure 4-71 South exterior wall of Room 5 showing the sash windows. Note the original joinery around the windows. The moulded skirting is not original but the same design shared throughout the 1929 addition which is a similar style to that seen in the original presbytery structure.
