Serving the Community: St Patrick's Church Complex

**Final Report for Archaeological Investigations
at Site No. I44/539 – I44/542
Under Archaeological Authority No. 2013/61**

Report Prepared for St Patrick's Development Committee
Authors: Sheryl Cawte, Eva Forster-Garbutt, Naomi Woods, Jeremy
Moyle and Peter Mitchell
Reviewed By: Dr Hayden Cawte
05/06/2018

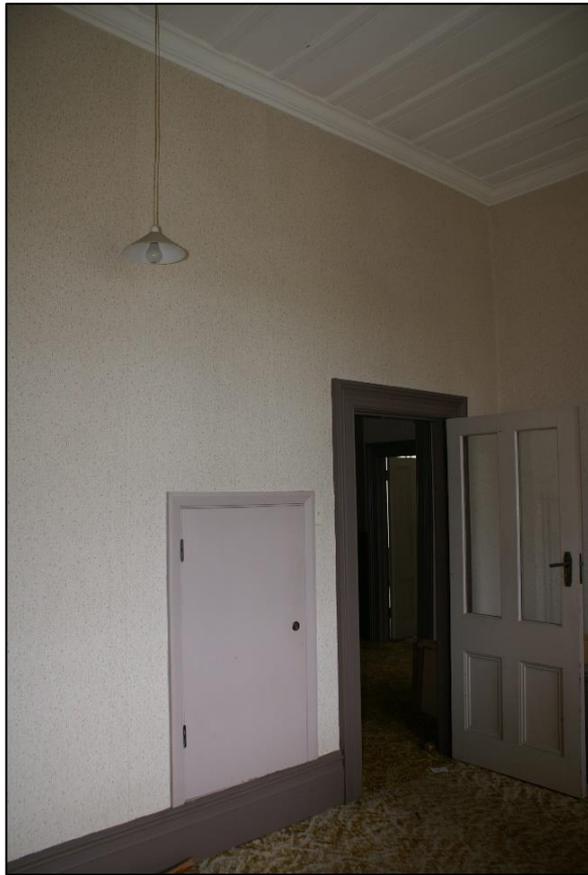
Figure 4-72 North-west corner of Room 5 showing the doorway access into Room 6 and the board and baton ceiling.

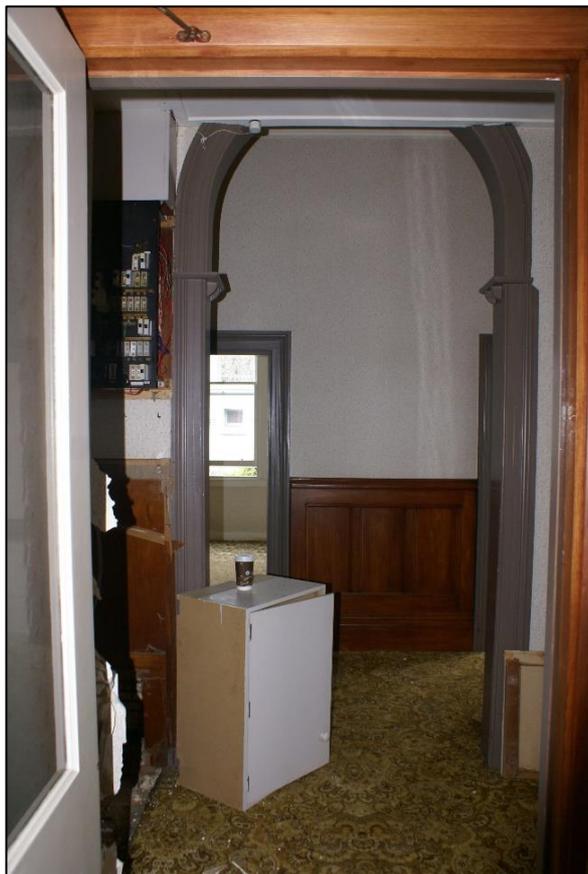
Figure 4-73 Looking east from Room 7 through Room 6 to Room 4.

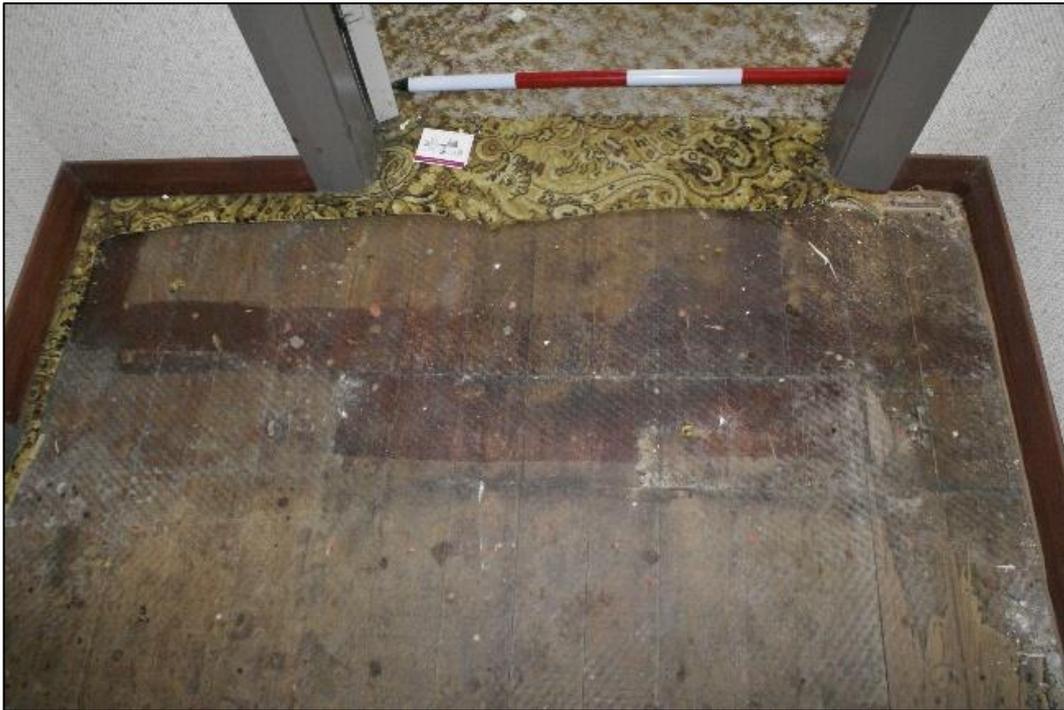
Figure 4-74 Discolouration of the floorboards at the west end of Room 6.

The tongue and groove floorboards were orientated north-south. Differences in finishes of the floor demonstrated the original location and dimensions of Room 5 (Figure 4-74).

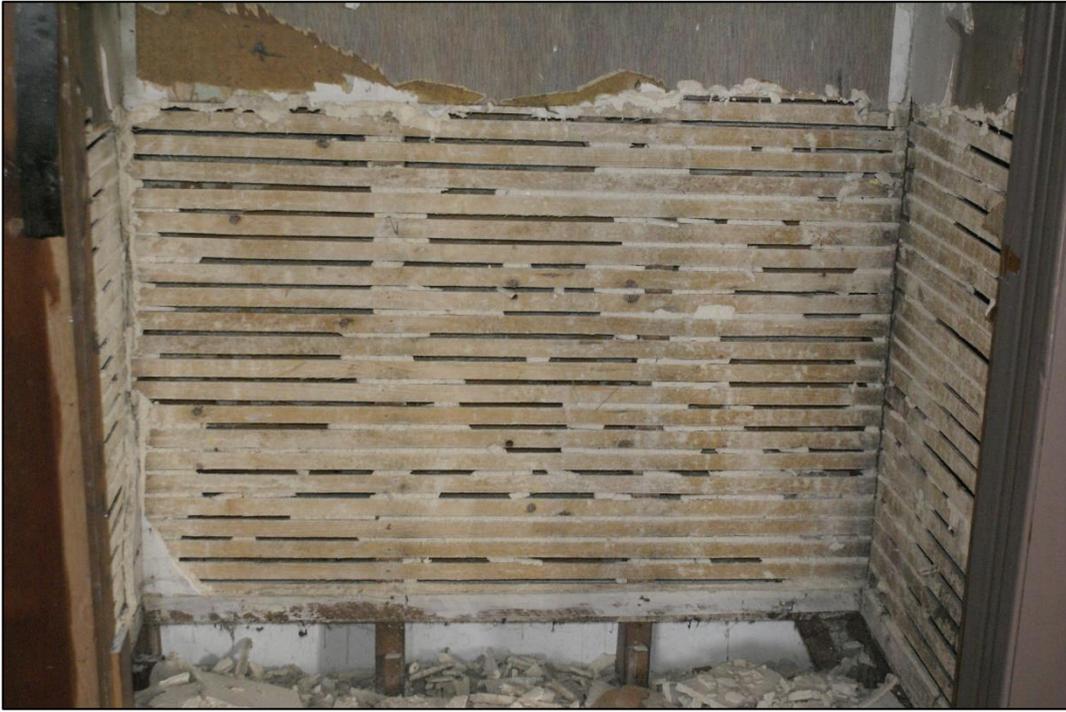
Figure 4-75 North internal wall of Room 6 (original north wall of Room 5) showing the wall linings of Room 5.

The wall linings throughout Rooms 5, 6 and 7 varied, depending on whether they are internal or external, original or late modification. The north wall of Room 6 and east wall of Room 5 were lined with wallpaper over Gib, lath and plaster and studs (Figure 4-75). Along the external south and original exterior west wall, the lath and plaster overlay an English Garden Wall bond brick wall on studs (Figure 4-76). The window architraves in Room 5 were original moulded pieces. The door and skirting moulded pieces within Room 5 were modern upgrades which were the same styles used throughout rooms constructed in the 1929 addition. The door and skirting moulded pieces within Room 6 were also modern upgrades, but of a later period.

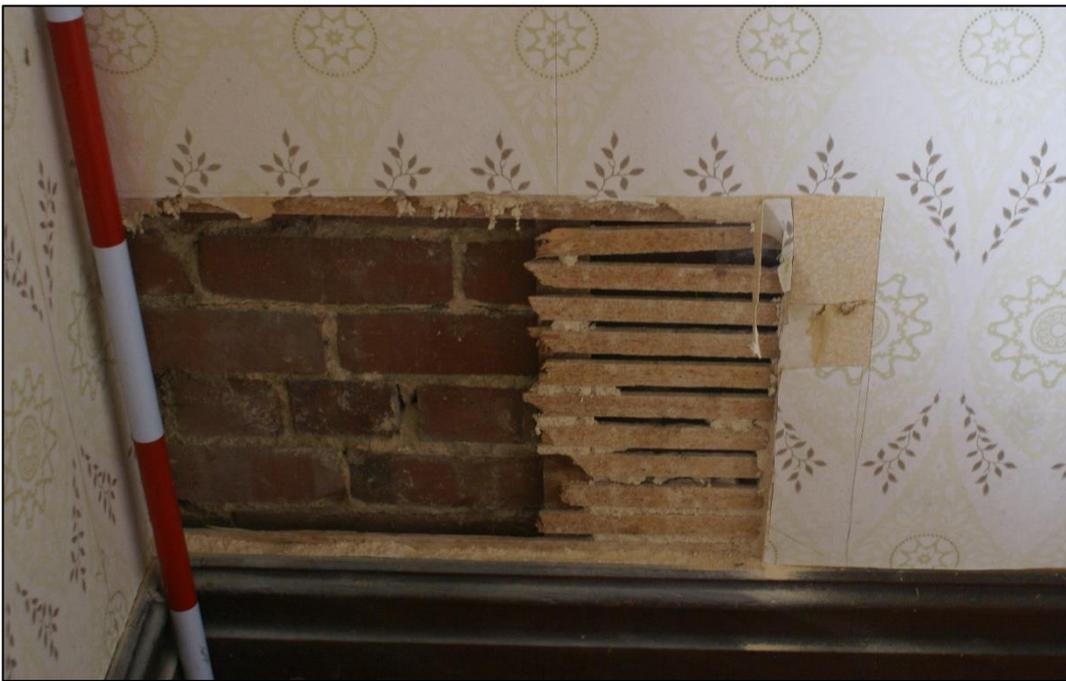
Figure 4-76 West (original exterior) wall in Room 5 showing wall linings.

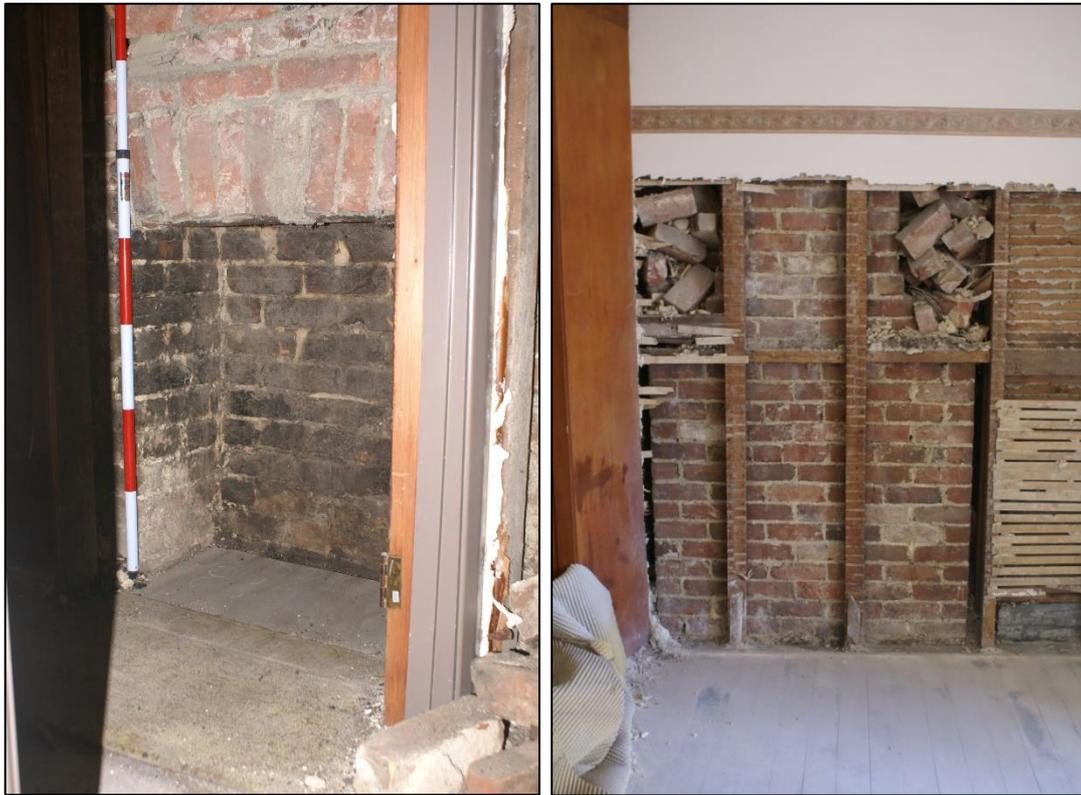
Figure 4-77 Left: Original fireplace from Room 5 converted into a cupboard in Room 6 along the interior north wall. Right: Fireplace back from Room 8 showing the deconstructed chimney in the wall space.

Along the north wall of Room 6, a fireplace that was once in Room 5 had been converted into a cupboard and the chimney stack deconstructed (Figure 4-77). The brick rubble from the chimney stack deconstruction filled the wall cavity.

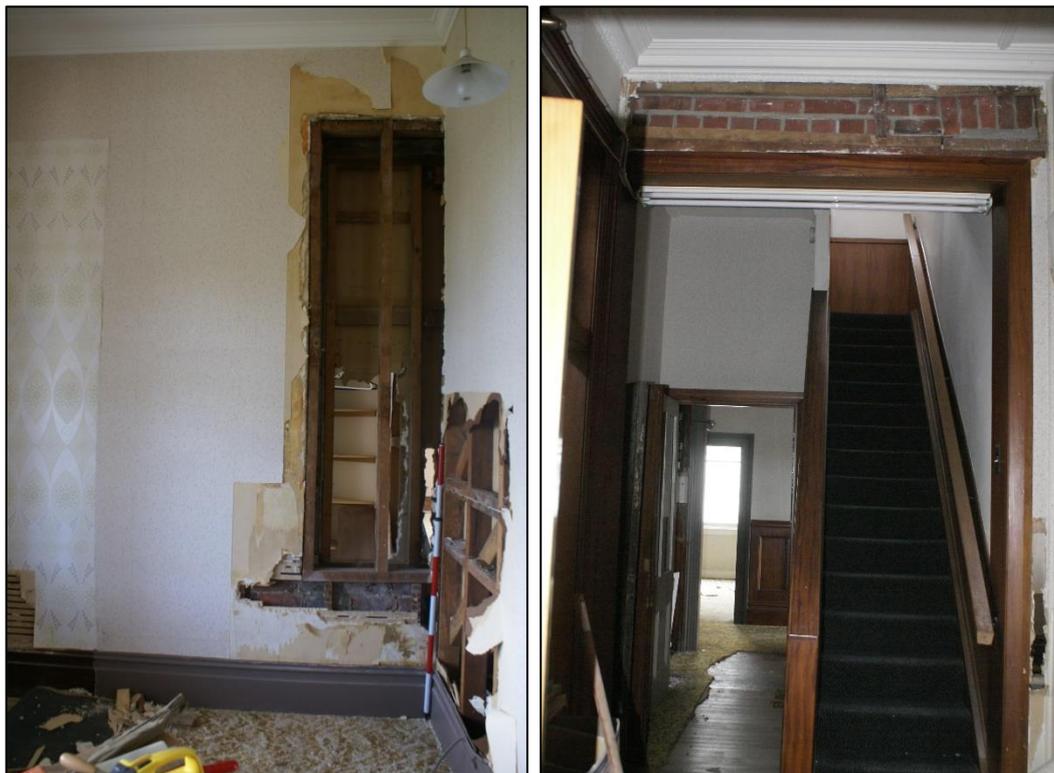
Figure 4-78 Left: Covered up sash window in the north-west corner of Room 5 along the original west exterior wall. Right: Top of window arch in Room 7 above the stairway going upstairs looking east towards Room 4.

Along the west original exterior wall in the northwest corner of Room 5, a sash window was uncovered, 2.2 m back from the front (south) wall of the room (Figure 4-78). The window extended beyond the northern wall of the room into Room 7 and was covered up when the 1929 addition had been constructed. The window height is 2.334 m.

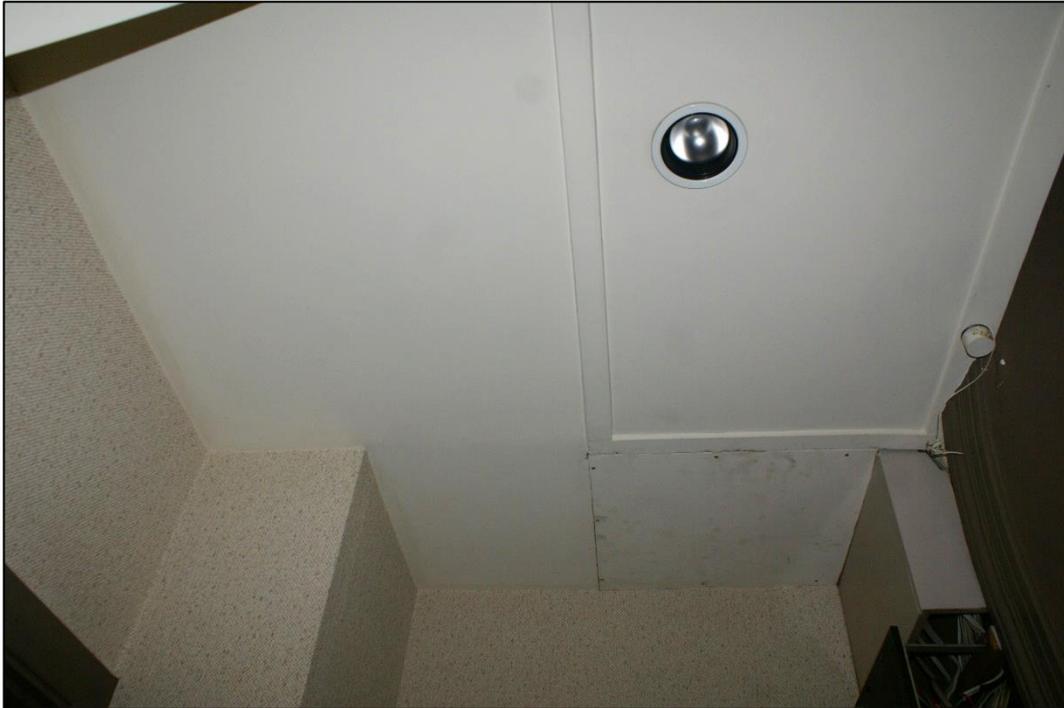
Figure 4-79 Modern dropped ceiling in Room 6.

In Room 5, the ceiling was board and baton with a plain ceiling rose in the centre of the ceiling. The ceiling in Room 6 had been dropped and was lined with Gib (Figure 4-79). The door into Room 5 was a four panel design and may be the original door to the room reused when the access way changed.

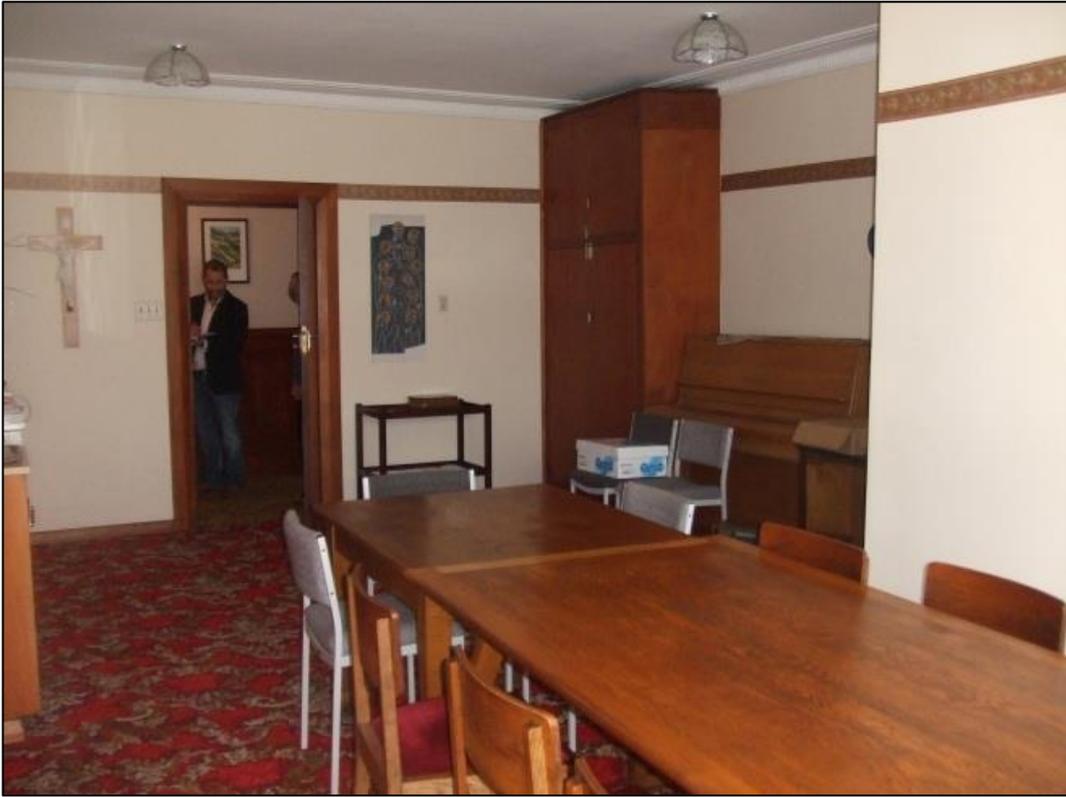
Figure 4-80 Southeast corner of Room 8 showing modern fittings. Looking east to Room 4

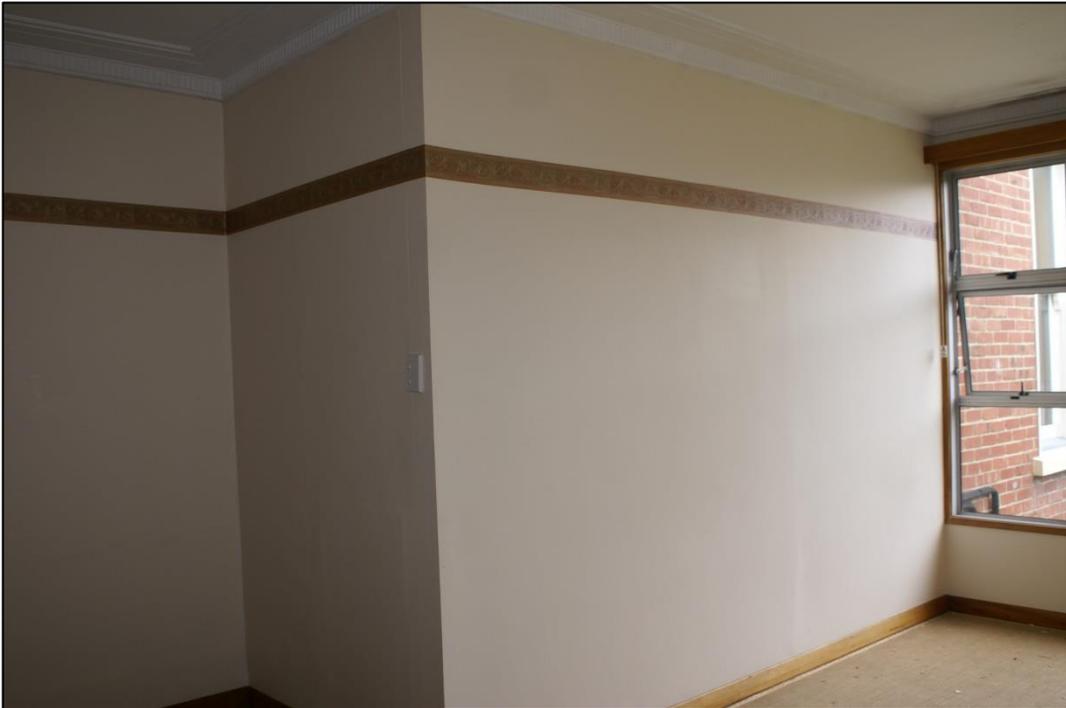
Figure 4-81 Looking southwest in Room 8 showing the 1956 addition in relation to the original room.

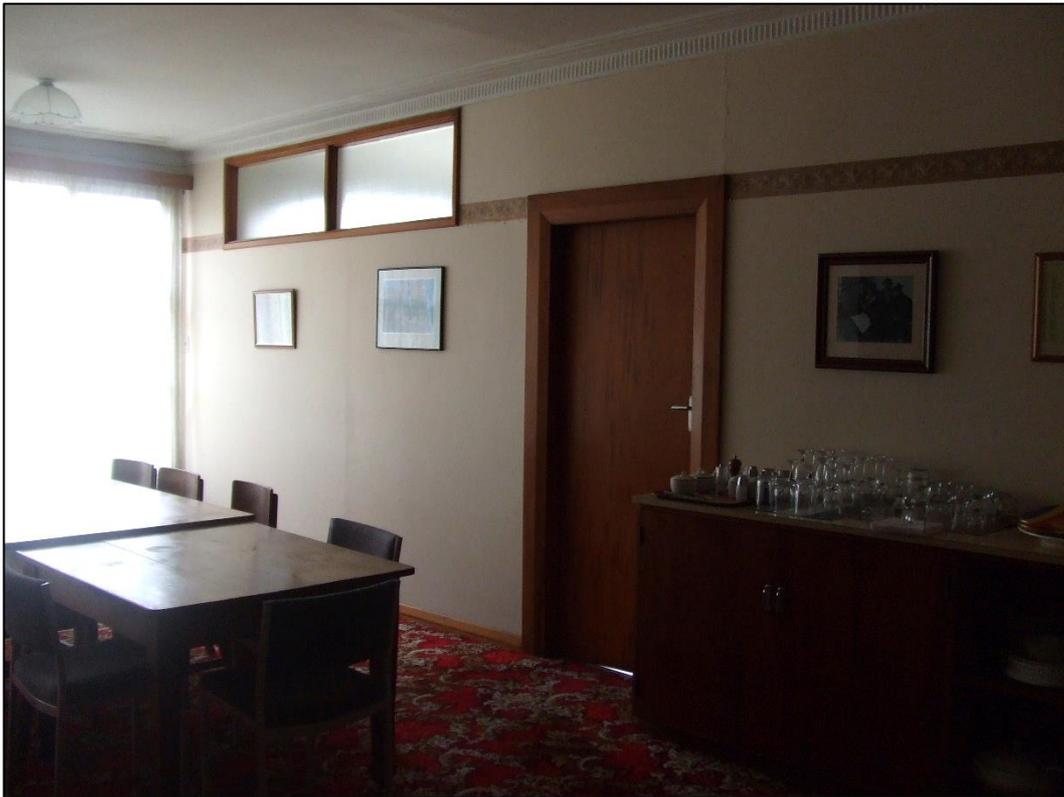
Figure 4-82 North-west corner of Room 8 showing doorway through to Room 9 and the transition from original presbytery structure and new addition due to the re-lining of the room.

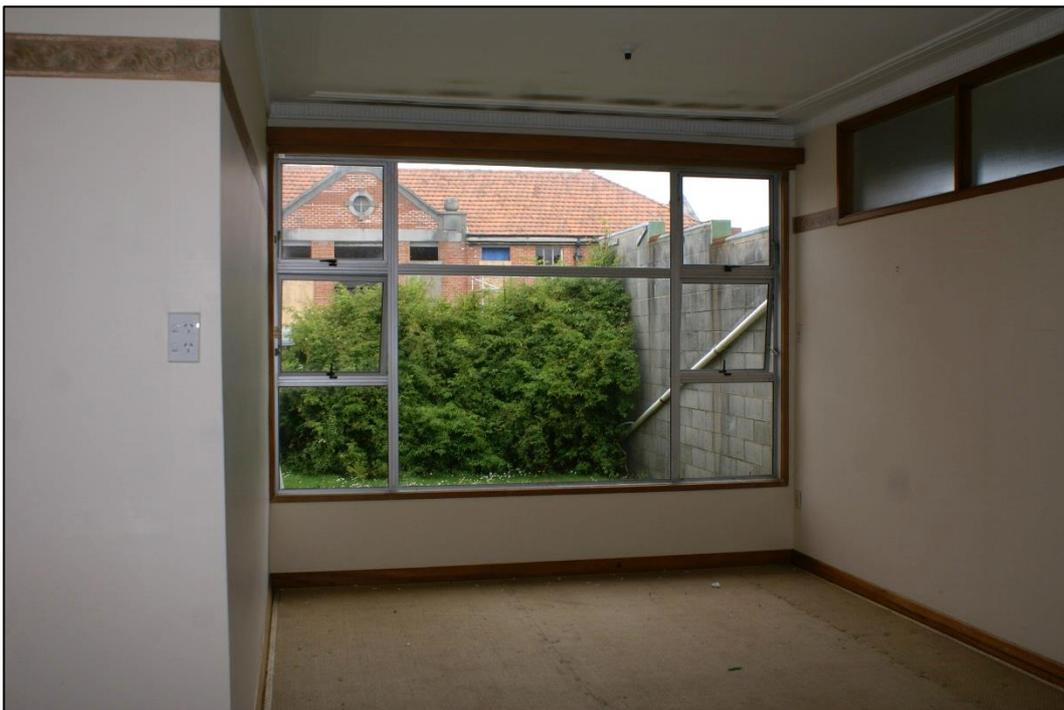
Figure 4-83 Modern external west wall of Room 8.

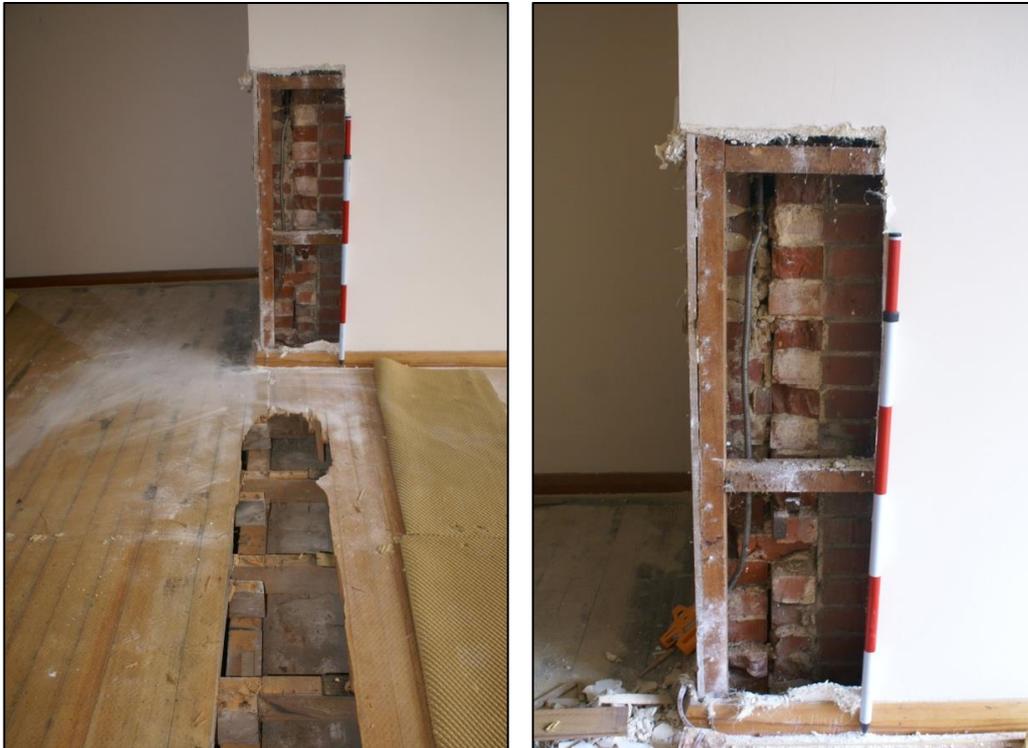
Figure 4-84 Portion of original exterior west wall deconstructed and footing still present beneath the floorboards when the room was extended.

The tongue and groove timber floorboards were orientated north-south. Beneath the floorboards, the original presbytery structure footing remained in-situ, with the wall deconstructed entirely (Figure 4-84). The wall linings throughout the room varied, depending on whether they are internal or external, original or late modification.

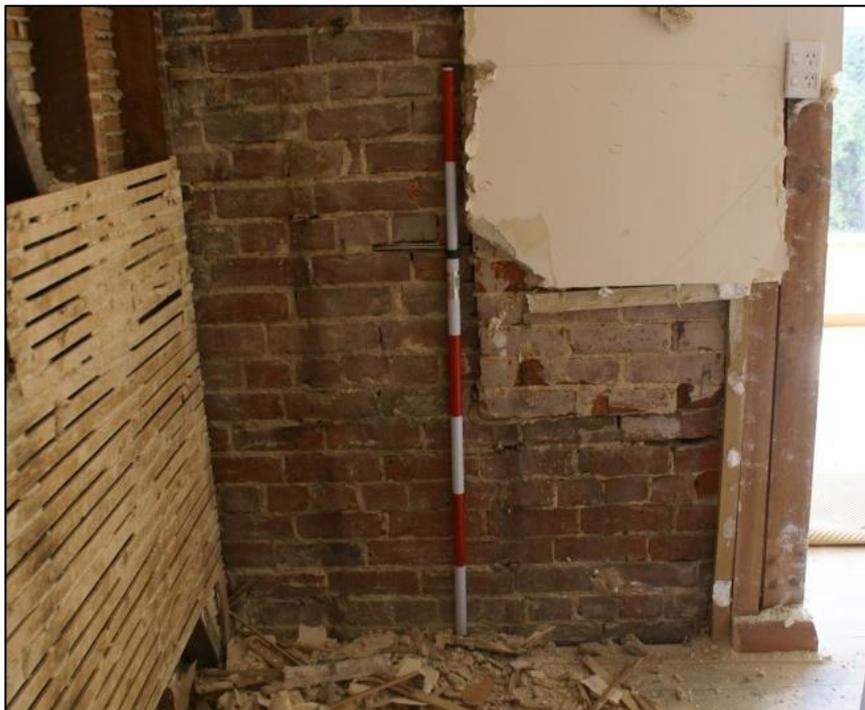
Figure 4-85 Looking southwest in Room 8 showing the remaining portion of the original exterior west wall still in-situ and interior south wall with the original wall linings. Note the bricked-up sash window partially obscured by remaining wall linings to the right of the stadia rod.

The east and south wall in the room were lined with wallpaper over Gib, lath and plaster and studs forming the original internal presbytery walls (Figure 4-85 and Figure 4-86). Along the original external (east) wall, the lath

and plaster overlay an English Garden Wall bond brick wall on studs. A portion of a bricked-up sash window was uncovered along this wall. The wall linings for the 1956 addition were plasterboard. The window and door architraves, skirting, floorboards and cornices were modern upgrades. The door into the hallway (Room 4) was an original four panel door while the door into Room 9 was modern. The ceiling was dropped and lined with plasterboard tiles.

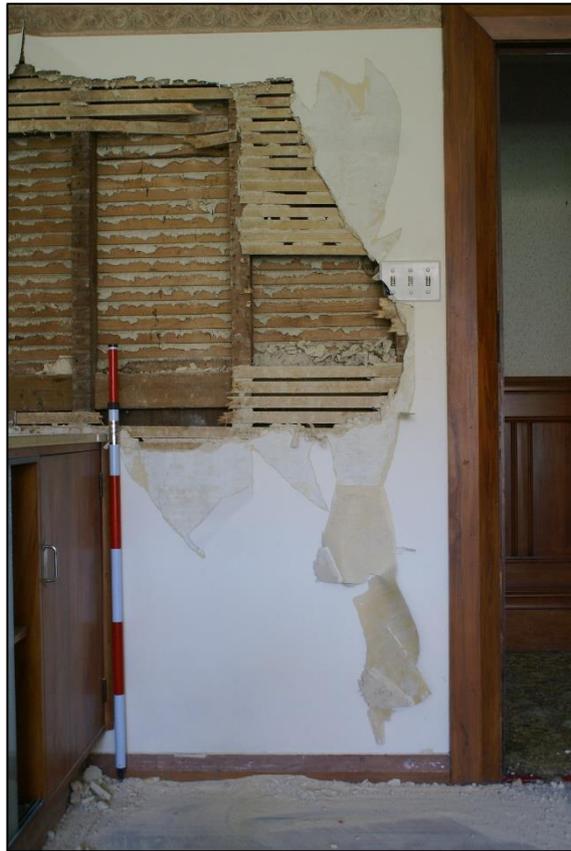
Figure 4-86 Looking east in Room 8 showing the wall linings of the interior wall it shares with Room 4.

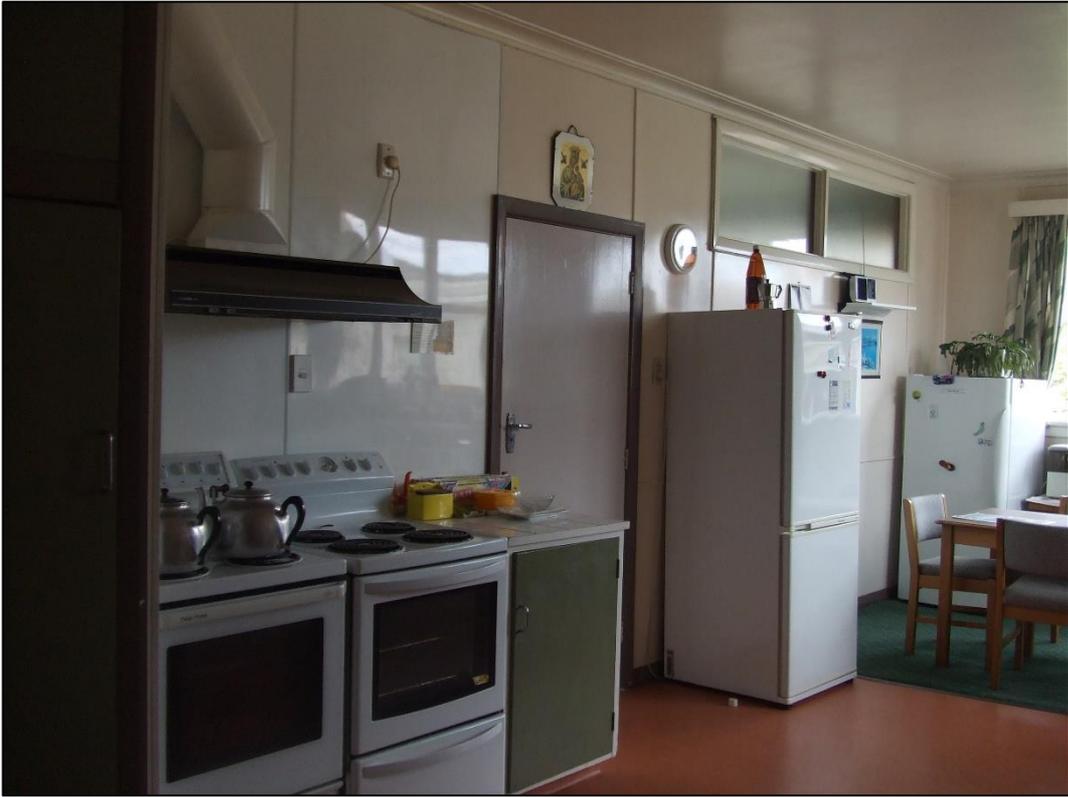
Figure 4-87 South wall Room 9 showing doorway to Room 8.

Room 9 was located on the west side of the building and was accessed through a hallway (east; Room 4) and Room 8 (south) (Figure 4-87 to Figure 4-89). It formed part of the original pre-1900 presbytery structure. In 1956 after a fire, in conjunction with Room 8, Room 9 was also extended west and the room size was increased. There were modern ceiling, wall linings, doors and joinery throughout the room, forming a modern kitchen.

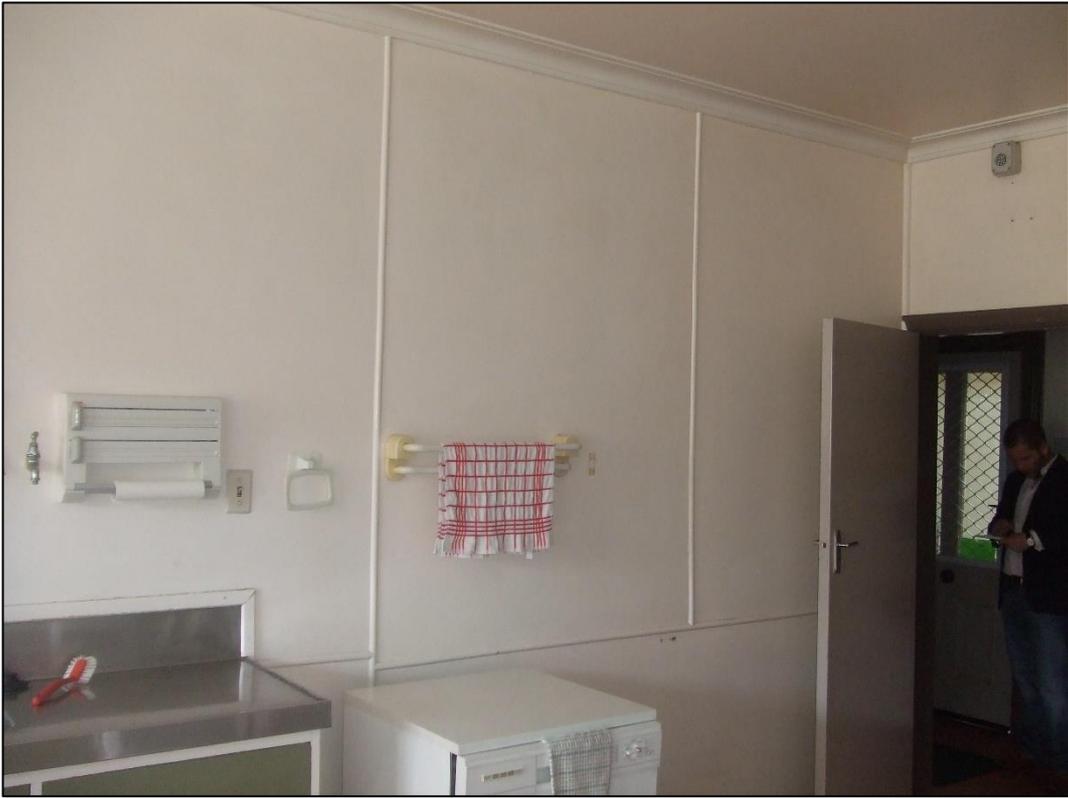
Figure 4-88 North wall Room 9 showing doorway to Room 4.

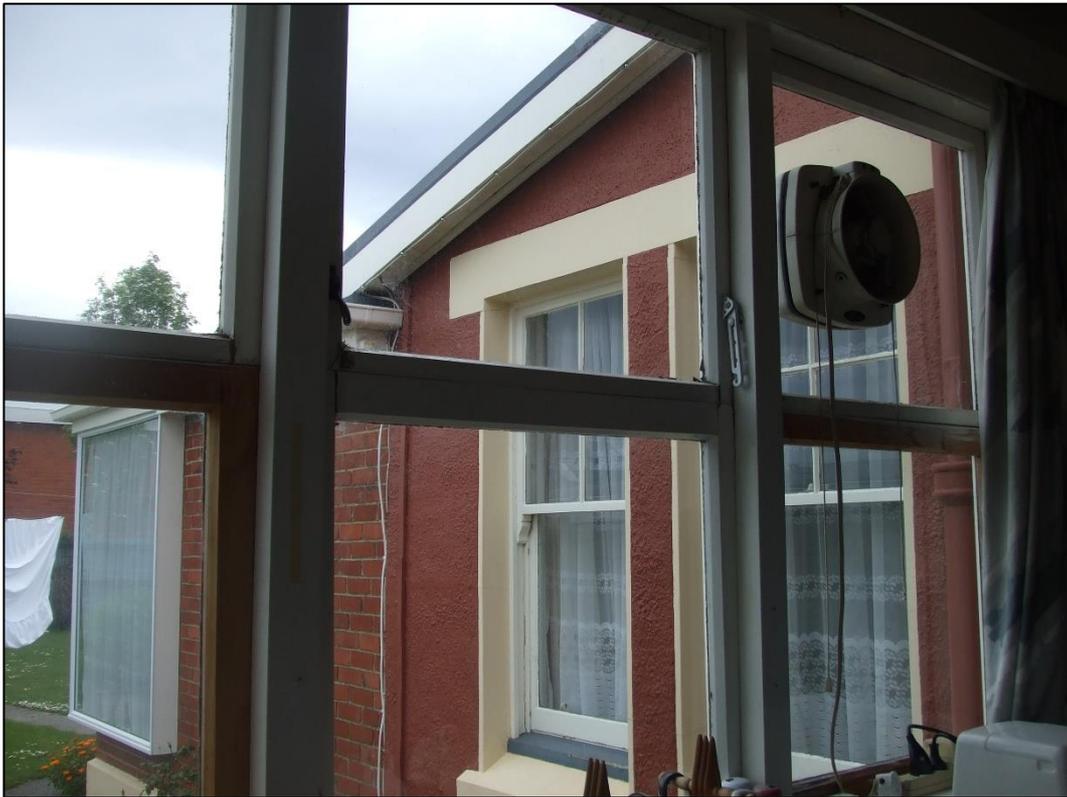
Figure 4-89 Modern 1956 west exterior wall of Room 9 looking towards the rear lean-to (Room 15) and 1951 addition.

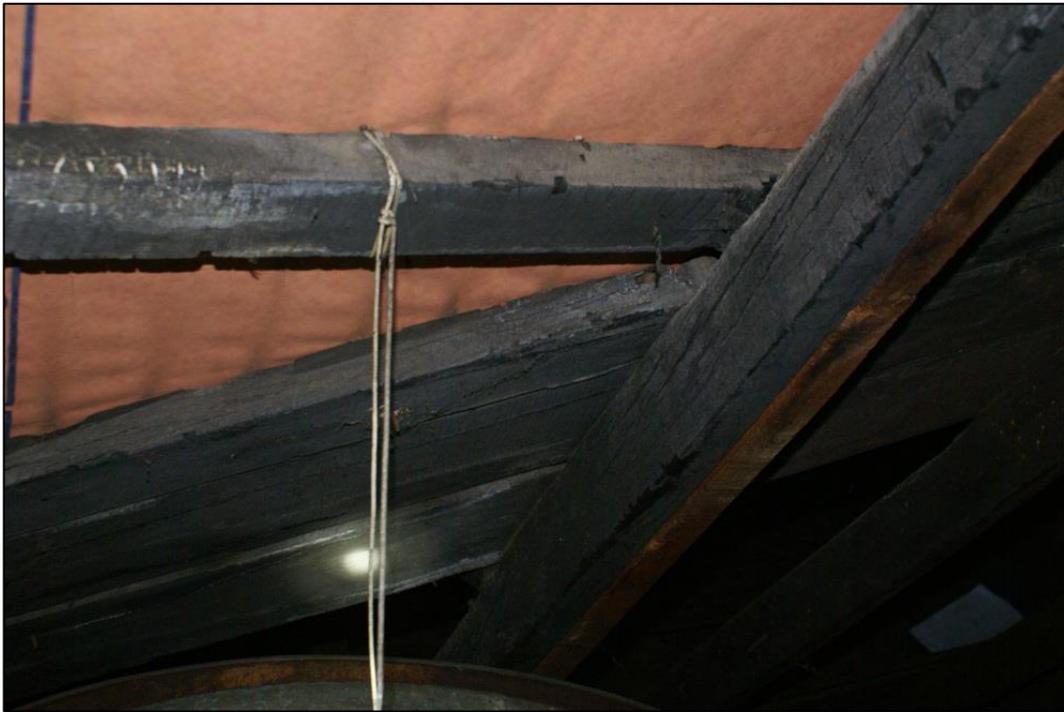
Figure 4-90 Charred trusses in the roof above Room 9.

In the roof space there was evidence of the extensive fire in the kitchen which resulted in the room modifications in 1956 (Figure 4-90). There was also some charred wood and soot visible when portions of the walls were removed.

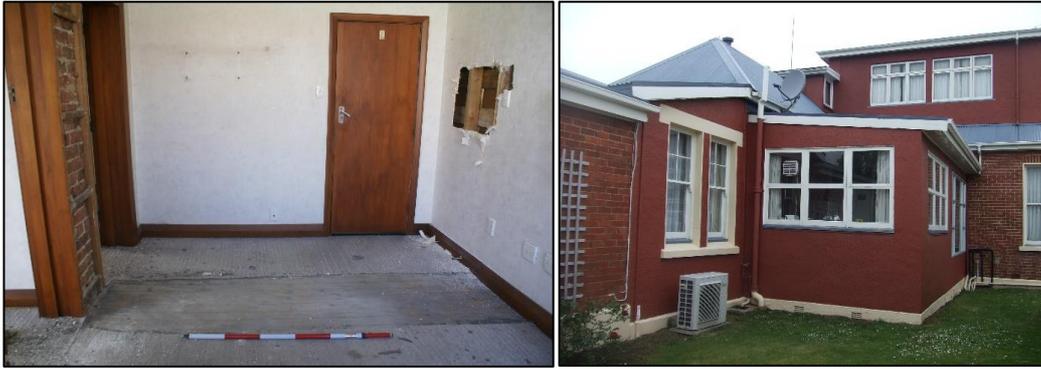
Figure 4-91 The interior (left) and exterior (right) of Room 15.

Room 15 was located at the rear of the presbytery on the north side of the building and was accessed through a hallway (east; Room 4) and two rooms forming part of the 1940 rear additions (north). It formed the rear, northwest corner of the original pre-1900 presbytery structure and was a lean-to ‘maid’s’ room. There were modern ceiling and wall linings and joinery throughout the room, as well as two sash windows along the western wall that were added in 1940 (Figure 4-91). The original window along the northern wall formed the doorway into Room 17.

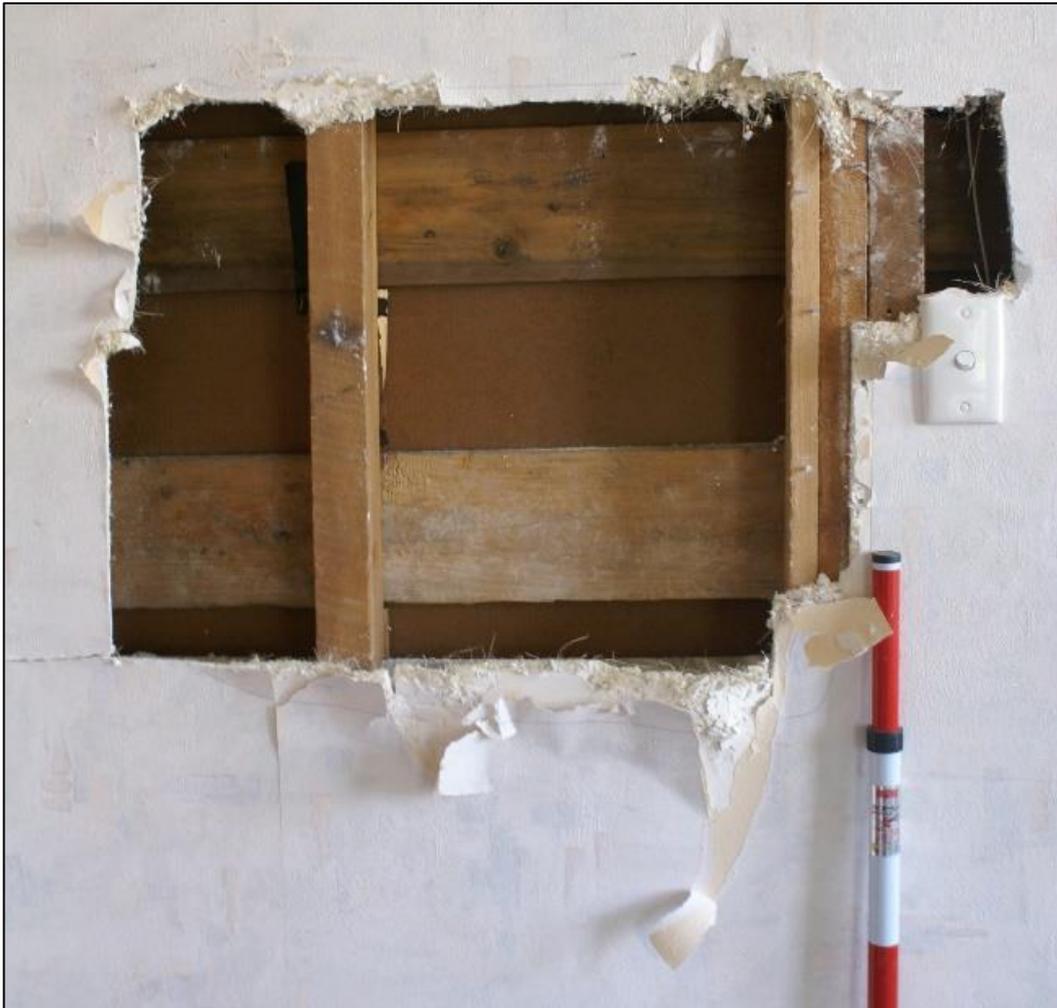
Figure 4-92 The southeast corner of Room 15 where the original doorway with Room 9 had been boarded up.

The tongue and groove timber floorboards were orientated north-south. The wall linings throughout the room varied, depending on whether they are internal or external, original or late modification. The west and north walls were finished with fibrous plasterboard, studs over the English Garden Wall bond. These two walls formed the original exterior walls of the presbytery. The east wall was finished with plasterboard over modern studs where the L-shaped scullery and pantry was reduced in size; increasing the original size of Room 15. The remaining original portion of the east wall shared with Room 16 was finished with fibrous plasterboard over lath and plaster overlying studs. The south wall, shared with Room 9 was also comprised of fibrous plasterboard over modern studs. In the southeast corner of the south wall, double studs were present where the original doorway between Room 15 and Room 9 had been boarded up (Figure 4-92).

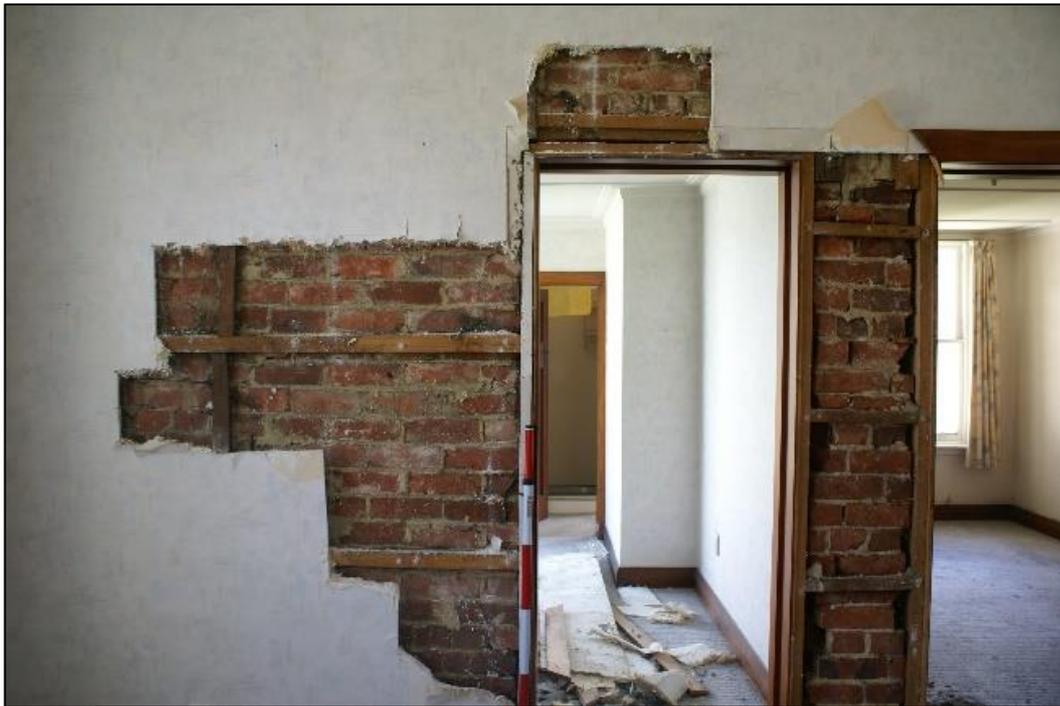
Figure 4-93 The north wall of Room 15 (original exterior wall) showing the space of the original sash window modified for the doorway into Room 15.

The doorway into Room 17 was created by modifying the original sash window along the north wall while the doorway into Room 18 had been created through the original presbytery exterior wall (Figure 4-93). The two sash windows along the west wall were installed in 1940 mimicking the original sash window style of the building.

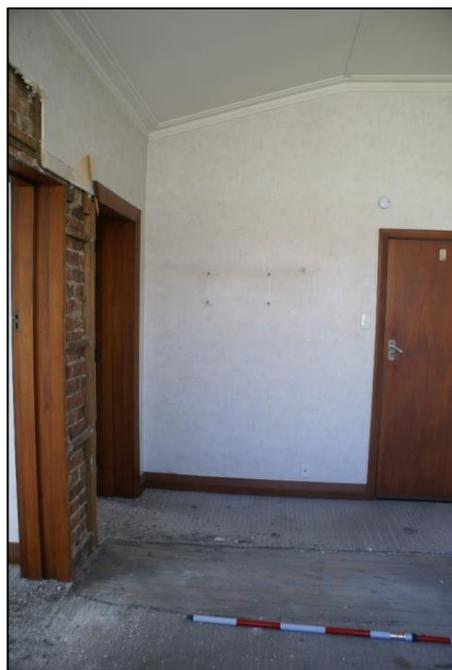
Figure 4-94 The east wall of Room 15 showing original lean-to roof.

The window and door architraves, skirting, and cornices throughout the room are all modern upgrades. The doors into Room 4, 17 and 18 are all modern. The ceiling in Room 16 is constructed of fibrous plasterboard and at the centre of the room starts angling downwards towards the north wall forming a typical lean-to roof design (Figure 4-94).

Room Section	Layers
Floor	<ol style="list-style-type: none"> 1. Foam-backed cream carpet 2. Floorboards – 10 cm wide, 25mm thick - running north-south
Wall	<ol style="list-style-type: none"> 1. Wallpaper – floral motif (cream) (see Figure 4-94) 2. Fibrous plasterboard 3. Studs 4. Brick - 70mm x 220mm x 100mm (East external wall and north original external wall)
Ceiling	<ol style="list-style-type: none"> 1. Gib-plasterboard 2. Plain modern timber cornices

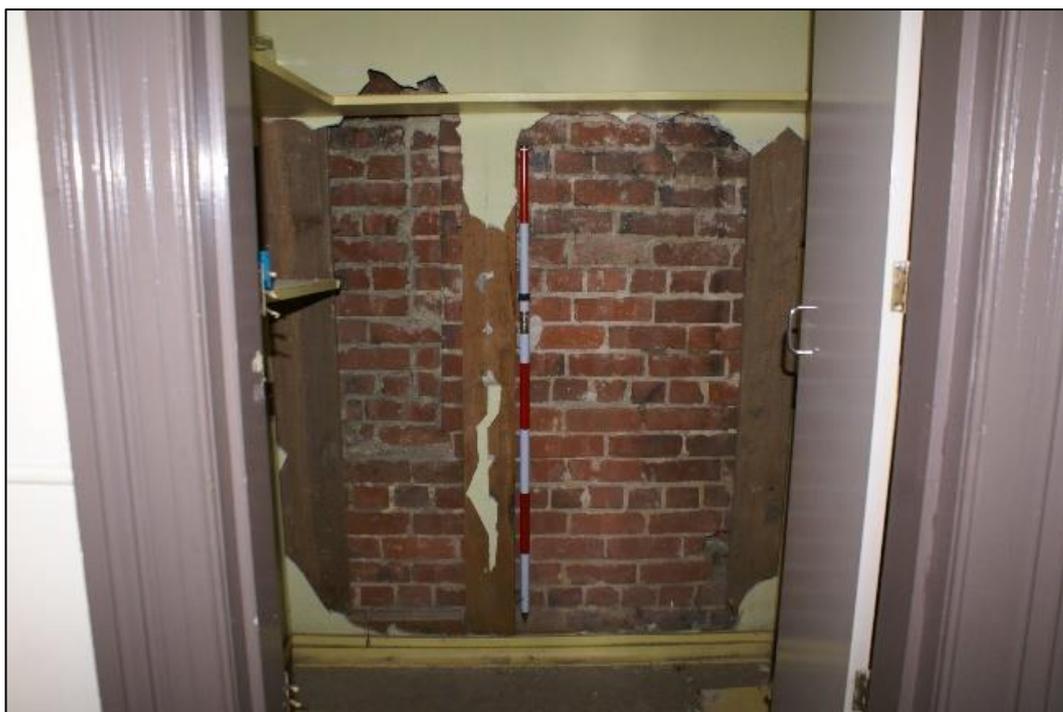
Figure 4-95 Looking north into Room 16 with the bricked up window visible to the left of the photo scale.

Room 16 was located at the rear of the presbytery on the north side of the building and was accessed through the hallway (south; Room 4) (Figure 4-95). It formed part of the original pre-1900 presbytery structure as the scullery. There are modern ceiling and wall linings and joinery throughout the room internally. The external door architrave appears to be original but sourced from elsewhere within the structure as this doorway was only formed in 1929. The walls throughout the room were lined with cement board over studs. Along the north wall (original external wall of the presbytery), the studs overlay English Garden Wall bond brick and the original sash window which had been bricked up (Figure 4-95). It extended into the northeast corner of Room 15 as the originally scullery was a larger L-shaped room reduced in size in 1929.

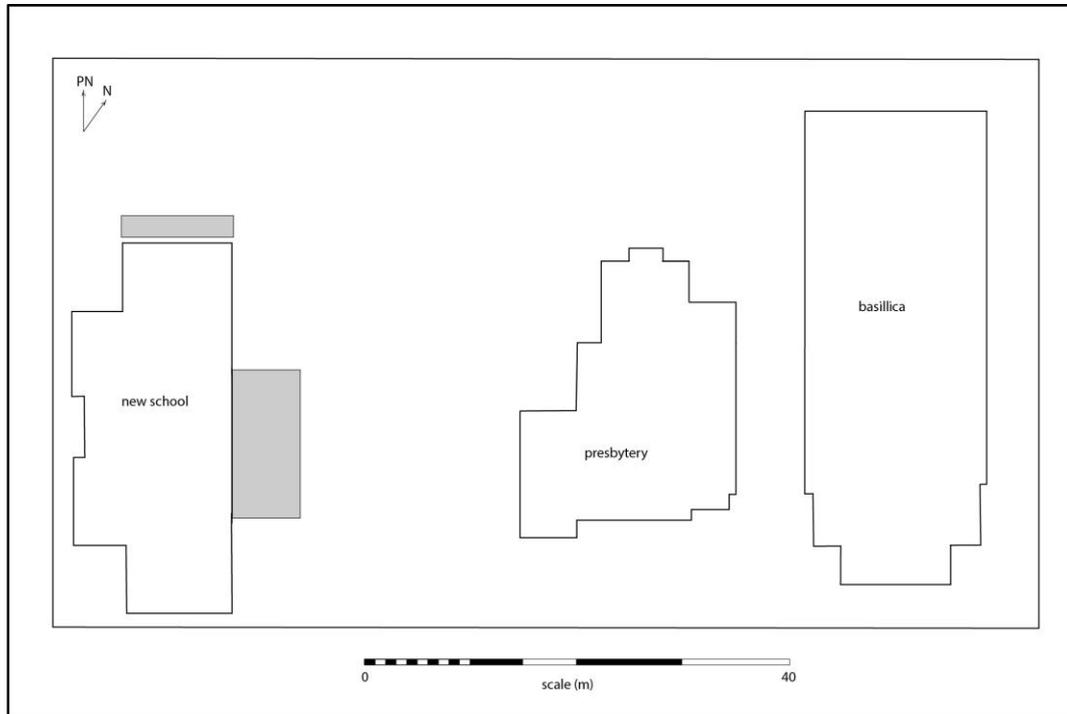
Figure 5-1 Stage 1 of excavations (in grey) at the St Patricks site.

Stage 1 involved monitoring the foundations for two new entrances into the new St Patrick’s school building on the eastern and northern aspects and the associated service upgrades. Fieldwork was conducted between the 8th and 10th of October 2012 by Adrian Taylor and Sheryl Cawte. The earthworks in EA1 consisted of a series of trenches a maximum of 350 mm deep for drainage and footings for the new school entrances (Figure 5-1).

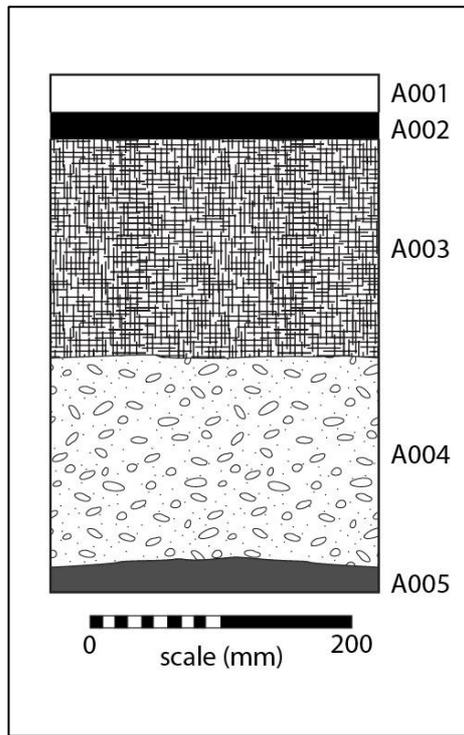
Figure 5-4 Scale drawing of the stratigraphic profile of EA1.

Across EA1, the stratigraphic profile was shallow with a maximum excavation depth of 350 mm (Figure 5-4). Five distinct stratigraphic layers were identified:

- A001: modern asphalt surface (30 mm)
- A002: mid-brown top soil (20 mm)
- A003: yellow/orange/brown mixed fill layer comprised of rock, fine sediment (150 mm)
- A004: natural dark grey anaerobic layer where the water table fluctuates (150 mm)
- A005: natural light grey natural clay subsoil (depth of approximately 350 mm)

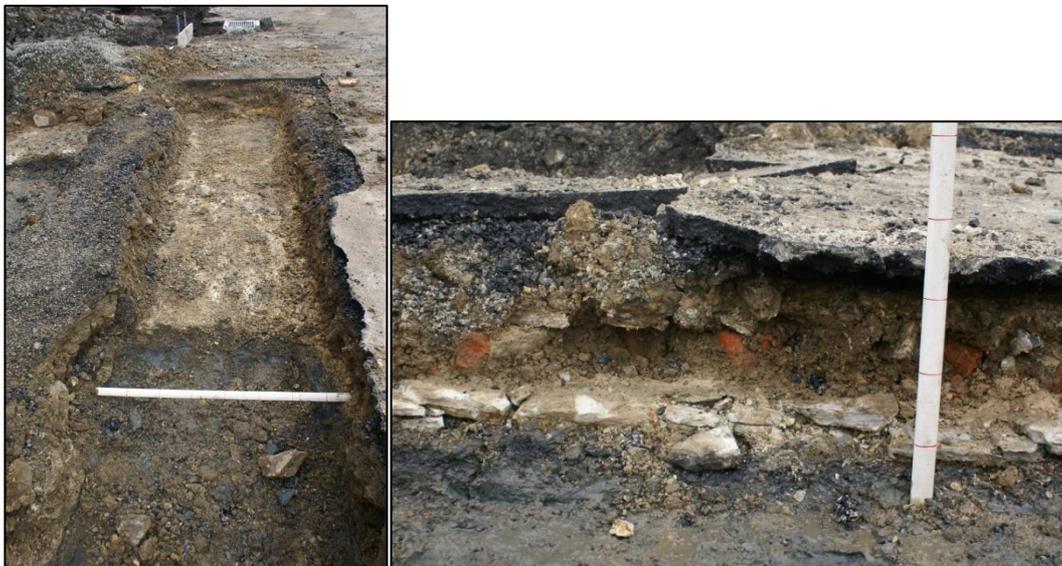
Figure 5-5 A006 beneath the A003. Left: Plan view. Right: Stratigraphic profile of EA1.

A hard-packed clay/concrete floor surface was only partially exposed during drainage trenching outside the eastern aspect of the school building. The surface was 50 mm thick and 220 mm beneath the current ground height. It was laid directly on A004, beneath A003 (Figure 5-5).
