Serving the Community: St Patrick's Church Complex

**Final Report for Archaeological Investigations
at Site No. I44/539 – I44/542
Under Archaeological Authority No. 2013/61**

Report Prepared for St Patrick's Development Committee
Authors: Sheryl Cawte, Eva Forster-Garbutt, Naomi Woods, Jeremy
Moyle and Peter Mitchell
Reviewed By: Dr Hayden Cawte
05/06/2018

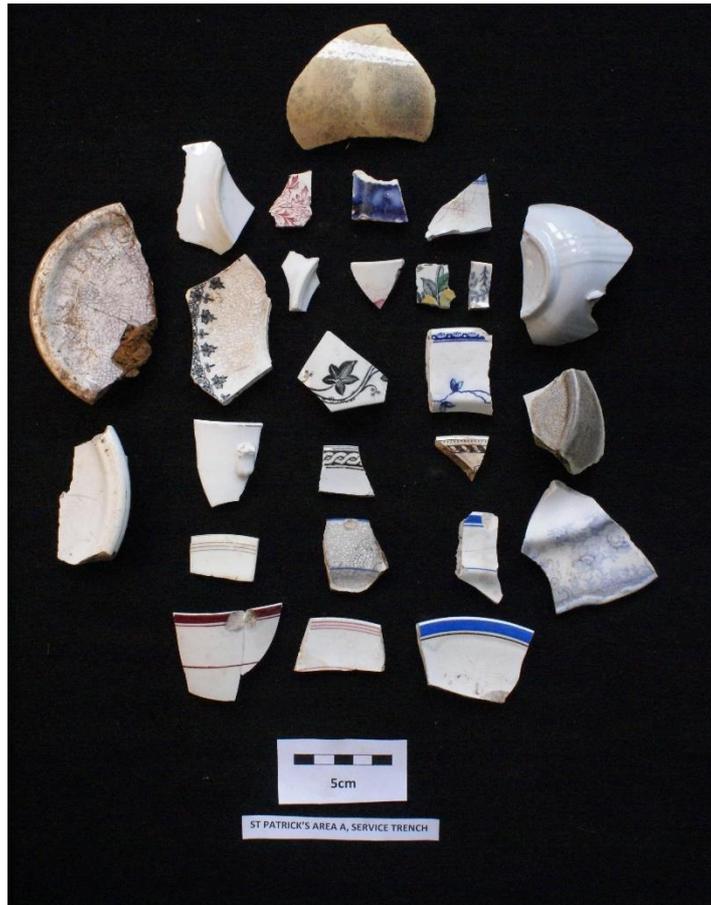
Figure 5-6 Selection of ceramic vessel sherds recovered during from EA1.

Whilst much of the tableware within the ceramic assemblage was undecorated, various decorative techniques were also observed (Figure 5-6). The range present is typical for a late nineteenth century assemblage. Most common among this assemblage these was blue under-glaze transfer printing (UGTP), closely followed by black UGTP. Collectively, the variety of different UGTP decorated ceramics make up 47% of the assemblage. Only two patterns, Asiatic Pheasant and Rouen, were able to be identified among these UGTP ceramics. These were two very common nineteenth century patterns. Additionally, one vessel was identified as having its UGTP decoration highlighted with paint. Other decorative techniques observed within the assemblage included gilding (two Bone China saucers and a cup, moulding (the Berlin Swirl motif on the White Granite mug), incising (a whiteware jar), banding (six vessels), and flow blue.

A maker's mark was present on the Bristol-glazed stoneware bottle that read "DOULTON & CO LIMITED/ LAMBETH/ 19." Doulton ran a pottery factory in Lambeth from the 1850s but was only incorporated as a limited liability company in 1899 (Tinkler, 2006), providing a *terminus post quem* (TPQ) for the ceramic vessels of 1899.

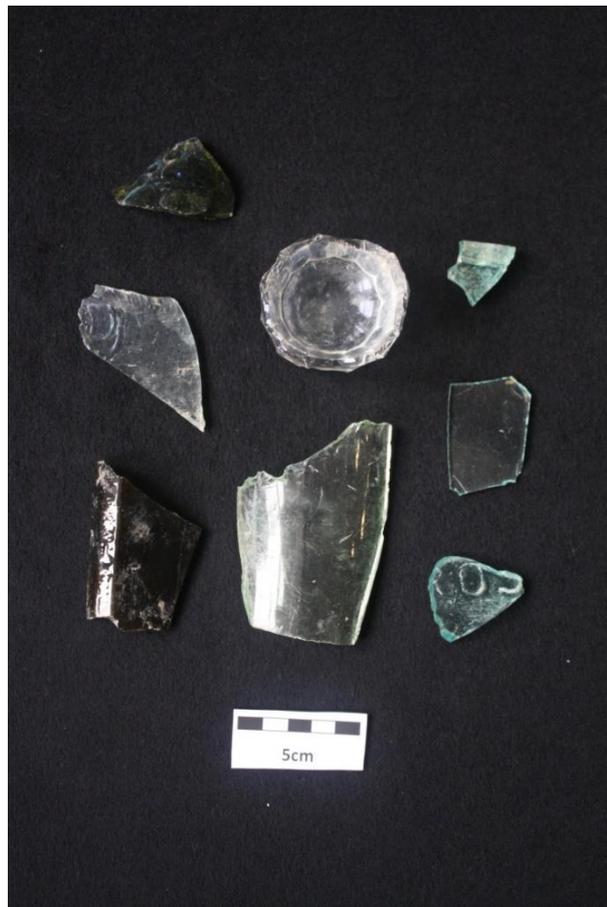
Figure 5-7 Glass fragments from EA1.

The majority of the glass fragments recovered were identified as bottle glass (Table 5-3 and Figure 5-7). Most of these fragments were too small to allow for the conclusive identification of form or function with the exception of one case gin and a schnapps bottle identified. Based on the variations in the colour of glass specimens, the assemblage represents at least five bottles. The base of a pressed glass tumbler was also recovered. No diagnostic fragments other than the tumbler base were present, and no fragments showed evidence of manufacture method, therefore no chronological conclusions can be drawn from the glass vessels.

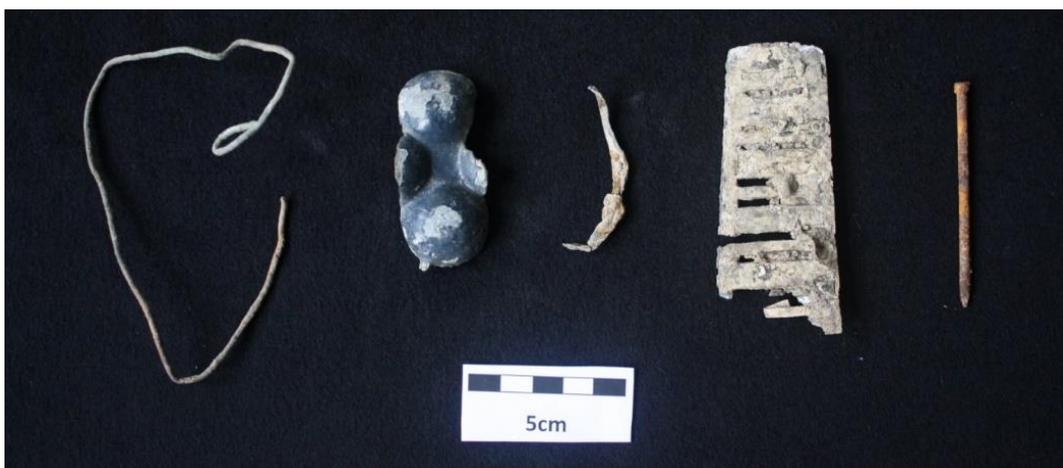
Figure 5-8 From left: Wire, quatrefoil architectural fitting, lead sheet, metal grate and wire nail.

Five metal artefacts were recovered from EA1 (Figure 5-8). The more ambiguous specimens include a length of tin wire (bent into a loop at one end), a small metal grate in the shape of a trapezium, and a strip of tin or lead sheeting. More distinct was a piece of cast iron moulded as a raised relief quatrefoil design. Though its exact use is unknown, it appears to be some form of architectural fitting. A single wire nail was also present in the assemblage. None of these artefacts provide precise chronological information and all are structural components.

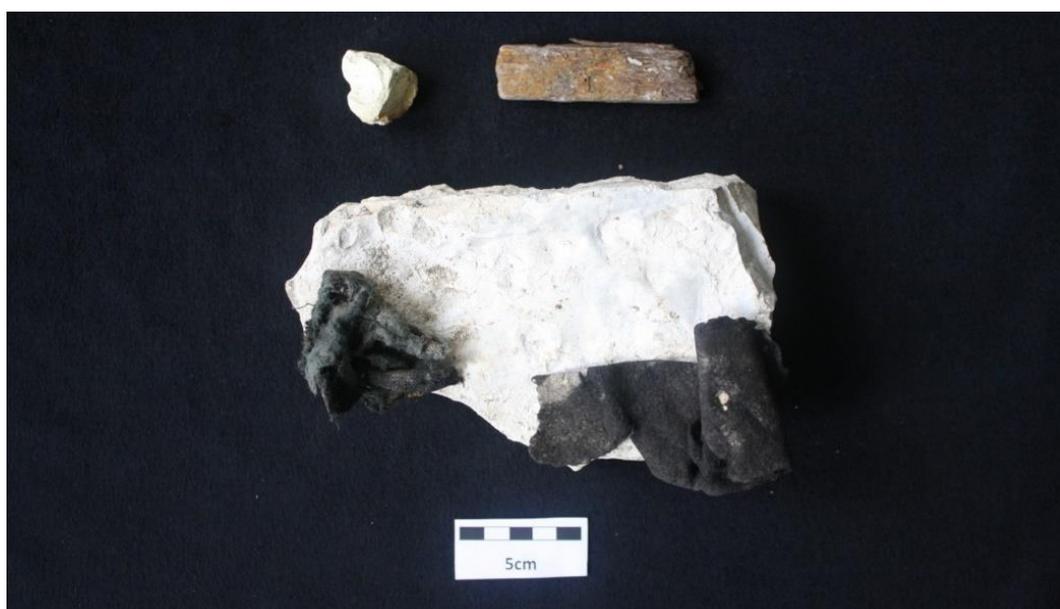
Figure 5-9 Timber, lime, concrete and fabric recovered from EA1.

Other artefacts recovered from EA1 were mostly structural materials (Figure 5-9). Two terracotta roof tile fragments from Marseilles tiles were found and both have the partial makers mark “GUICHARD [FRERES]/SEON [ST. HENRI, MARSEILLE].” This was a company active from 1890 till 1908 (Tasker, 1993), and Marseille tiles were only introduced to New Zealand c1901 (Tasker, 1993). These tiles relate to the new school building as it is the only structure on site with a terracotta tile roof, and also provide an overall TPQ for the

assemblage of 1917 when this building was erected. Two samples were also taken of the concrete and lime-cement ‘floor’ that was discovered during the excavations. Considering the uneven top surface of the lime-cement layer, as well as the large amount of fill that covered it, it is possible that this feature represented the discard of waste building materials or a foundation for the asphalt layers above. Five fragments of window glass, three pieces of weathered limestone, and two pieces of timber were recovered from the site. The difference in colour between the various flat glass fragments suggests that the fragments represented two windows. One of the timber pieces appeared to be rectangular in cross section. In addition to these structural components, two small (c. 50mm across) pieces of textile were collected. One of these was felt while the other was cotton, and both were black.

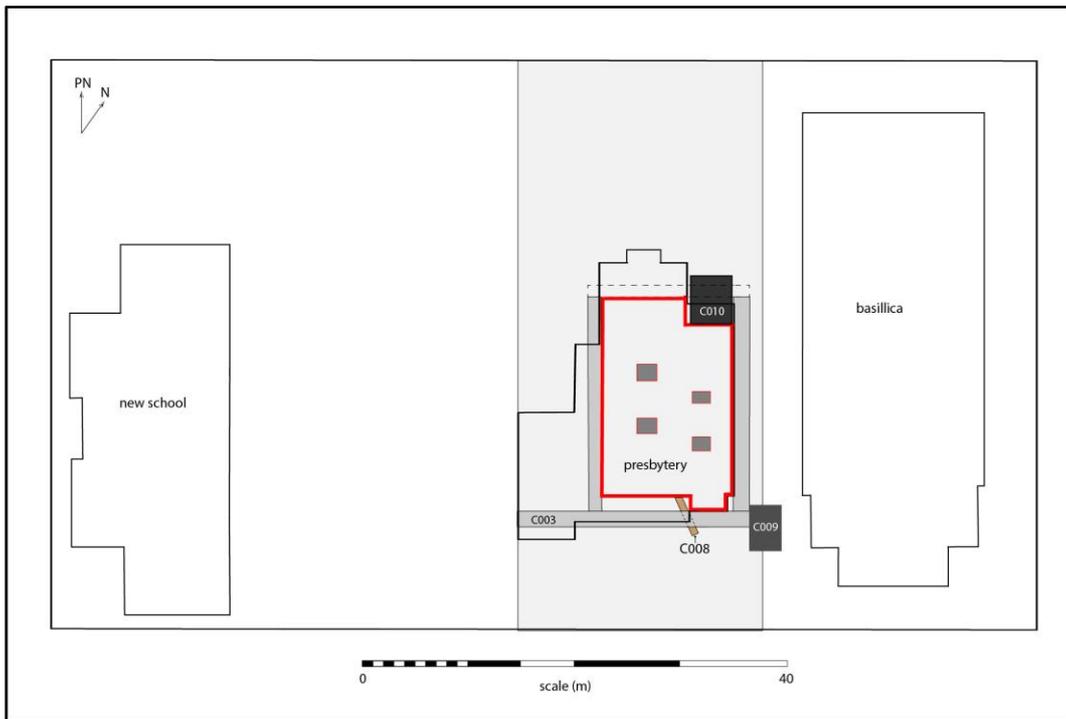
Figure 5-10 Stage 2 of excavations at St Patricks (in grey) with the Phase 1 presbytery foundations in red and fireplaces marked.

Stage 2 excavations involved the building recording of the presbytery structure (EA2) and monitoring the site clearance of the presbytery post demolition for landscaping (EA3). Fieldwork was conducted by Sheryl Cawte and Danielle Dyer between the 29th of January 2013 and the 1st of February 2014. Site works involved the removal of the presbytery floorboards that had been left in-situ following the demolition of the structure, removing subsurface post-1900 building structural elements and scraping the site in preparation for landscaping. EA3 included the footprint of the presbytery and the site from MacAndrew Street (south) back to the Mercy Chapel (north) and from the path along the basilica (east) to the edge of the carpark (west) (Figure 5-10 to Figure 5-12).

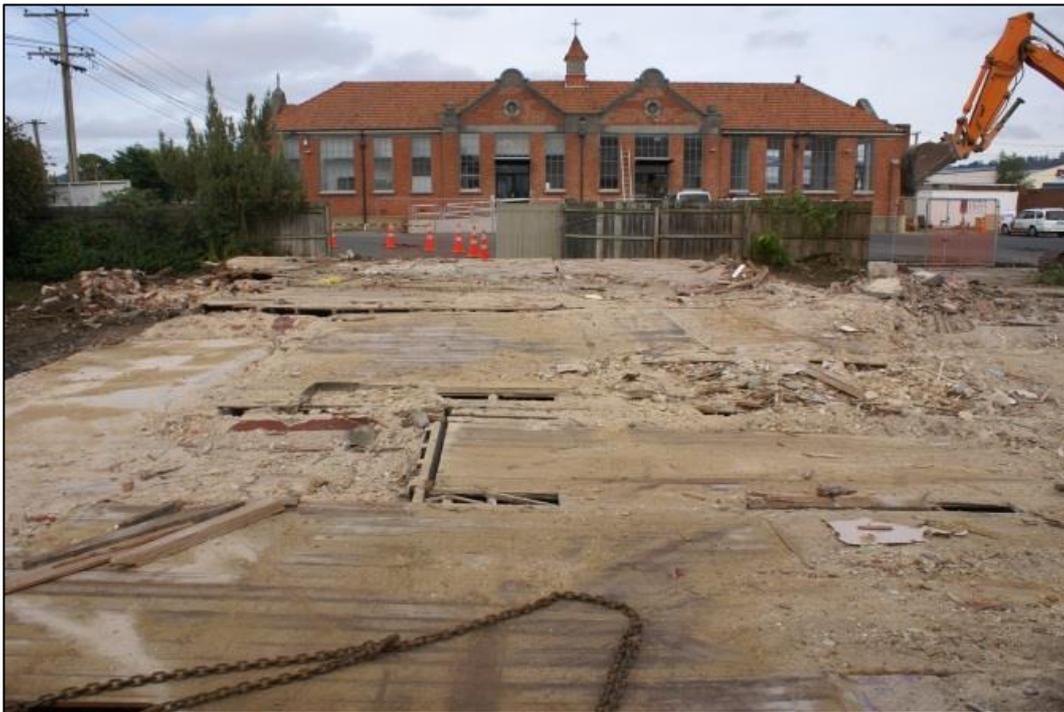
Figure 5-11 Presbytery wooden floors in-situ after the building was demolished.

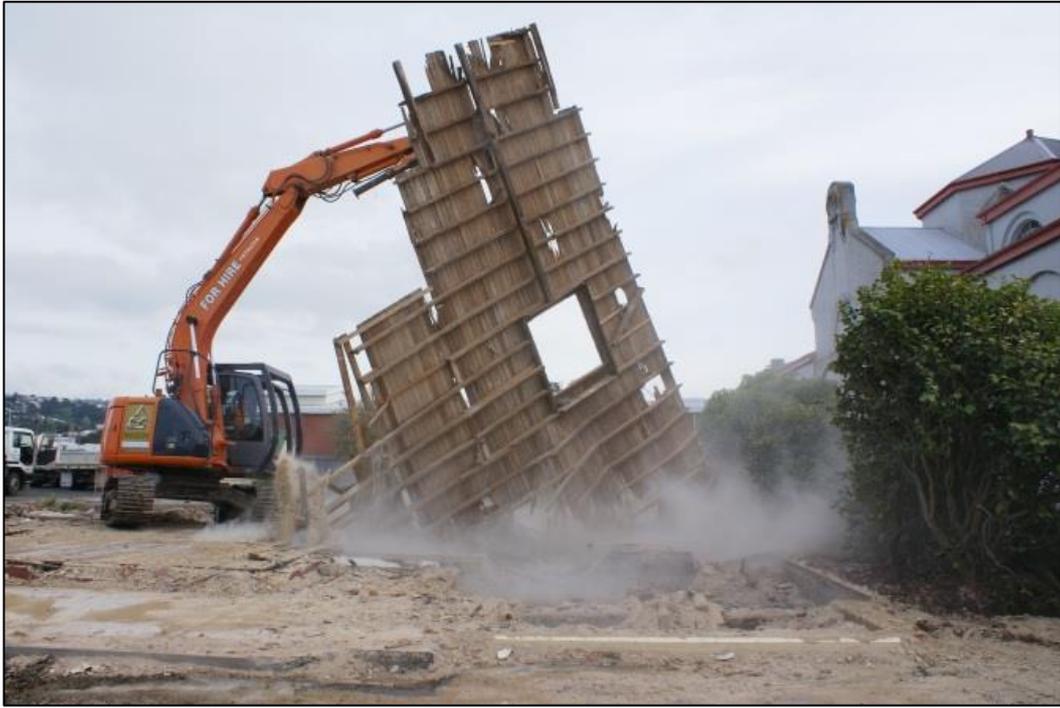
Figure 5-12 Lifting the floors.

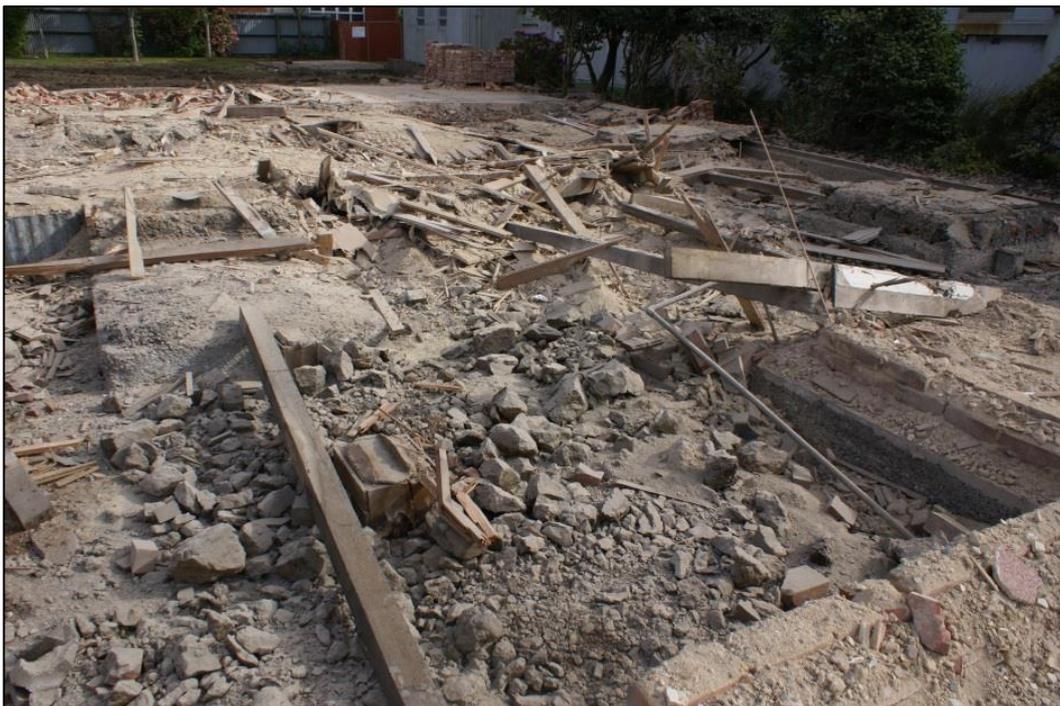
Figure 5-13 The ground beneath the lifted floor boards.

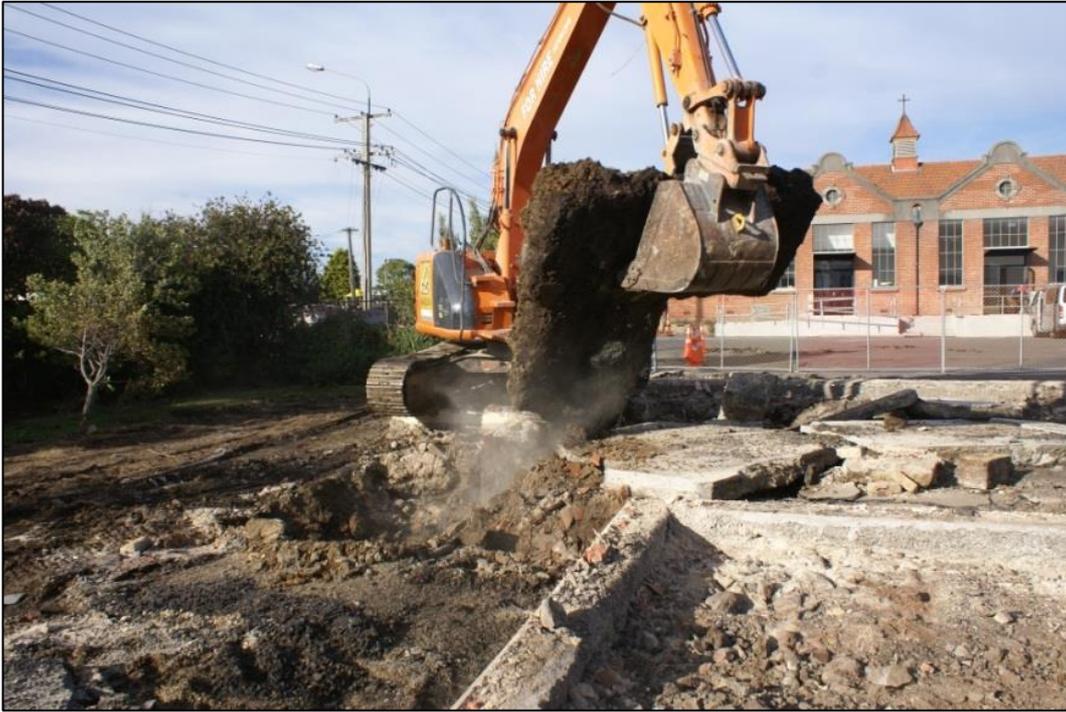
Figure 5-14 Removing a section of the footings from the presbytery addition. Looking east.

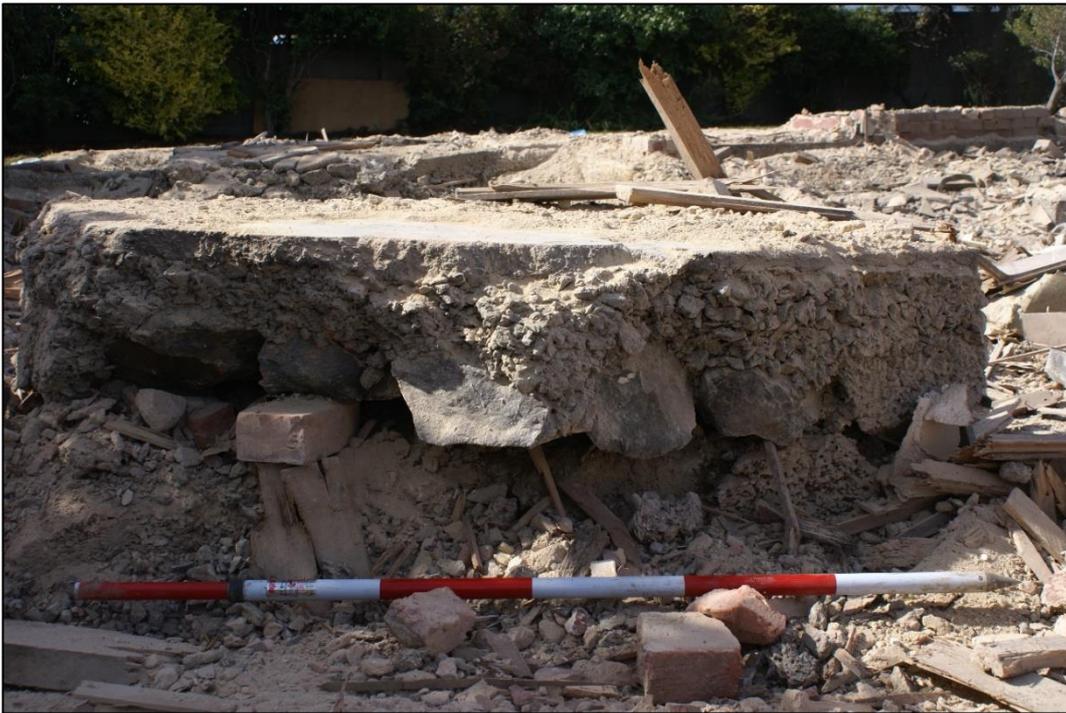
Figure 5-15 Base of the double-back fireplace between Rooms 1 and 2 constructed of a concrete and stone mix. Looking south.

As discussed above, the external founds were constructed of a combination of concrete and large stones beneath the original presbytery structure. Piles were concrete encased in wood boxing measuring 250 mm x 350 mm. This suggests they were poured onsite. All of the original fireplace foundations remained in-situ when the floor was lifted constructed of a combination of concrete and large stones (Figure 5-15). The piles in the 1929 addition were also constructed of concrete encased in wood as was the fireplace base (Figure 5-16). The foundations and chimney bases of the 1929 addition were both deeper and larger in size than those of the original presbytery structure, seeming to account for the poor ground surface when the extension was built. The piles measured 300 mm x 250 mm with a depth of 650 mm while the fireplace bust had a double foundation and had a depth of 750 mm (Figure 5-17).

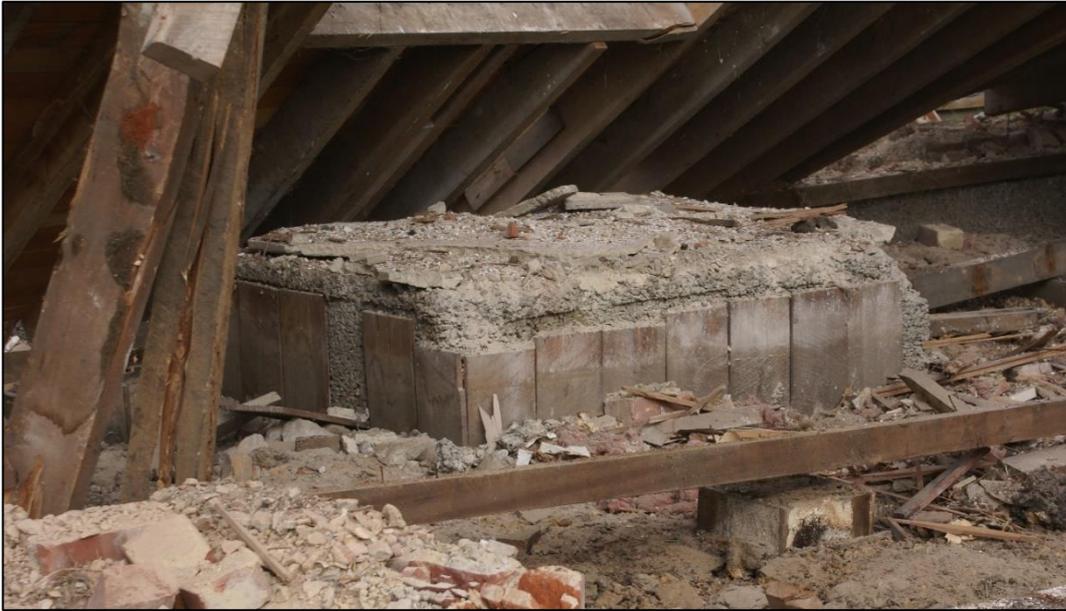
Figure 5-16 Fireplace foundation in-situ within 1929 addition.

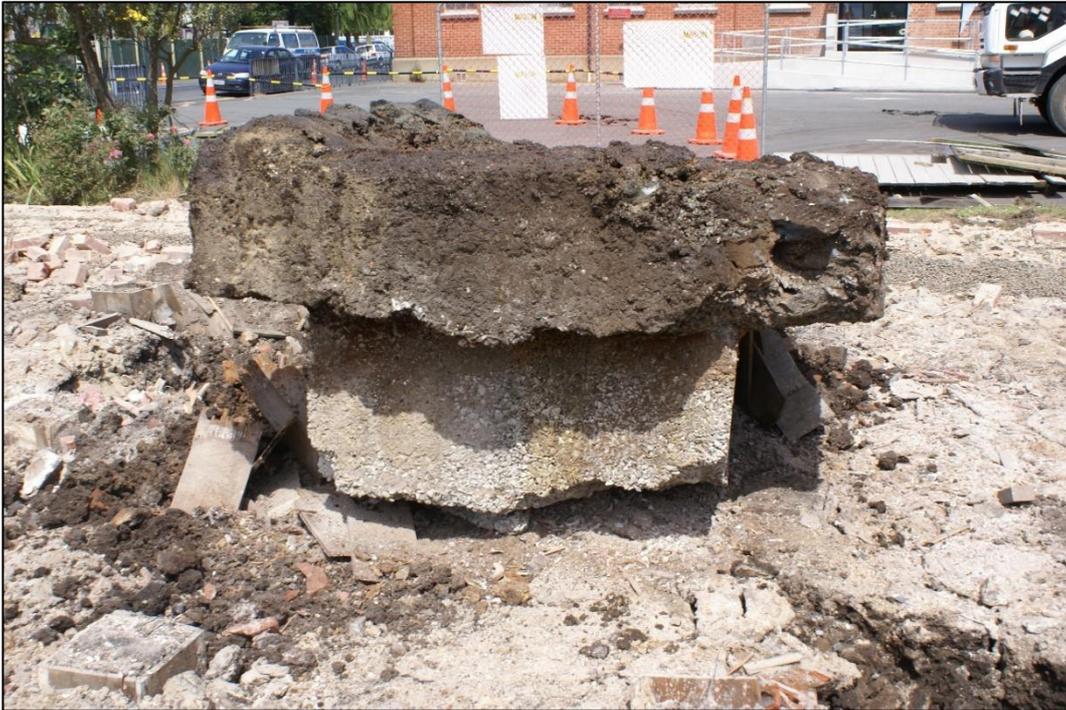
Figure 5-17 The larger foundations of the fireplace base from 1921 addition.

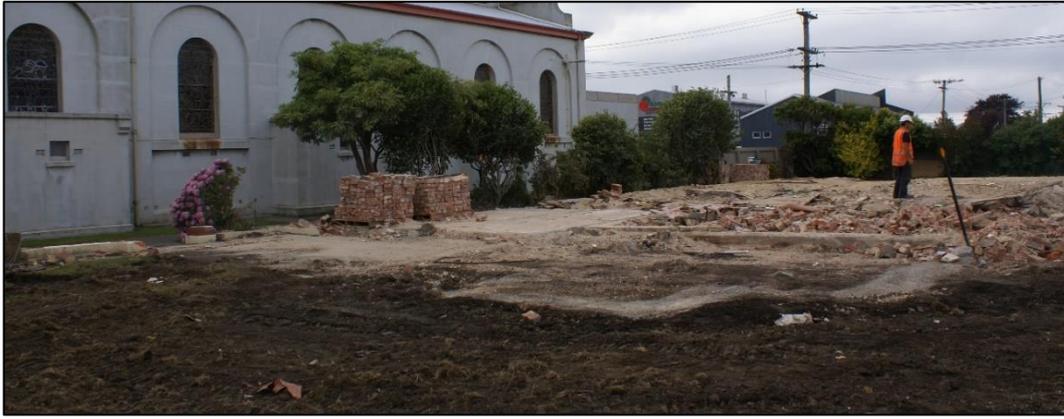
Figure 5-18 Foundation pads of the later additions.

The foundations of the post-1929 additions were comprised of various concrete pads (Figure 5-18).

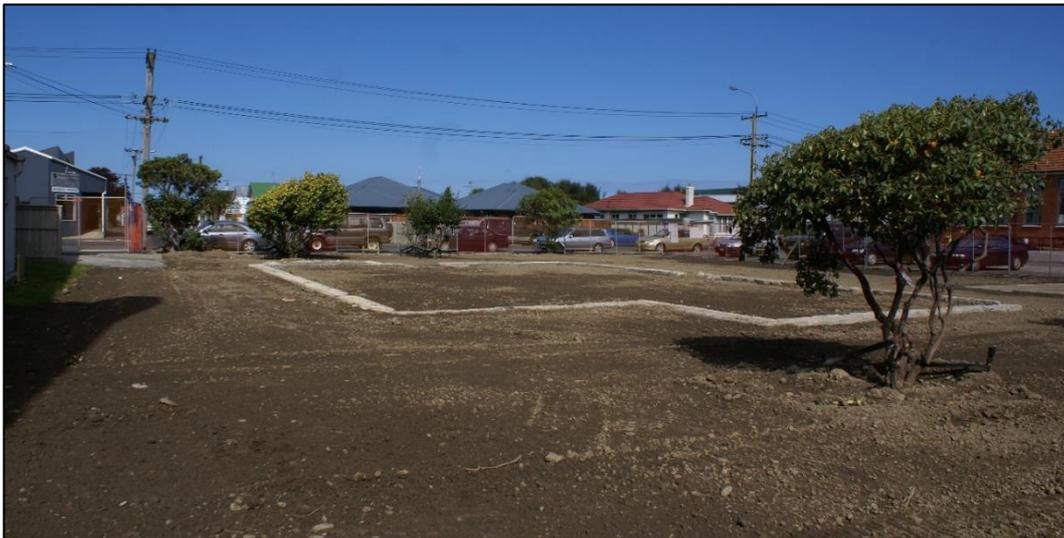
Figure 5-19 EA3 after site clearance with original presbytery founds left in-situ. Looking southwest.

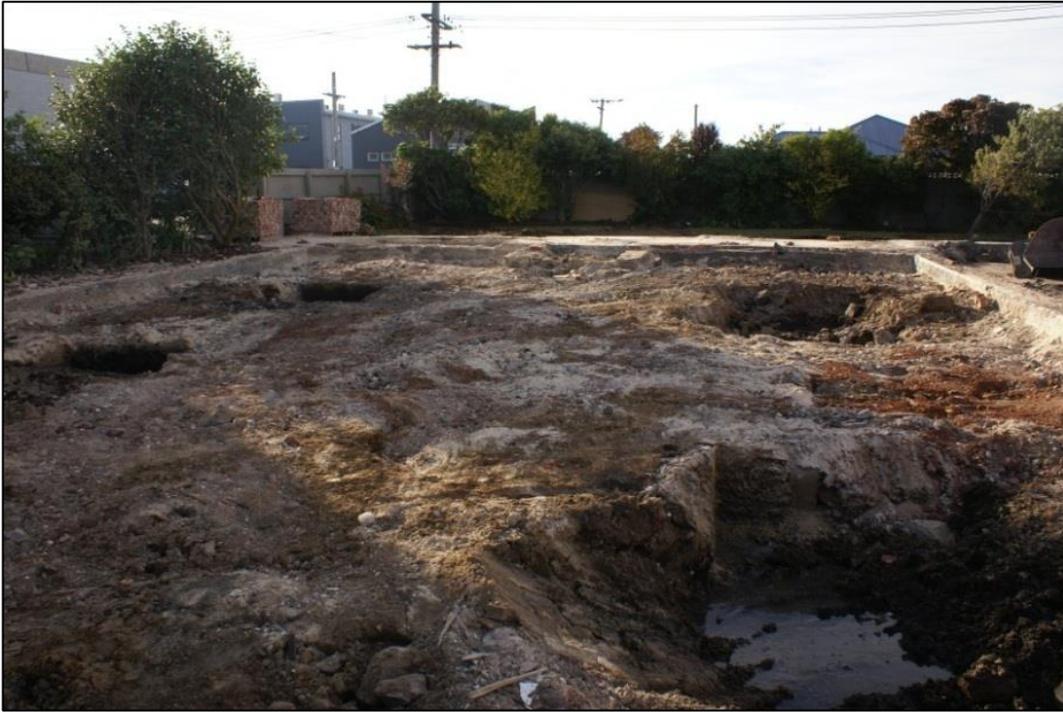
Figure 5-20 Within the presbytery founds of the pre-1900 portion showing the high-water table after the fireplace bases had been removed and site area scraped.

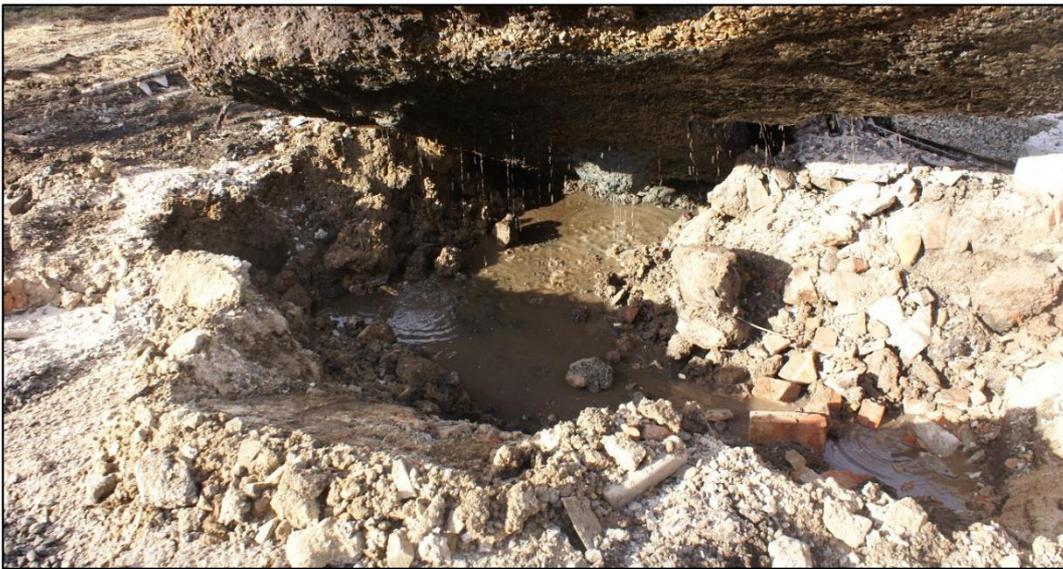
Figure 5-21 Water visible when 1929 portico concrete slab was lifted at the front of the presbytery.

Across EA3, including beneath the presbytery structure, the stratigraphic profile was shallow with the water table sitting approximately 500mm below the current ground level. When the foundations, piles and fireplace bases were removed, the holes filled immediately with water (Figure 5-21). The water level within the holes varied with rising and falling of the tides.

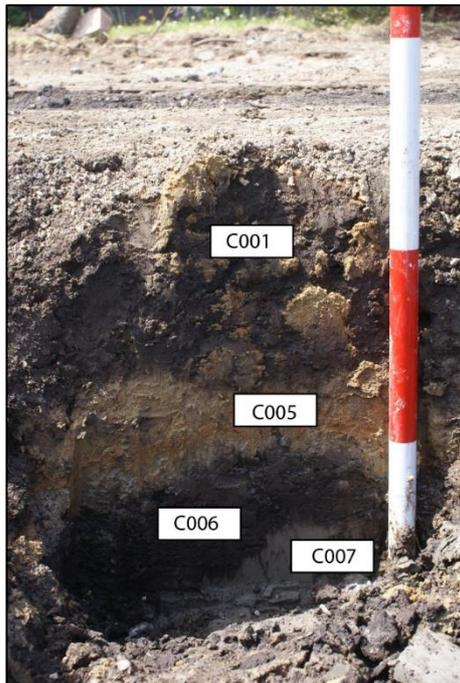
Figure 5-22 Stratigraphic profile of EA3.

- C001: mid-brown top soil (interior of presbytery foundations only) (identical to A002, Stage 1)
- C002: modern concrete (exterior of presbytery foundations only) (200 mm)
- C003: asphalt surface (exterior of presbytery foundations only) (20 mm)
- C004: asphalt preparation layer (exterior of presbytery foundations only) (100 mm)
- C005: yellow/orange/brown mixed fill layer comprised of rock, fine sediment (200 mm) (identical to A003, Stage 1)
- C006: natural dark grey anaerobic layer where the water table fluctuates (300 mm) (identical to A004, Stage 1)

- C007: light grey natural clay subsoil (Figure 5-22 and Figure 5-23) (depth of approximately 600mm) (identical to A005, Stage 1).

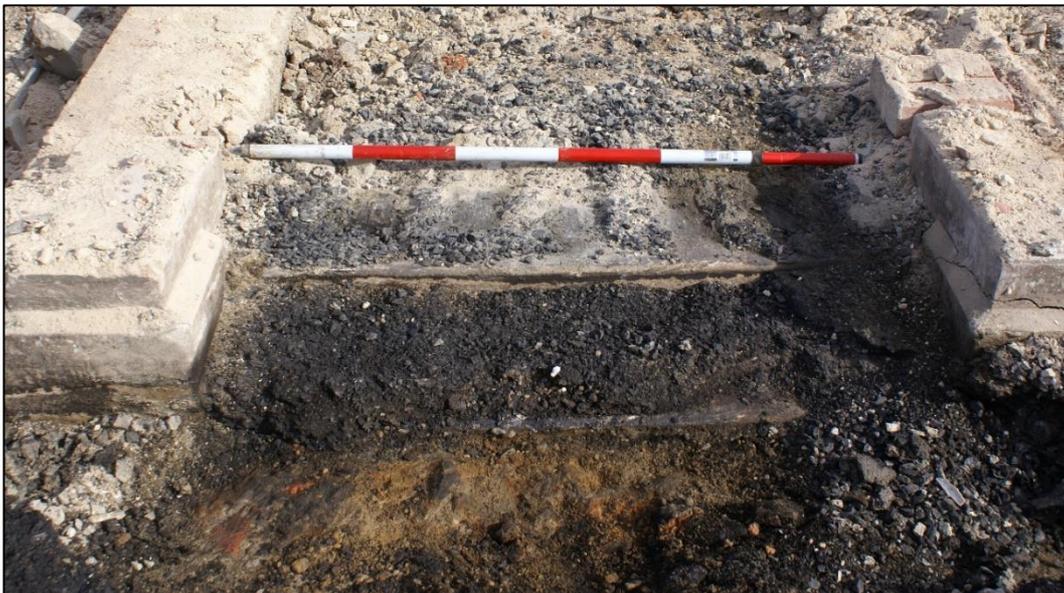
Figure 5-23 Presbytery entrance showing plan view of layers C002, C003 and C005.

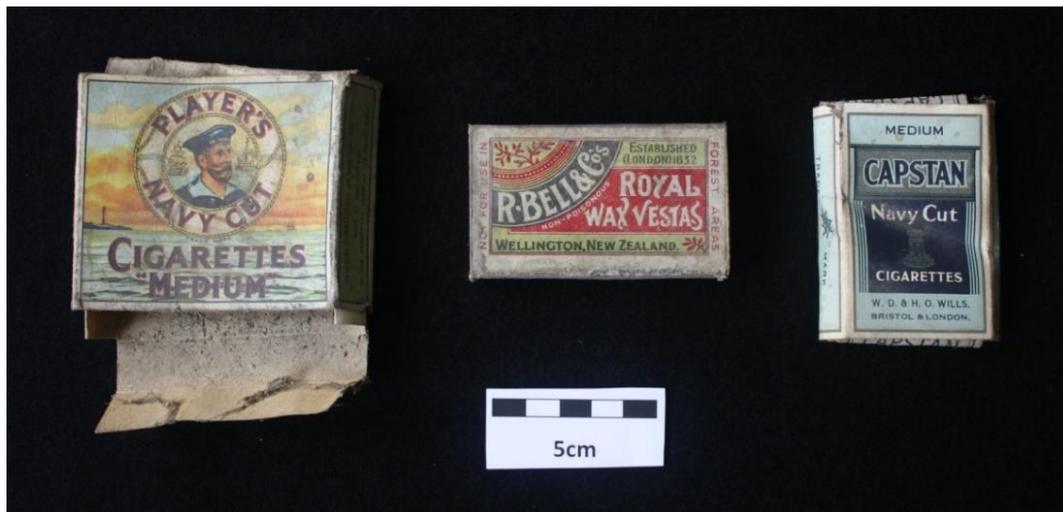
Figure 5-24 From left: Player's cigarette box, R. Bell & Co wax vesta matchbox and Capstan cigarettes.

The three artefacts from Room 8 were all related to smoking and included one match box and two cigarette packets, all made of cardboard (Figure 5-24). These specimens were in good condition, and the text on them was

easily readable. One cigarette packet is branded 'CAPSTAN NAVY CUT CIGARETTES/MADE IN NEW ZEALAND BY W. D. & H. O. WILLS.' This manufacturer opened its factory in Wellington in 1919 and the Capstan brand was in existence until at least the late 1950s (W. T. Henley Electrical, 2012). The other cigarette packet was branded 'PLAYERS NAVY CUT CIGARETTES/ JOHN PLAYER AND SON/ MADE IN NEW ZEALAND/ IMPERIAL TOBACCO COMPANY OF NEW ZEALAND LTD.' This brand was one of the most widely sold in the first half of the twentieth century (Otago Daily Times, 1900b). The wax vesta matchbox was branded 'R. BELL & CO'S ROYAL WAX VESTA'S/WELLINGTON NEW ZEALAND/ESTABLISHED 1832 (LONDON).' This artefact most likely dates to the first half of the twentieth century as R. Bell wax vestas were only manufactured in New Zealand after 1894, and production ended in 1962 (Evening Star, 1918).

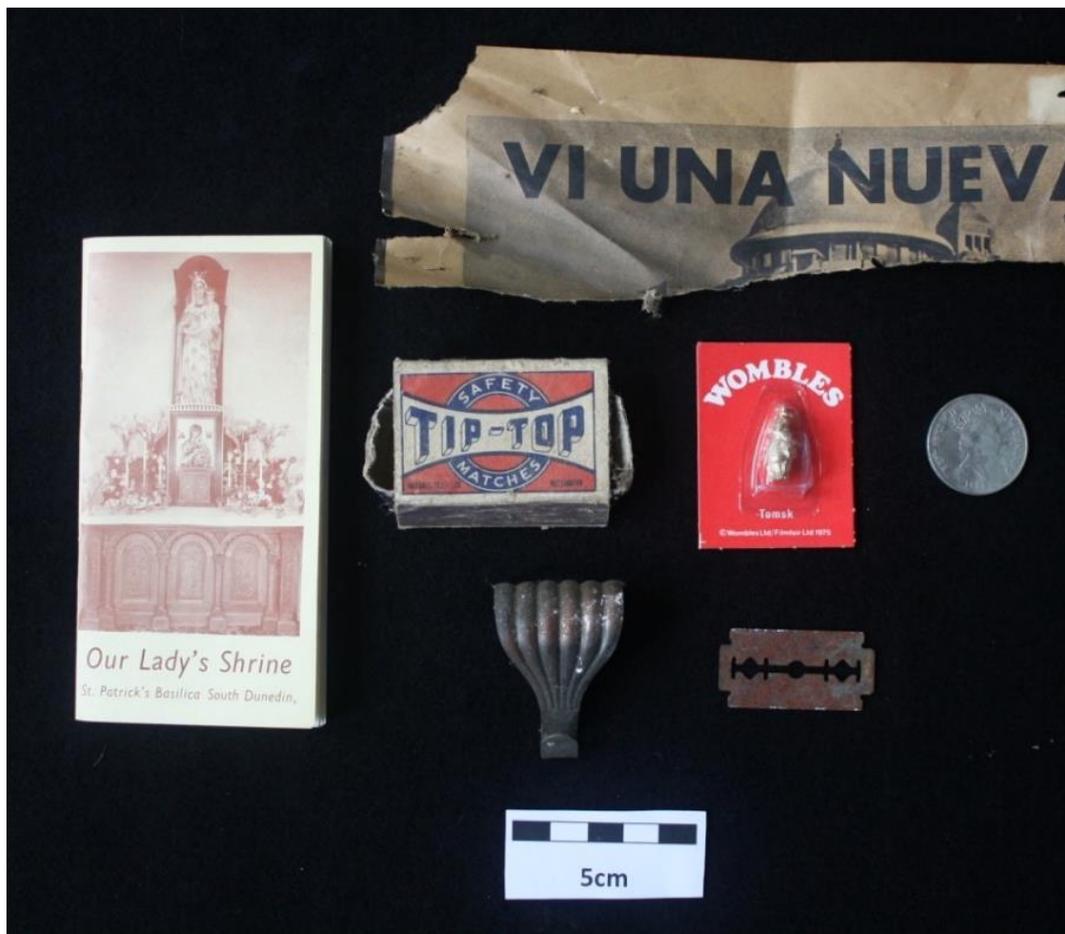
Figure 5-25 The artefacts recovered from Room 5.

The artefacts collected from Room 5 were a matchbox branded 'TIP TOP SAFETY MATCHES,' a prayer booklet containing devotional prayers for the Shrine of Our Lady at St Patricks Basilica, a picture hook (for use with a picture rail), a scrap of newsprint with Spanish printed on both sides in large characters (VI UNA NUEVA. . .//. . .EDABAD, Y LAS QUE VENDTA. . .), a New Zealand 20 cent piece from 1988, a razor blade, and a Wombles key chain. Tip Top matches were manufactured from 1947 to 1951 (Otago Daily Times, 1921), the prayer book published in 1951 and the Wombles keychain copyrighted in 1970, dating the assemblage to the mid to late twentieth century.

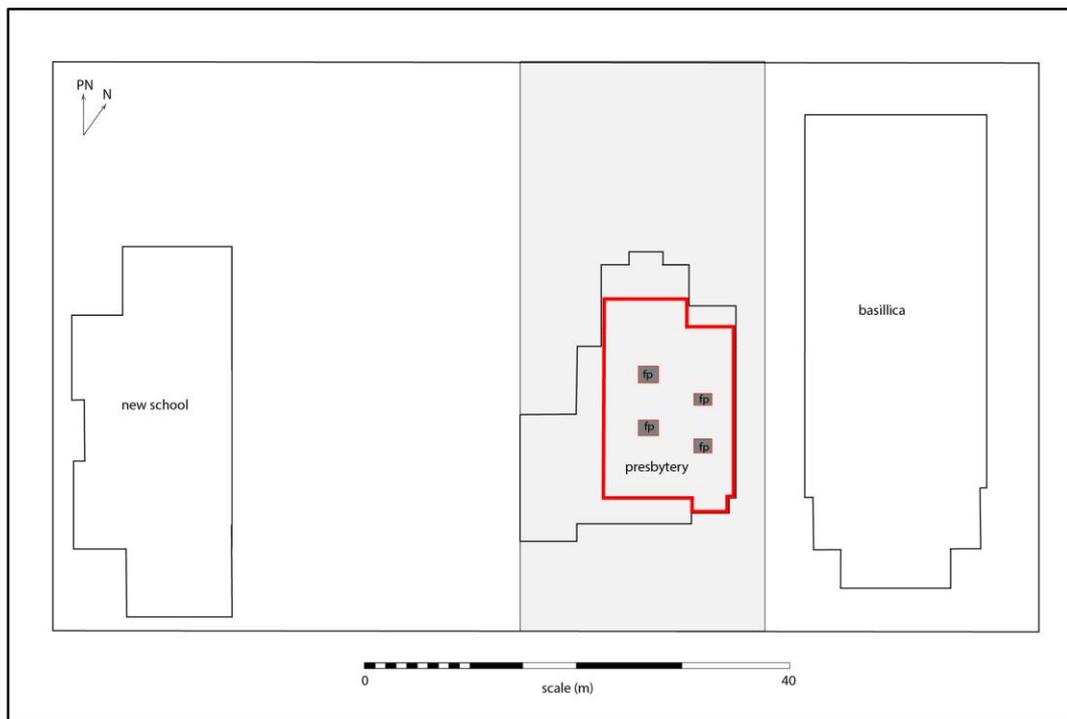
Figure 5-26 Site plan of excavation EA3.

During site clearance, beneath the modern 1929 portico and once the 1929 addition was demolished, an asphalt surface abutting the original presbytery structure was uncovered (Figure 5-26). The asphalt surface extended out from the front of Room 1 and continued beneath the concrete pad of the 1929 Californian bungalow portico (Figure 5-27 and Figure 5-28). The surface then formed a path along the western boundary of the presbytery structure and another towards the modern carpark area. Along the western boundary of the pre-1900 presbytery founds, the piles for the 1929 addition had cut through this path (Figure 5-28). The path measured 1550 mm wide and had been largely destroyed when the 1956 addition had been built along the western boundary. At the rear of the presbytery beneath the 1940s and 1950s concrete pads, the surface was uncovered again (Figure 5-29). The asphalt surface was 200 mm thick and was laid on top of C004 and C005.

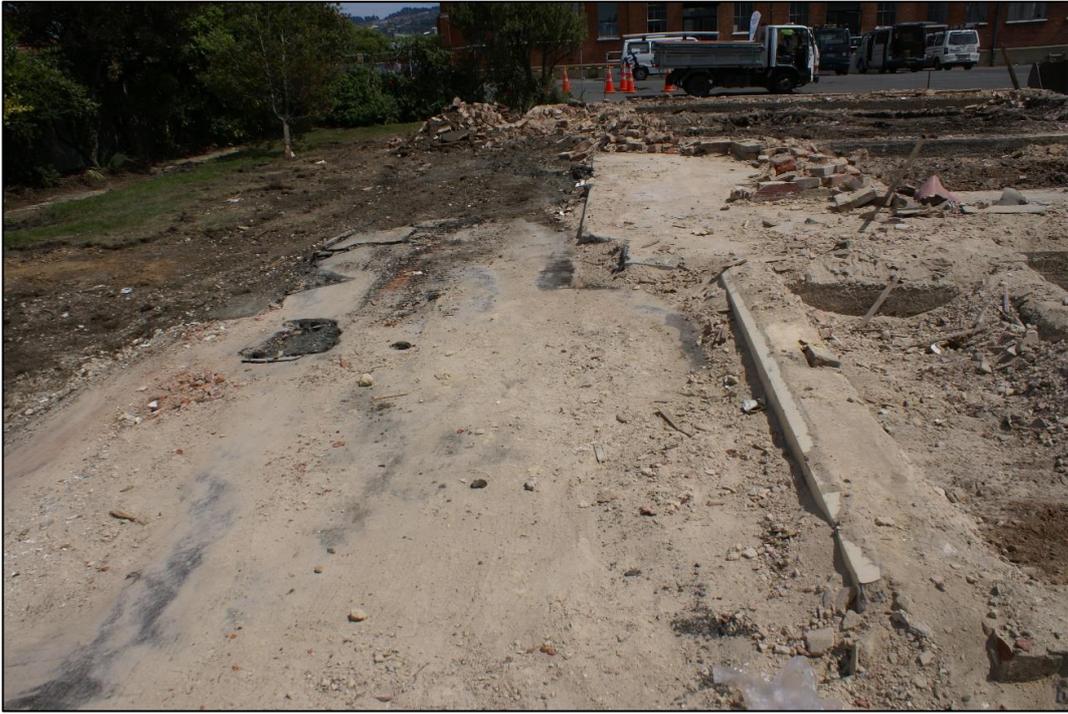
Figure 5-27 C003 uncovered at the front of the pre-1900 presbytery which continued west beneath 1929 Californian bungalow portico concrete slab. Looking west.

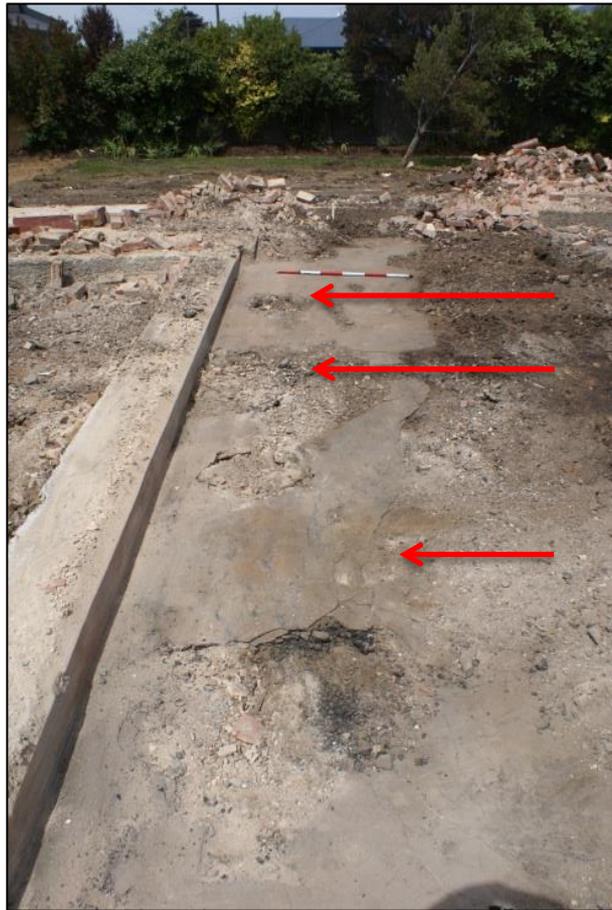
Figure 5-28 Along the western side of the original presbytery structure showing the asphalt path in-situ and the 1929 addition piles cut through it (looking south towards MacAndrew Road).

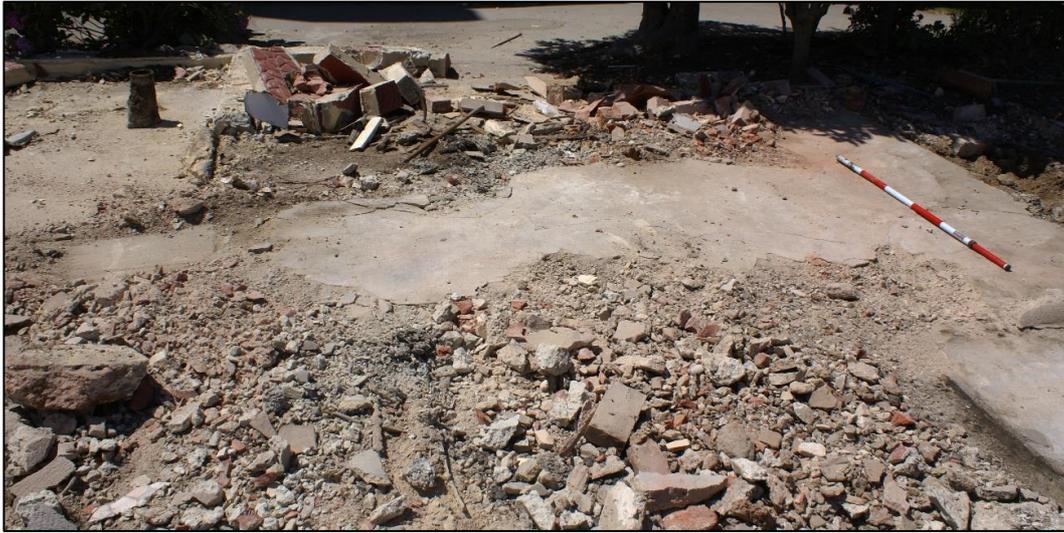
Figure 5-29 Asphalt surface uncovered at rear of presbytery. Looking east towards basilica.

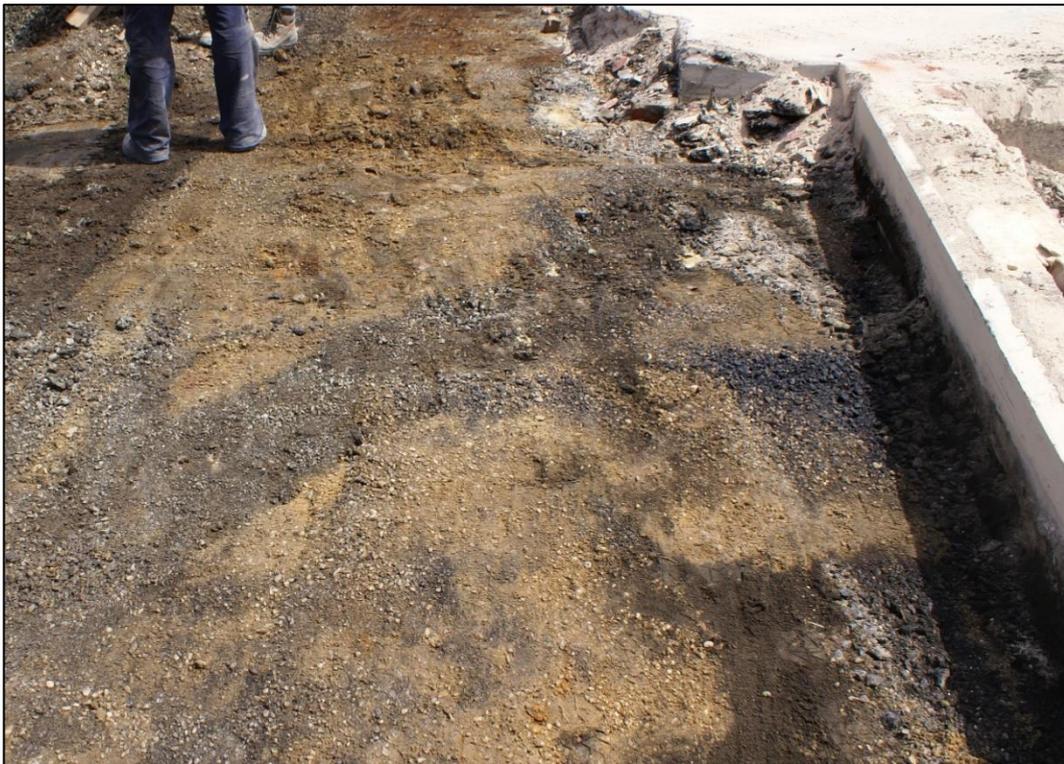
Beneath C002 and C003 and cut into C005, a 250 mm wide drainage channel was uncovered aligned northwest to southeast.

Figure 5-30 Drainage channel beneath C005 aligned northwest to southeast. Room 1 to the right of the photo.

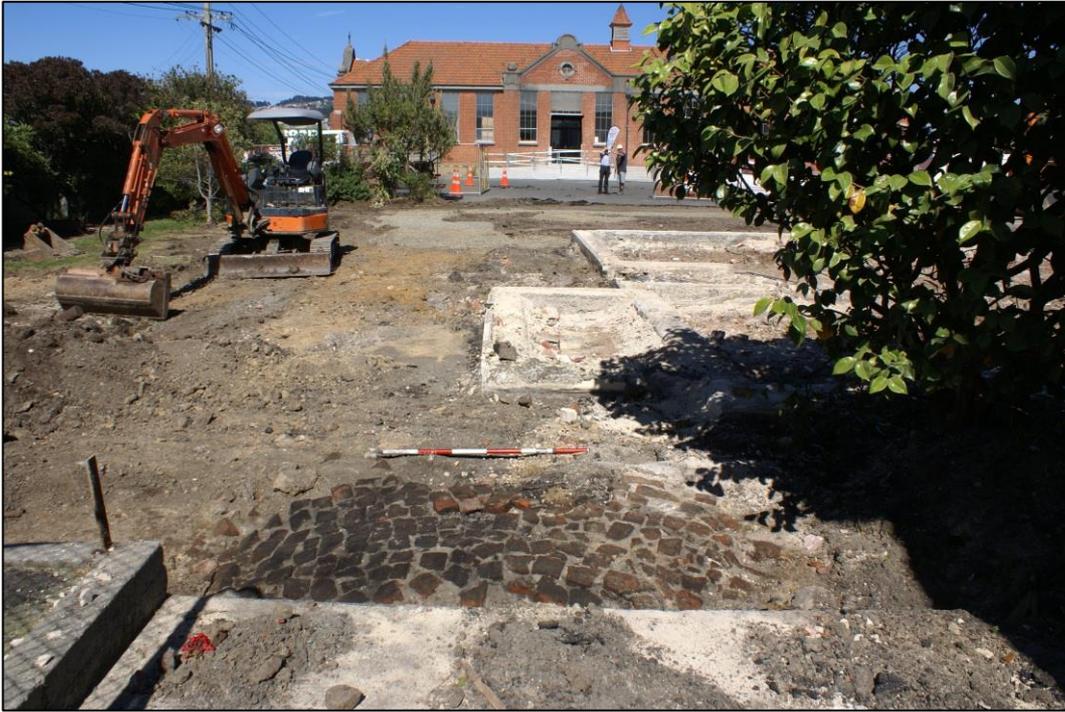
Figure 5-31 C009 in-situ. Looking west.

At the front of the presbytery at the southeast corner between the presbytery and the basilica a section of a brick-paved surface was uncovered. This feature was capped by C005. The surface was comprised of broken brick fragments and measured approximately 1.4 m wide and 3 m long (Figure 5-31). It was laid on C006 and very disturbed from later service installations occurring around it such as water pipes and storm water. It terminated at the modern concrete slab in front of the basilica, presumably continuing beneath it. When the surface was removed, several artefacts were uncovered.

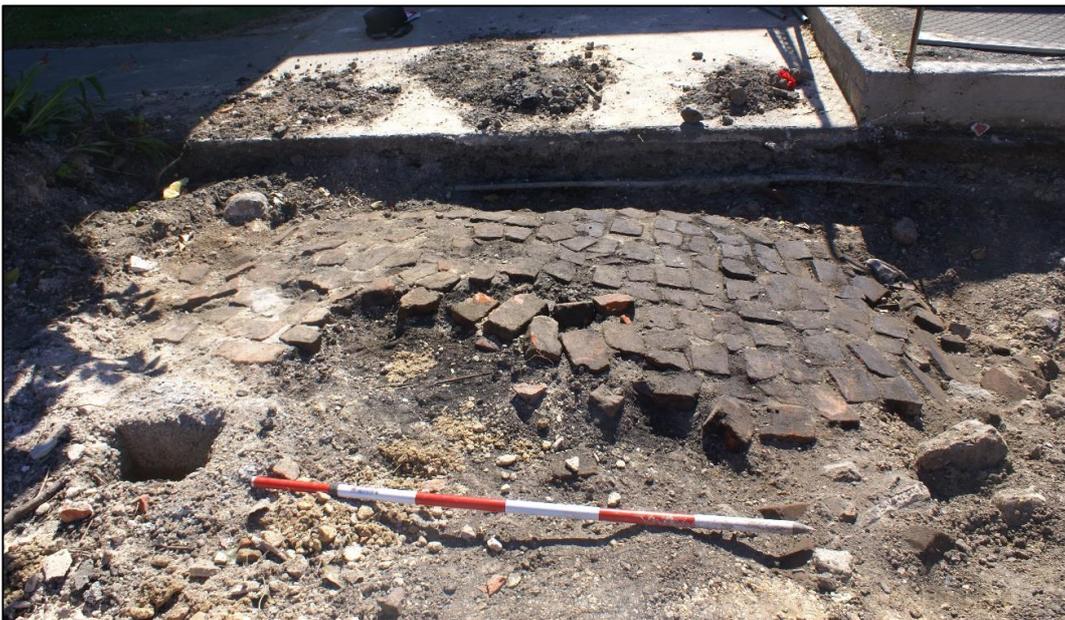
Figure 5-32 C009 in-situ. Looking east.

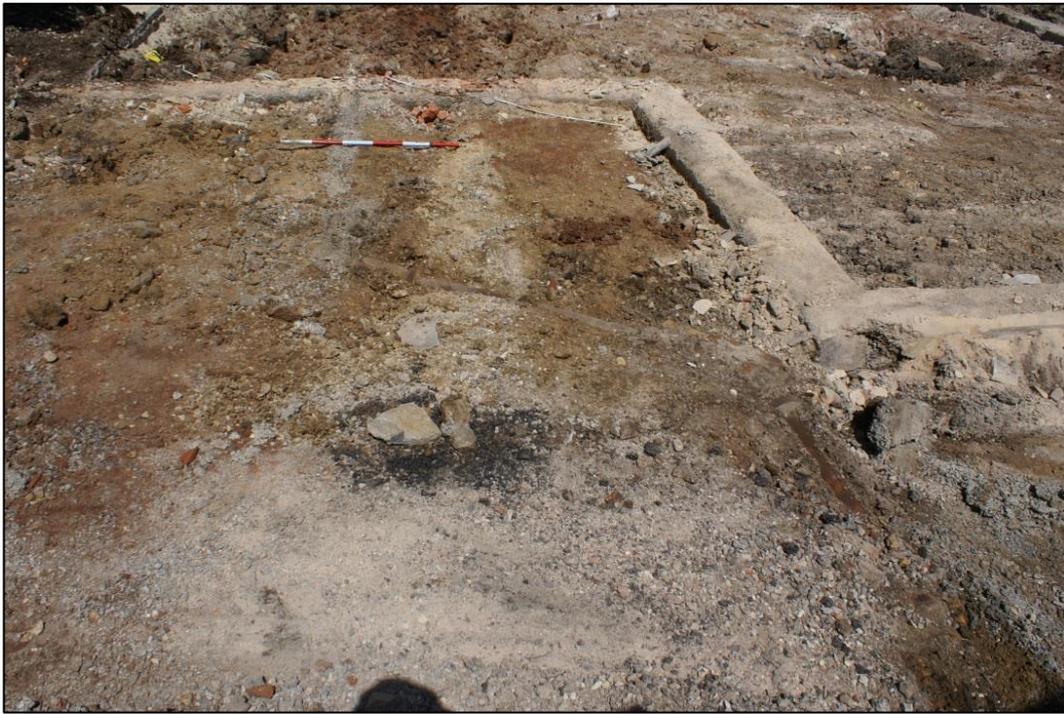
Figure 5-33 Drainage systems at the rear of the presbytery beneath post-1900 concrete pad foundations.

At the rear of the presbytery structure beneath the concrete pad of the mid twentieth century addition was a series of sewage and storm water drains (Figure 5-33 and Figure 5-34). These were all installed post-1900 and constructed of metal and ceramic ranging in diameter from 8 inches to 22 inches.
