Serving the Community: St Patrick's Church Complex

**Final Report for Archaeological Investigations
at Site No. I44/539 – I44/542
Under Archaeological Authority No. 2013/61**

Report Prepared for St Patrick's Development Committee
Authors: Sheryl Cawte, Eva Forster-Garbutt, Naomi Woods, Jeremy
Moyle and Peter Mitchell
Reviewed By: Dr Hayden Cawte
05/06/2018

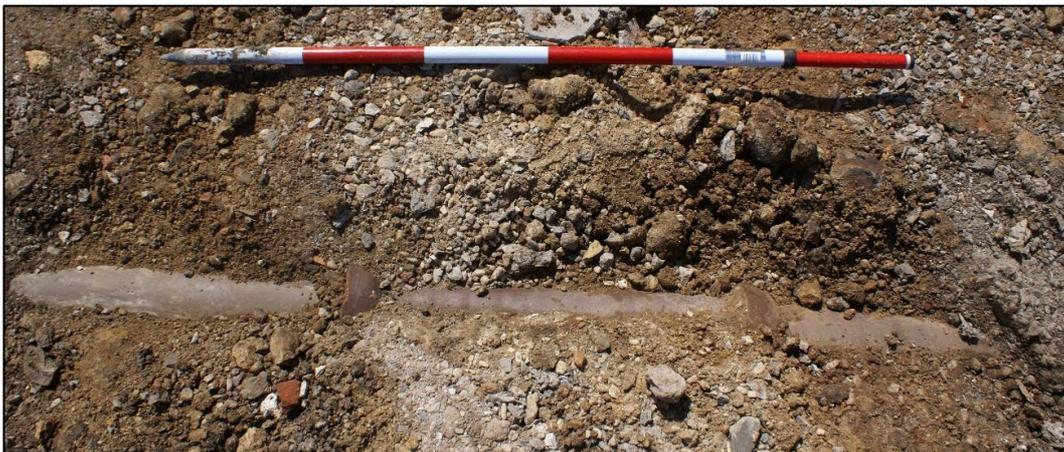
Figure 5-34 Portion of drainage uncovered at rear of presbytery.

At the rear of the presbytery structure beneath the concrete pad of the mid twentieth century addition was a series of sewage and storm water drains (Figure 5-33 and Figure 5-34). These were all installed post-1900 and constructed of metal and ceramic ranging in diameter from 8 inches to 22 inches.

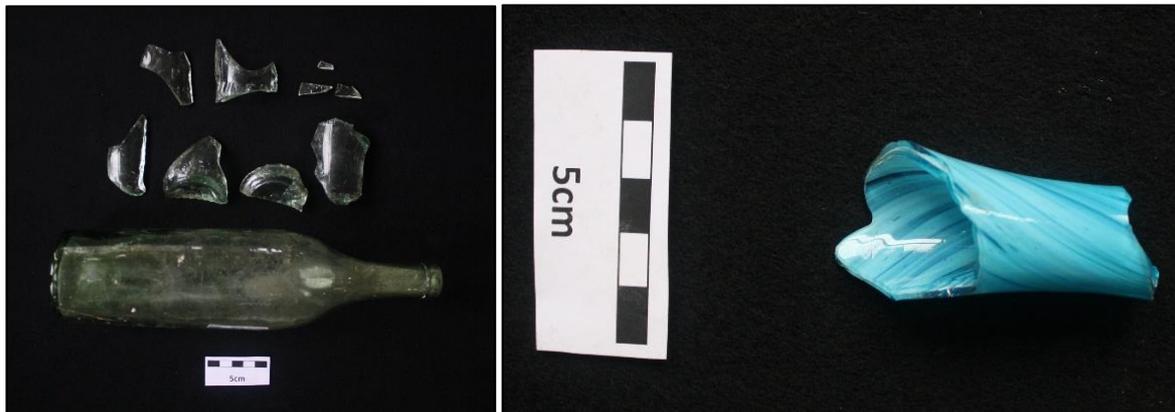
Figure 5-35 Left: Codd (top) and Bordeaux bottle. Right: Vase neck.

Six ceramic sherds were recovered, representing a MNV of three. This included an egg cup, bowl (both recovered from the basilica drainage ditch), and a saucer. Ware type and decoration were not recorded. Sixteen fragments of glass were collected, representing seven bottles and a vase. Only three of the glass vessels could be identified to form: a Bordeaux, a Codd bottle and a vase (Figure 5-35). The Bordeaux bottle is commonly

associated with wine but held a variety of contents and was regularly re-used in the nineteenth century. This particular example was made in a turn mould and had an applied ring seal finish. The Codd bottle was embossed with “CANNINGTON SHAW CO LTD ST HELENS,” the name of the bottle’s manufacturer, around the heel. Cannington, Shaw and Company were a large English glassmaking firm based in St Helens, Lancashire, and they operated from the 1870s until 1913 (British Antique Bottle Forum, 2013). On the base of the bottle “1900” was embossed, presumably the bottle’s date of manufacture. While much of the side embossing has been lost during the bottle’s fragmentation (only the base was recovered, and this was in nine pieces), the word “DUNEDIN” remains clearly visible, suggesting that this was a bottle manufactured for a local aerated water company. The other fragments included the neck of a blue and white swirled glass vase and five body fragments from unidentified bottles.

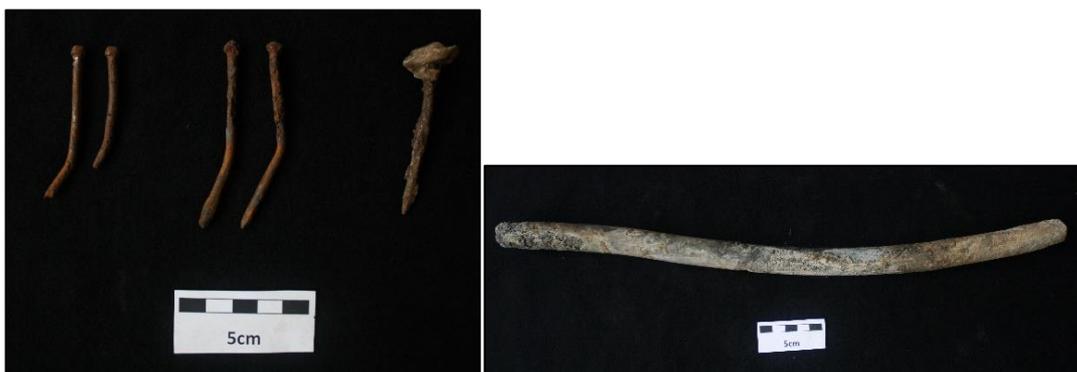
Figure 5-36 Left: Wire nails with rhomboid heads (left), rose heads (centre) and lead roofing head (right). Right: Length of lead pipe recovered during the presbytery demolition.

Nine identifiable metal artefacts were recovered from EA3, most of which relate to the presbytery structure. Five used wire nails (two with rhomboid heads, two with rose heads and one lead-headed roofing nail), a length of lead pipe (Figure 5-36) and a metal drain gully trap (Figure 5-37) would have originally been part of the presbytery building. Part of a matchbox and another unidentified rectangular container (Figure 5-37) were recovered from the fill along with five amorphous metal items.

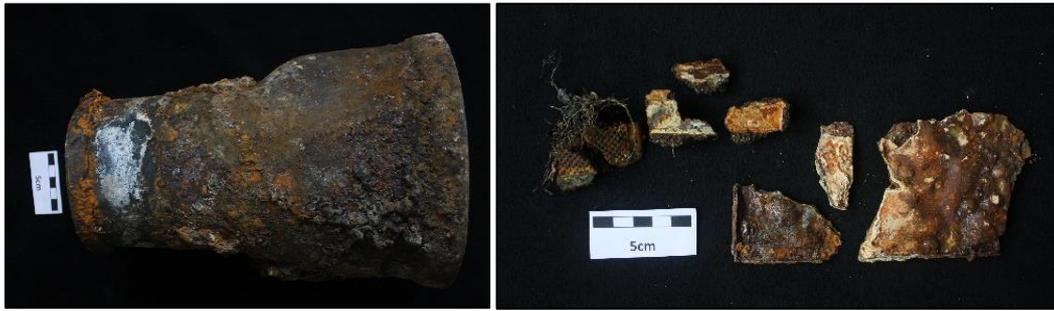
Figure 5-37 Left: Metal gully trap. Right: Matchbox (left) and unidentified container.

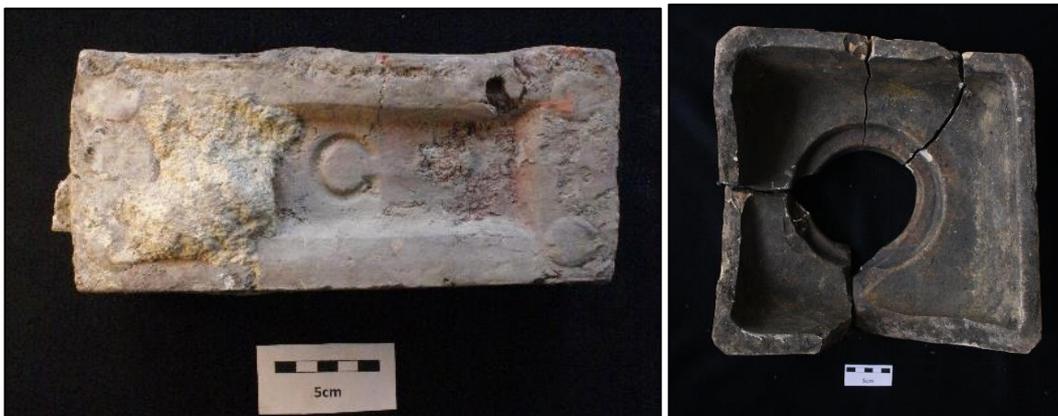
Figure 5-38 Left: Gore Brothers brick. Right: Stoneware gully trap.

The miscellaneous artefacts were also dominated by structural remains, including four fragments of roofing slate, three bricks and two ceramic drain fittings. The roofing slate relates to the basilica building rather than the presbytery, as the presbytery had an iron roof. One of the bricks was taken as a sample from C009 and was wire cut. The other two were found within the fill and both were moulded with frogs and maker's marks. One had "G" in the frog (Figure 5-38), attributing it to the Gore Brothers' Wingatui Brickworks in Dunedin. This brickworks was established in 1880 and was at one time the largest brickworks in New Zealand (Lindsey, 2015). The last Gore brother died in 1918 (Ellesmere Guardian, 1917) but the Wingatui brickworks continued production at least until the 1920s (Poverty Bay Herald, 1920), although it is unclear how long the "G" brand was continued. The other brick was stamped "RUN E," but this mark was unable to be attributed to a manufacturer. One of the ceramic drain components was a gully trap made of stoneware, was salt-glazed, and square in shape with bevelled corners (Figure 5-38). The other was a length of coarse earthenware pipe, with a notably small internal diameter of c. 5 cm. One end had a screw fitting. Two fragments of a hobnail shoe or boot (Figure 5-39) were also recovered. The brass hobnails were visible on the sole leather. Only three faunal specimens were present among Excavation Area 3 assemblage: a sheep rib and metatarsal, and the shell of a Turangi Cockle (*Austrovenus stutchburyi*) (Figure 5-39).

way through the construction of the school building, or alternatively replaced the original Marseilles tiles with cheaper Abbotsford versions when the roof required repair. A Gore Brothers brick recovered during the site clearance after the presbytery demolition provides another link to local manufacturers: the brothers ran the Wingatui brickworks just two miles from the Abbotsford tiler.

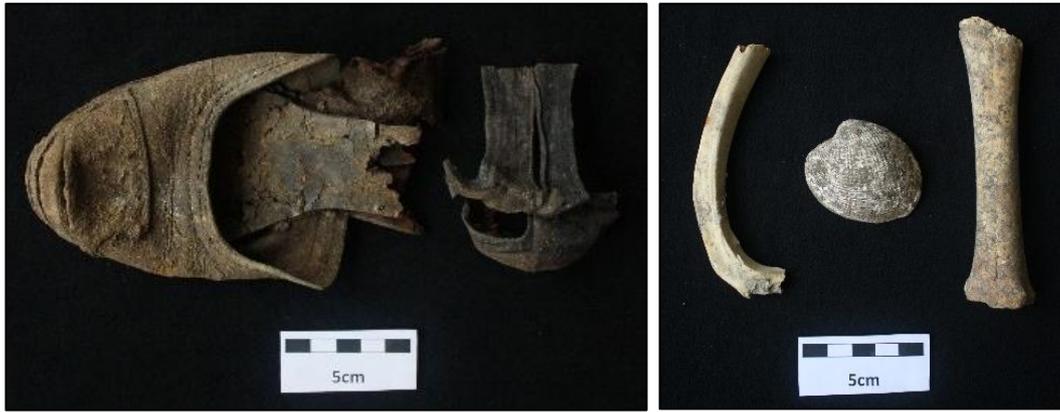
Figure 5-39 Left: Hobnailed boot. Right: Faunal remains collected during the presbytery demolition.

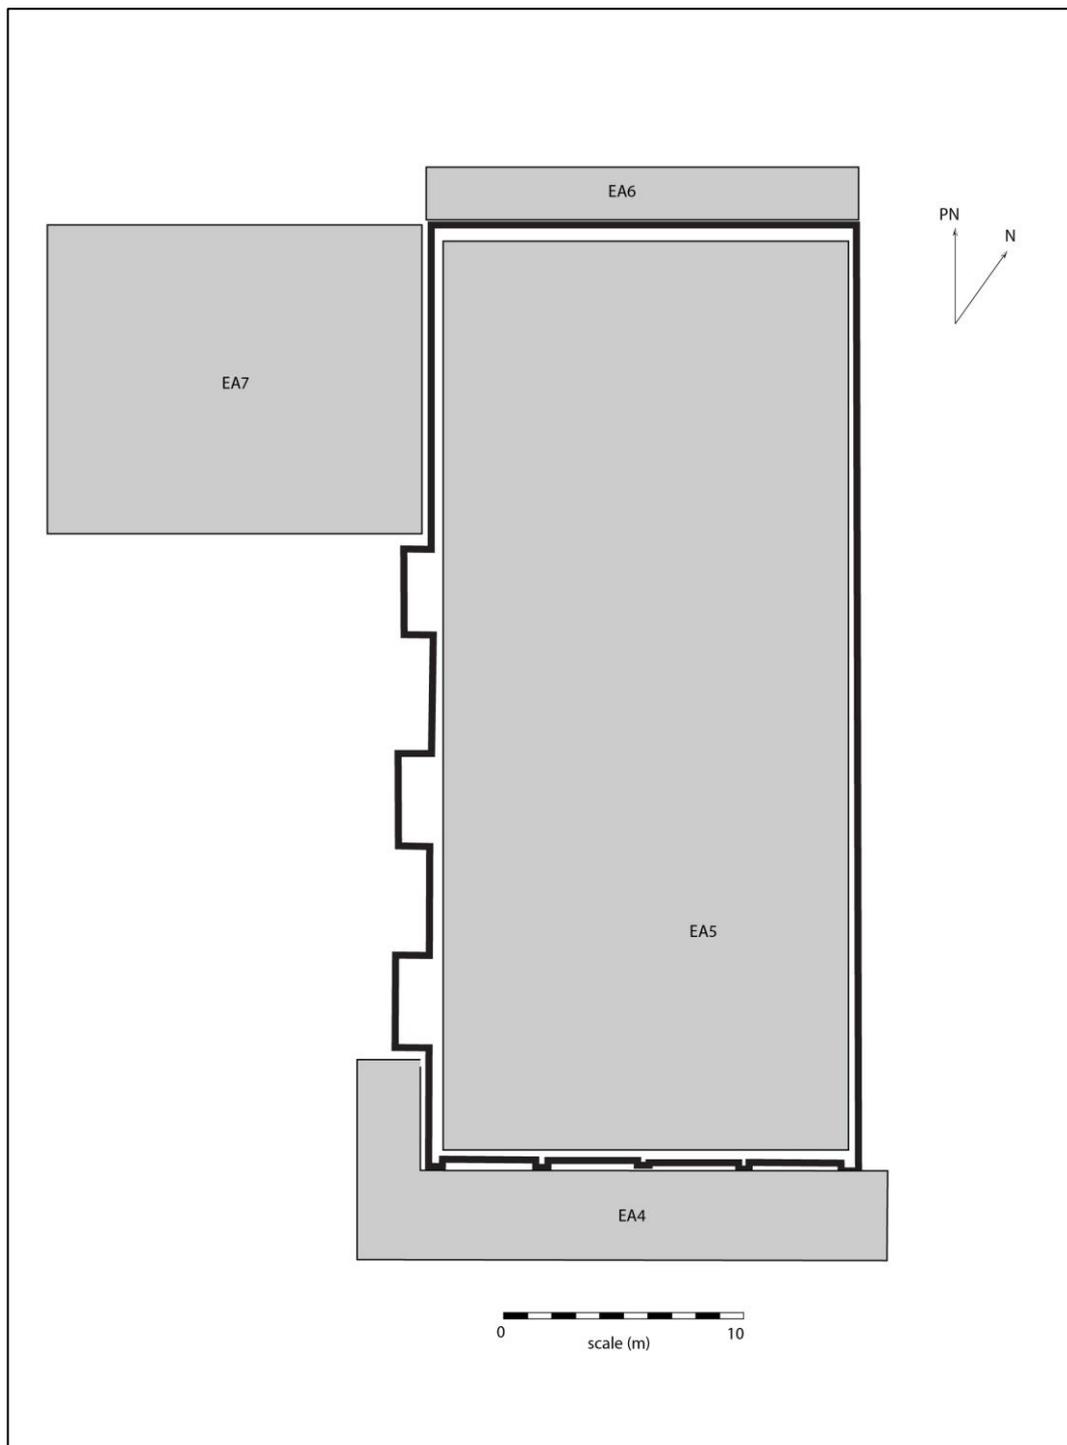
Figure 5-40 Scale plan of the Stage 3 excavations at basilica.

- The removal of the 1960s front portico entrance to the basilica and service trenching (Excavation Area 4 (EA4));
- The uplifting and reinstatement of a new floor within the basilica structure (Excavation Area 5 (EA5));
- A new rear entrance on the northern aspect of the basilica and service trenching (Excavation Area 6 (EA6));
- The construction of a new egress on the northwest aspect of the basilica (Excavation Area 7 (EA7)).
- Resurfacing the carpark area.

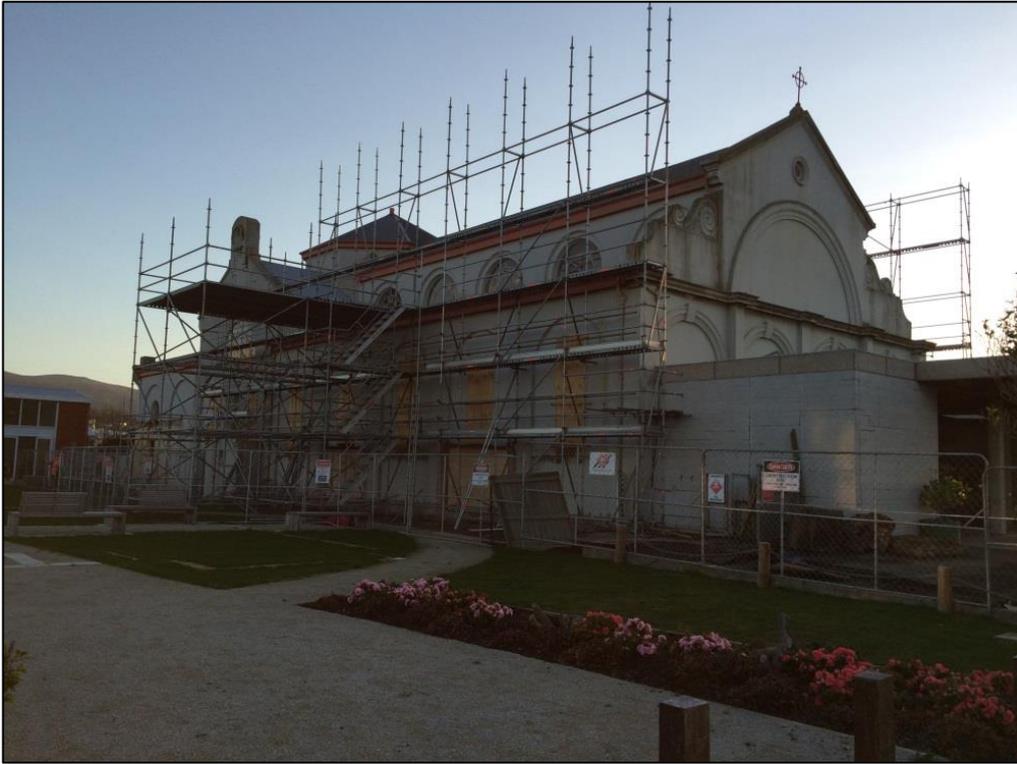
Figure 5-41 The site when damage was recorded with the portico still in-situ. Looking northeast.

Stage 3, EA4 involved monitoring the removal of the 1960s front portico and trenches for new basilica services. Both of these were undertaken without an archaeologist present and thus site damage was assessed and recorded when alerted. Recording of the site damage relating to service trenching was undertaken on the 22nd May 2015 by Hayden Cawte. All services had been trenched and partially backfilled. Upon arrival, two large, partially faced breccia stones had been excavated out during trenching from an approximate location (D004) (Figure 5-41 to Figure 5-44). The portico was removed some time in the month following without archaeological notification for monitoring.

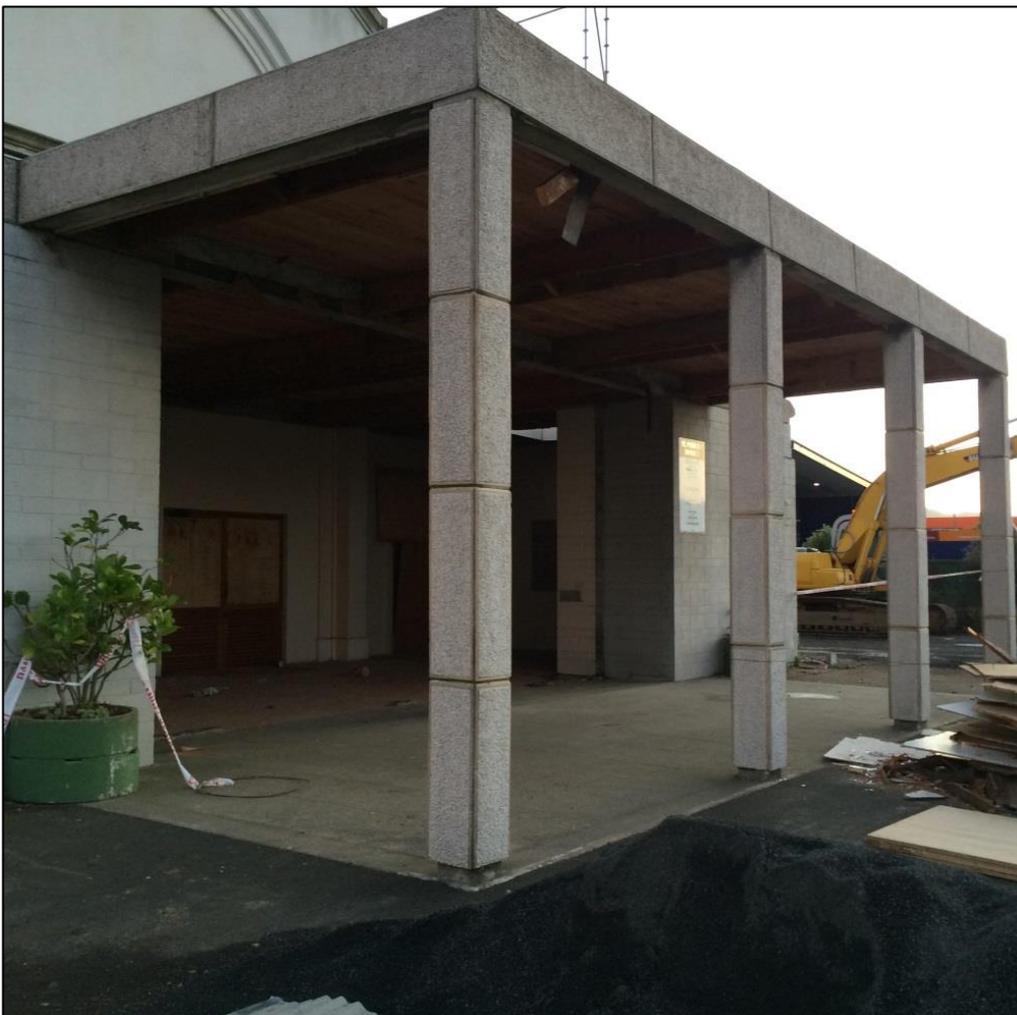
Figure 5-42 The portico in-situ.

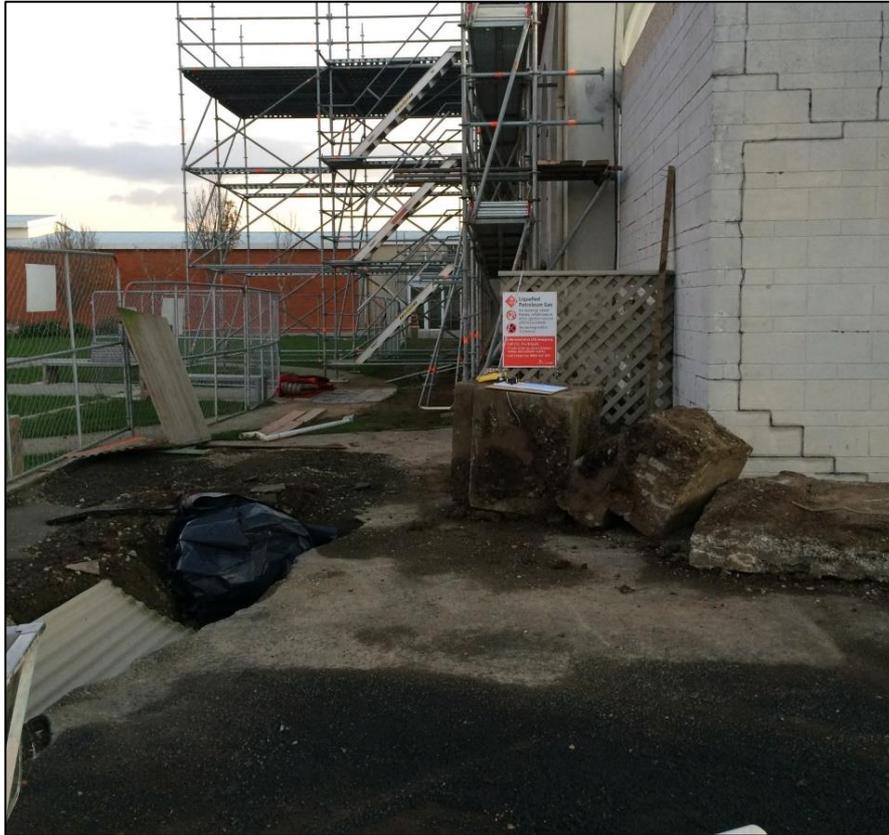
Figure 5-43 Half-filled and completed trenches at the southwest corner of the basilica. Large faced breccia stones removed during trenching. Black tarpaulin is where contractors said they had removed them from.

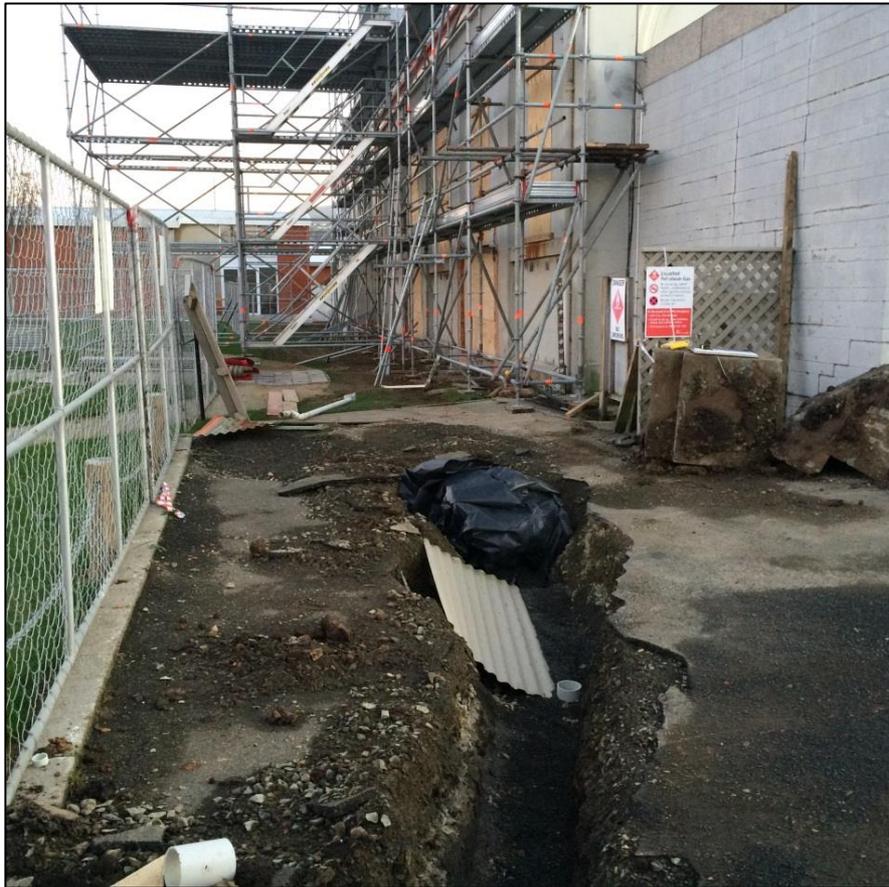
Figure 5-44 Service trench partially back-filled where breccia stones were encountered. Approximate location of where C009 extended.

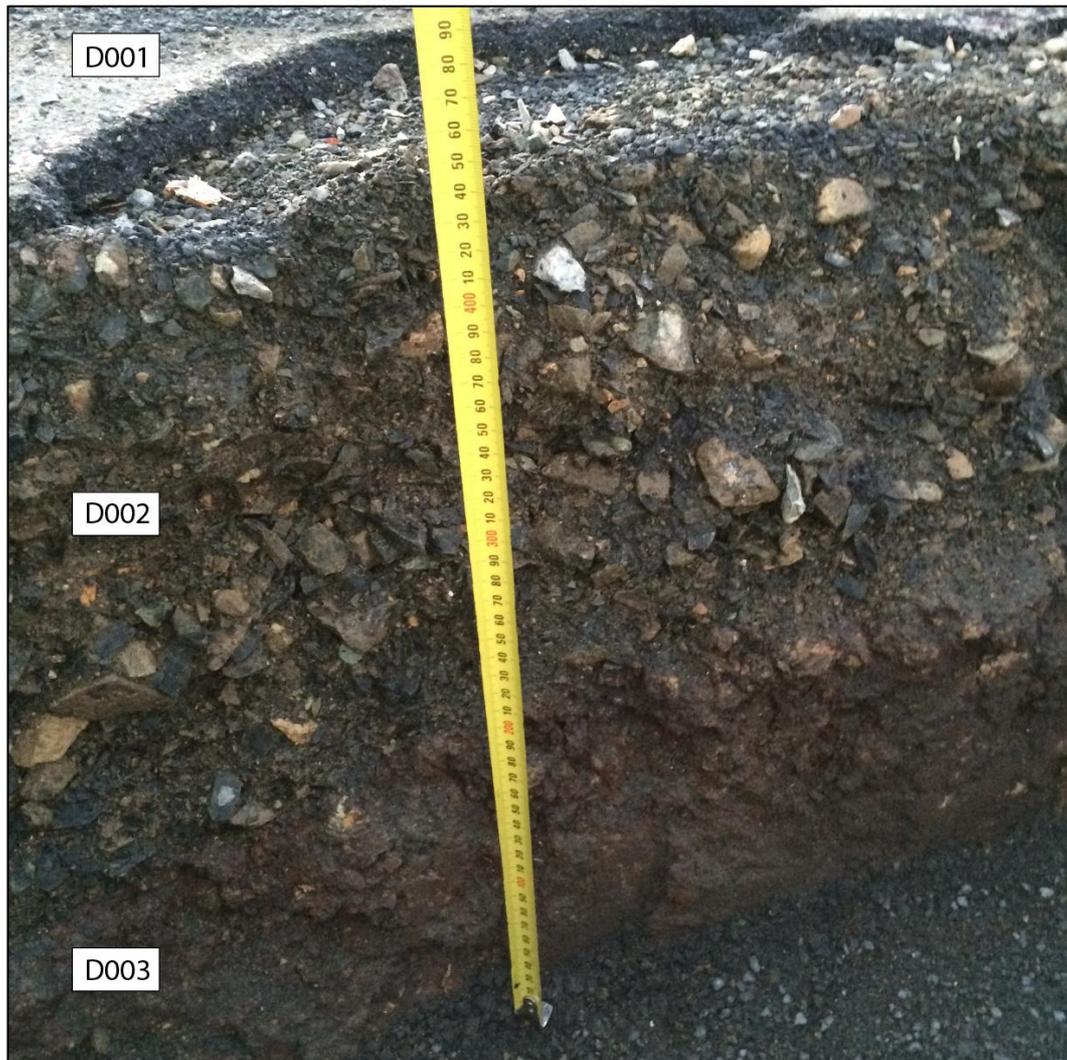
A basic stratigraphic profile was recorded from a trench partially backfilled (Figure 5-45). Three distinct layers were identified;

- D001: asphalt (30 mm)
- D002: coarse shingle fill (250 mm)
- D003: brown mottled clay silt with some cultural material visible (>150 mm)

Figure 5-45 EA4 stratigraphic profile.

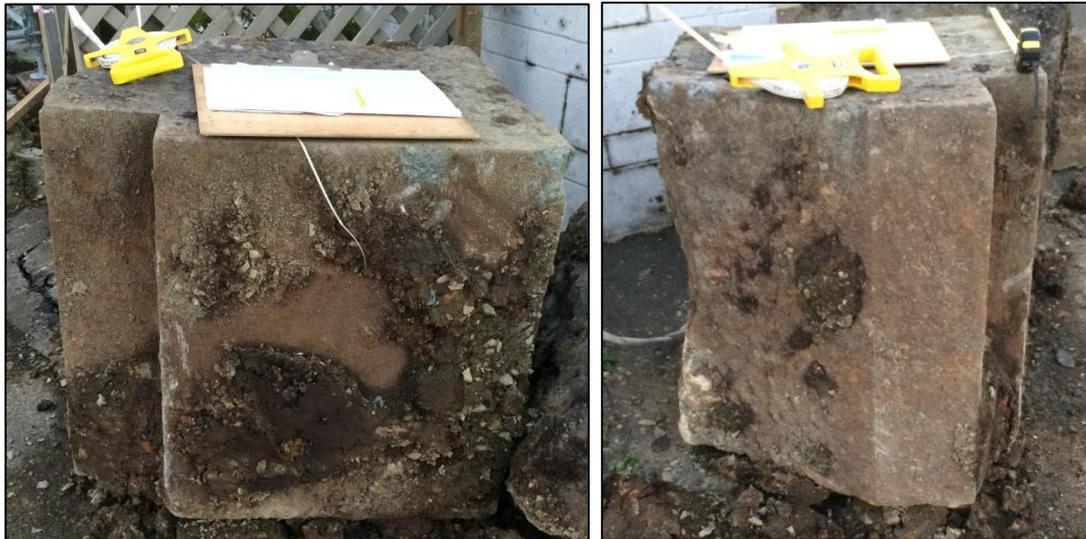
Figure 5-46 One of the blocks showing shape and dressed sides.

Two large breccia stones were unearthed EA4 at the southwest corner of the basilica (Figure 5-46 and Figure 5-47). The blocks were of uneven shape, measuring approximately 730 mm x 630 mm x 500 mm and 300 mm x 220 mm x 500 mm. Both were faced and dressed. Based on the size, shape and features of the two blocks, these appear to be steps. However, due to the lack of provenance it cannot be ascertained if and how these relate to the site.

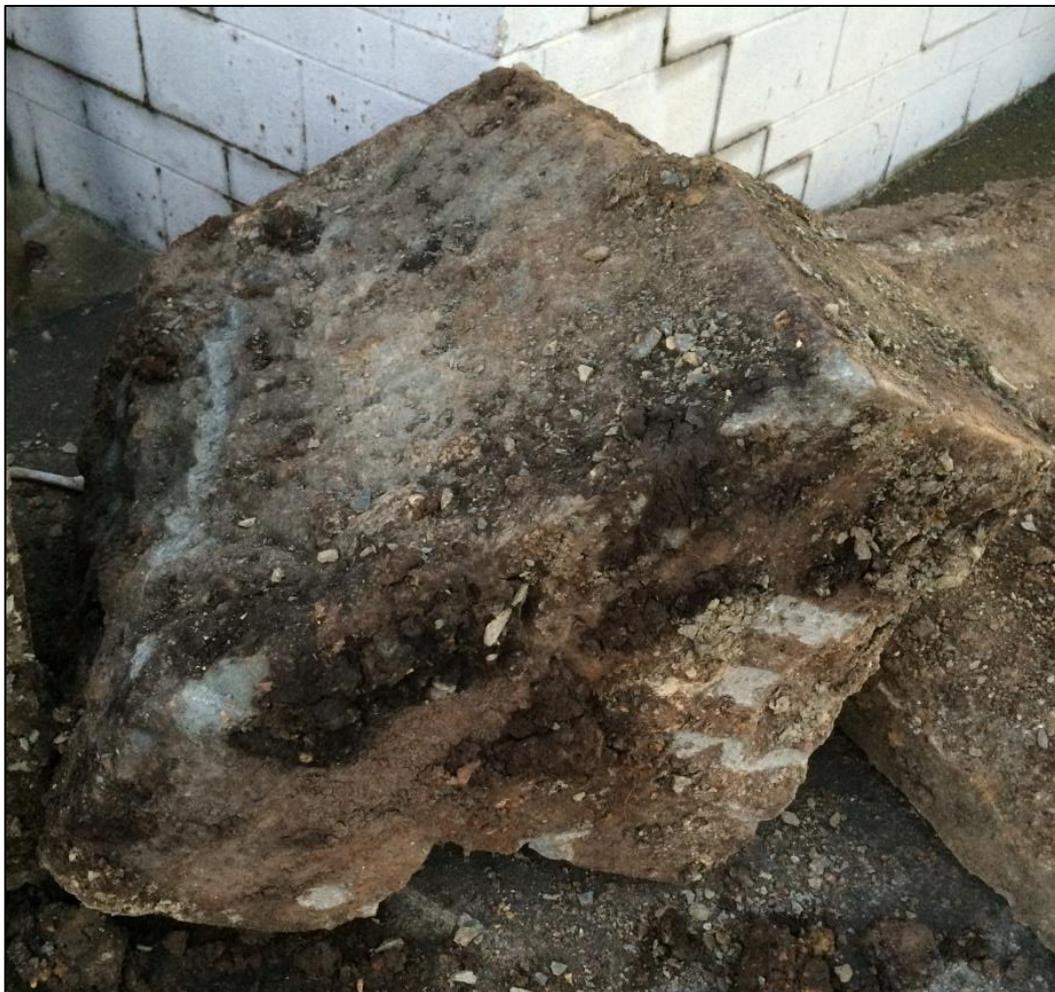
Figure 5-47 Second block of same shape and dressed.

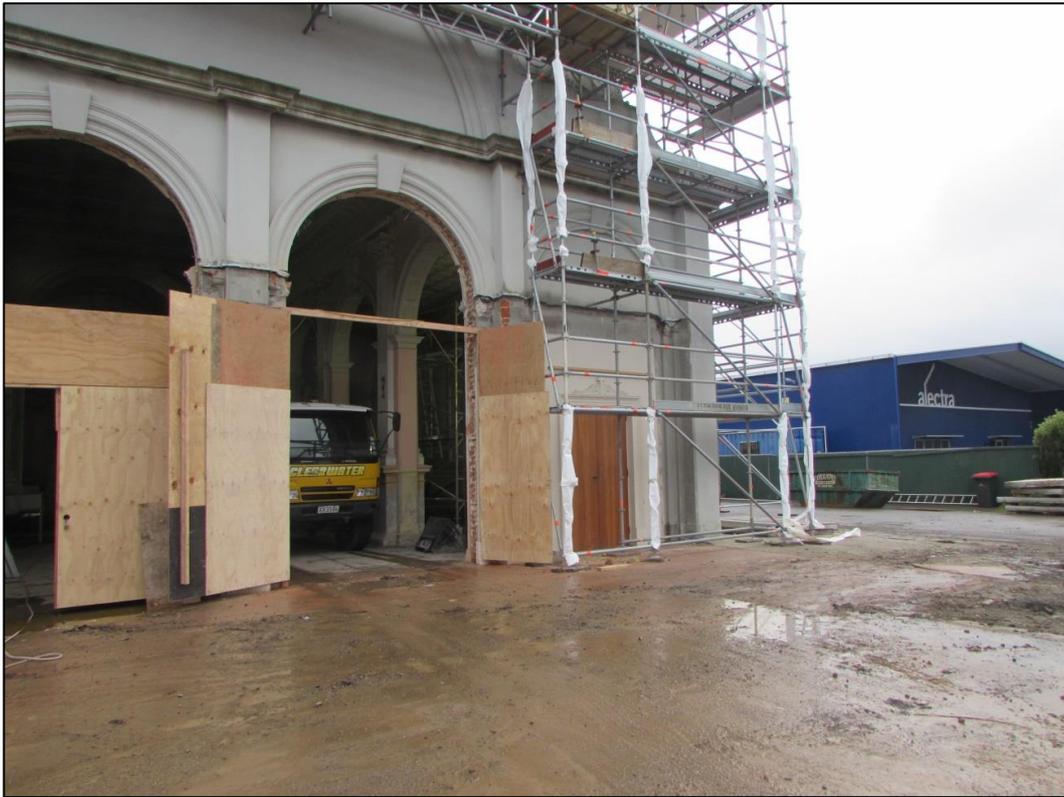
Figure 5-48 Front of basilica with the front portico removed (25th June 2015).

Stage 3, EA5, excavations involved monitoring the uplifting and reinstatement of a new floor within the basilica structure. Fieldwork was conducted by Hayden Cawte, Laura Davies and Carl Murray between the 25th May 2015 and the 25th June 2015. Once the basilica was cleared out, uplifting of the floor began in the northeast corner, moving east to west across the room and continued back towards the front entrance (south) (Figure 5-48 to

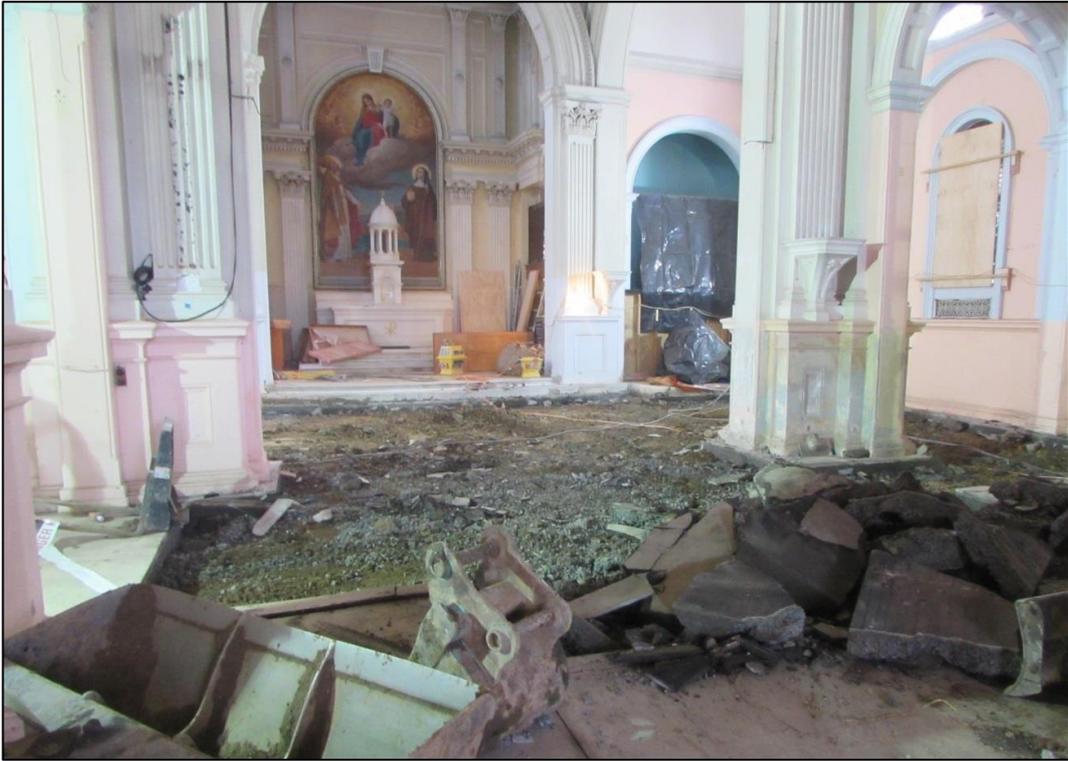
Figure 5-52 Halfway through lifting the floor. Looking north towards the nave.

Figure 5-54). The process involved cutting through the existing tiled and concrete floor and the original floating concrete pad beneath before scraping the ground surface in preparation for laying the new concrete pad.

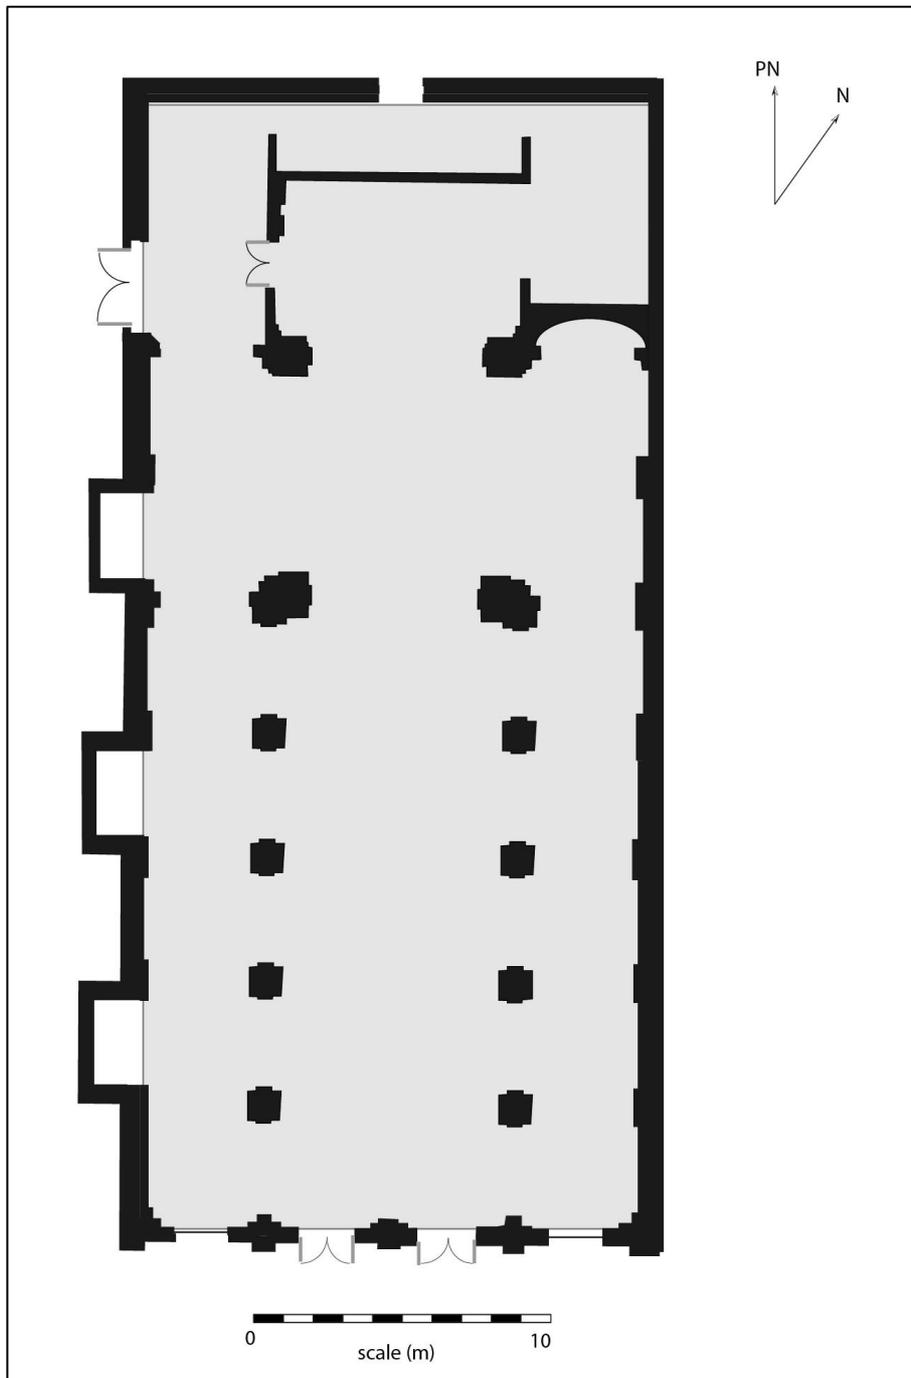
Figure 5-54 Floor plan of the St Paul's basilica. The grey shading represents the excavated area.

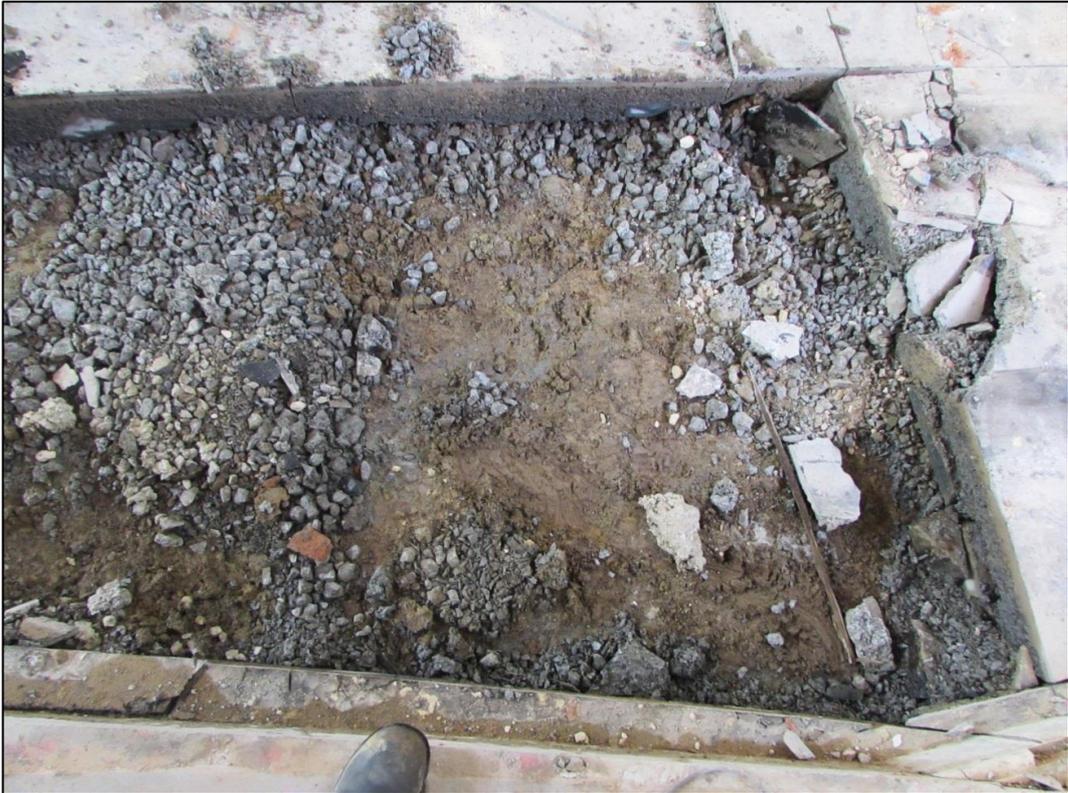
Figure 5-55 Plan view showing E002 to E005 at north end of basilica.

Across EA5, the stratigraphic profile was shallow, at a maximum depth of 250 mm. Unlike excavations around the other parts of the site, the water table was not encountered when the floor was lifted. Seven distinct stratigraphic layers were identified (Figure 5-55 to Figure 5-57):

- E001: tiled surface (the nave) (5mm)
- E002: thin layer of concrete (5mm)
- E003: asphalt surface (30mm)
- E004: original 1890s floating concrete pad with bluestone inclusions (100mm)
- E005: a yellow/orange/brown mixed fill layer comprised of rock, fine sediment (identical to A003, Stage 1 and C005, Stage 2)
- E006: collection of building rubble, bricks and slate in northwest corner beneath E002 and within E005.

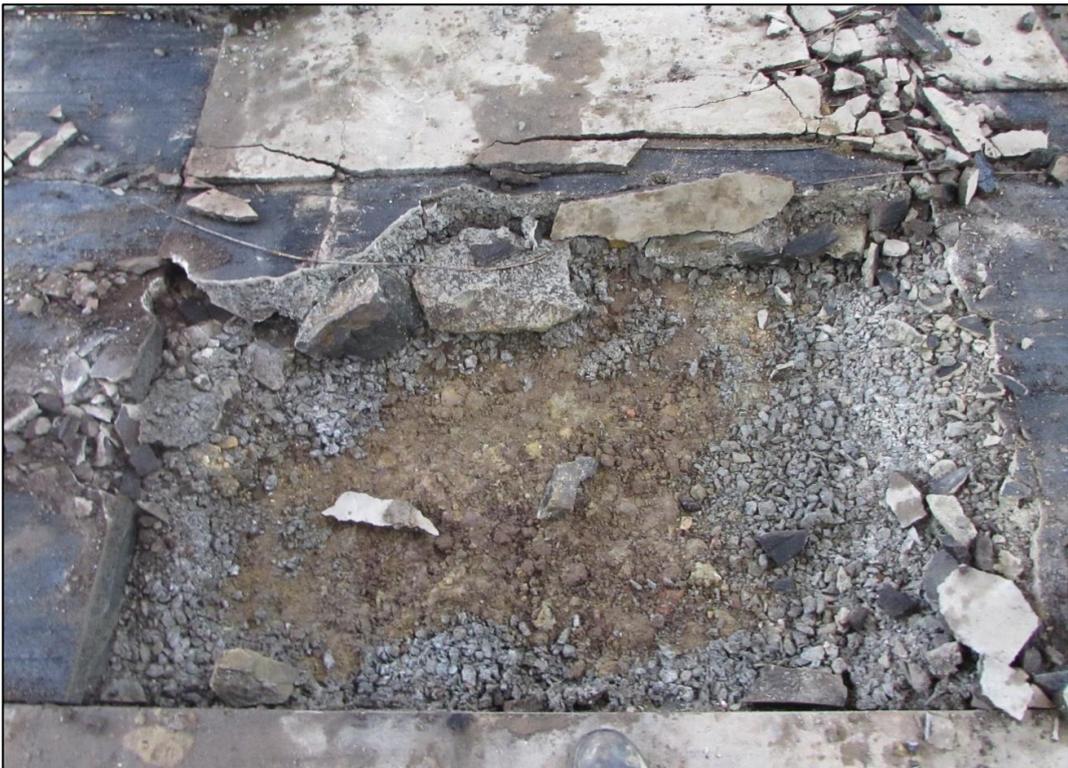
Figure 5-56 Portion of the floor lifted showing E002, E004, and E005.

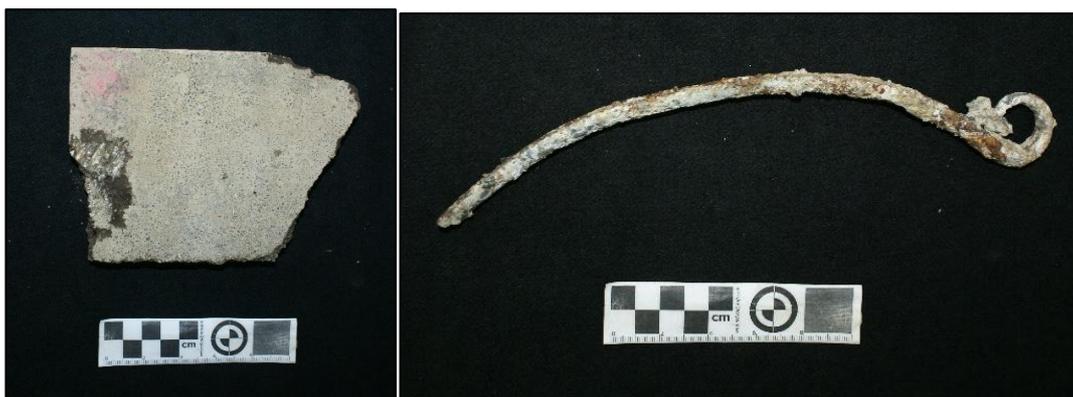
Figure 5-58 Left: sample of the 1890s basilica floor. Right: metal bucket handle recovered from beneath the floor.

A small assemblage of fragmentary artefacts was recovered from below the floor in EA5 in the northeast corner. This included a sample of the 1890s floor surface (Figure 5-58). None of the artefacts were recovered from discrete features. The artefacts recovered were a metal bucket handle (Figure 5-58), a fragment of unmarked brick, a single body fragment from a green glass bottle, three fragments of slate tile, two thin strips of timber (Figure 5-59) and part of a larger timber beam.

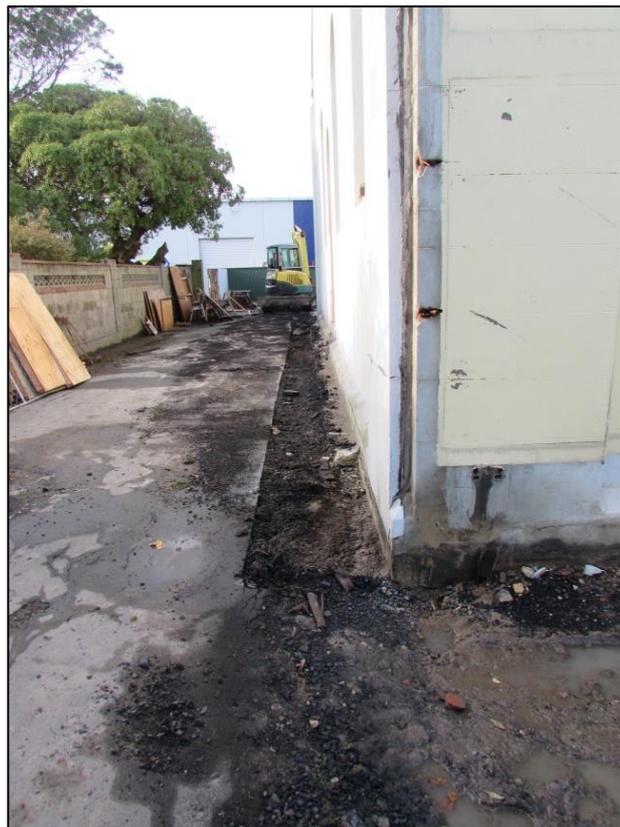
Figure 5-60 Concrete removed ready to excavate the service trench along the rear of the basilica. Looking east.

Stage 3, EA6 involved monitoring the creation of a new rear entrance to the basilica on the northern aspect and trenching for services. Fieldwork was conducted by Laura Davies on the 22nd June, 2015. Service installation included excavating a 500 mm wide and 600 mm deep trench along the rear (northern aspect) of the basilica which would connect to the storm water drains. Further ground works and the construction of the rear access was undertaken without notification for monitoring.

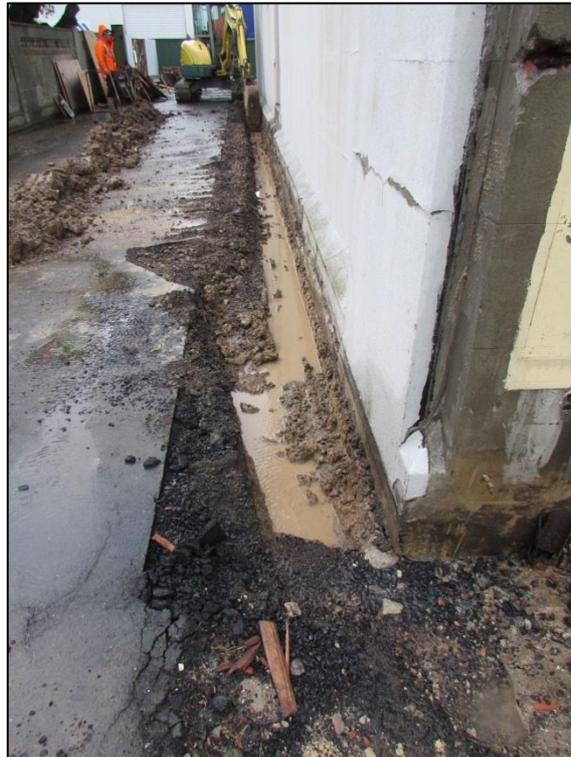
Figure 5-61 Trench filling with water from the high water table as it was excavated.

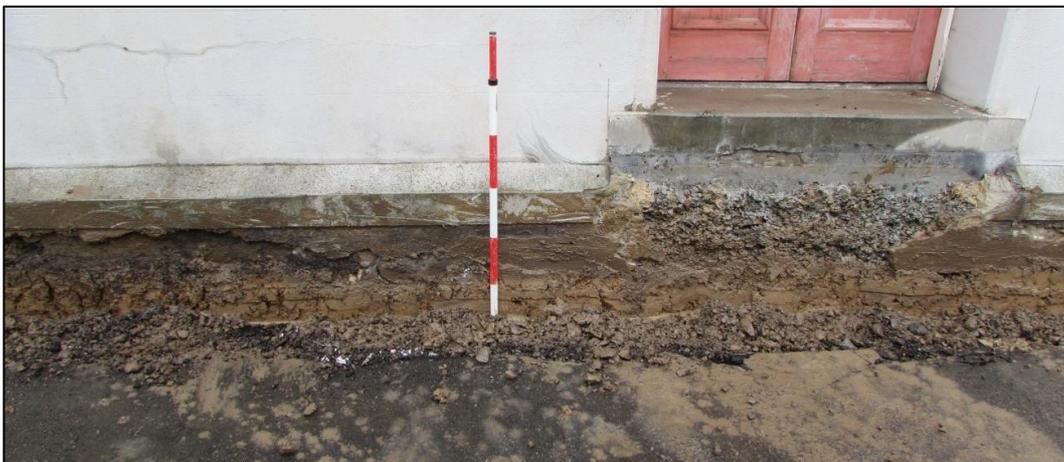
- F001: modern concrete surface (90 mm)
- F002: concrete preparation layer (60 mm)
- F003: brown mottled clay silt with inclusions (identical to D003, EA4, Stage 3) (100mm)
- F004: light grey natural clay subsoil (identical to A005, Stage 1, C007, Stage 2 and E006, EA5, Stage 3)

Figure 5-62 Stratigraphic profile of EA6.

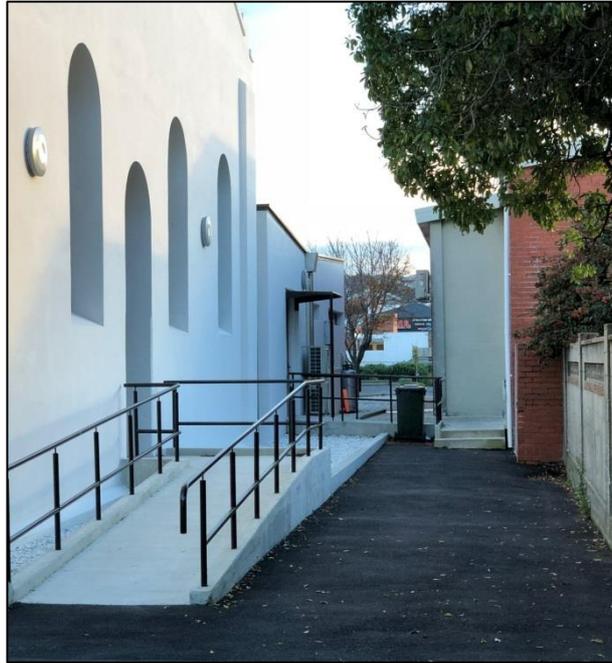
Figure 5-63 Rear entrance to the basilica completed. Looking west.

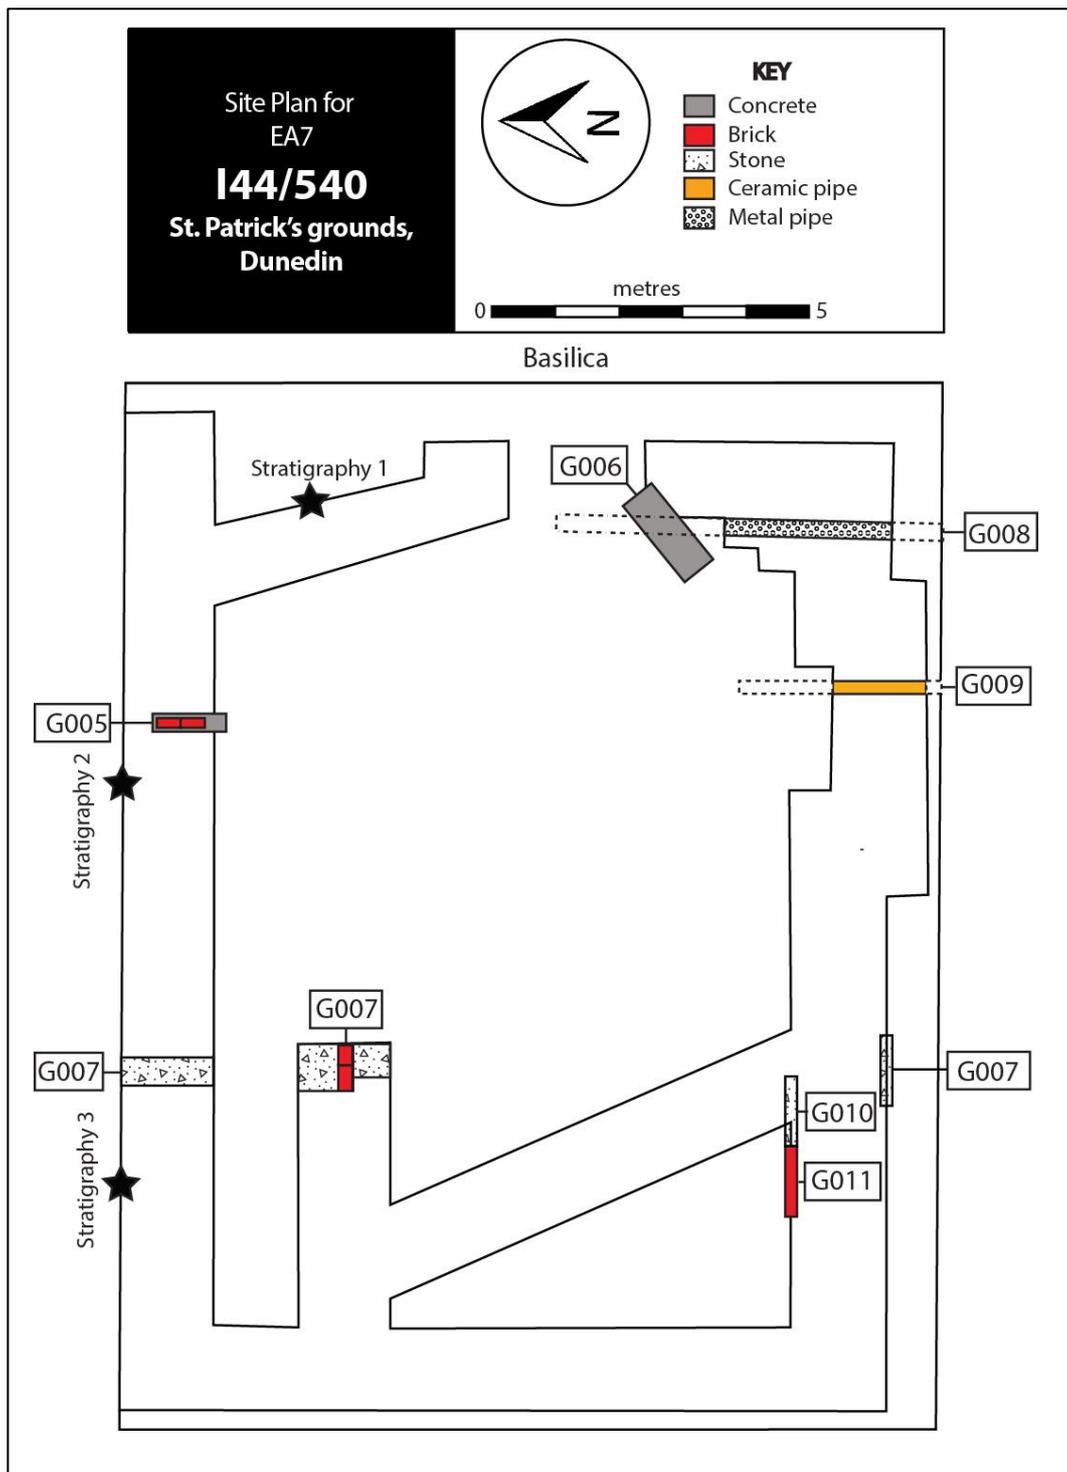
Figure 5-65 Site plan for EA7 showing locations of excavated trenches, contexts and locations where the stratigraphy has been recorded.

Stage 3, EA7 involved monitoring the foundations for the new egress to the northwest aspect of the basilica (Figure 5-64). The earthworks in EA7 consisted of a series of service trenches and footing for the new structure. Fieldwork was undertaken by Sheryl Cawte and Eva Forster-Garbutt. The excavated area measured 15.3 m by 12.8 m extending west from the northwest corner of the basilica and had been previously scraped flat in 2015 at the end of Stage 2 works (Figure 5-65).

Across EA7, three stratigraphic profiles were recorded in three locations (Figure 5-65). As seen elsewhere on the site, the stratigraphic profiles were shallow with the water table sitting approximately 500 mm below the current ground level.
