Serving the Community: St Patrick's Church Complex

**Final Report for Archaeological Investigations
at Site No. I44/539 – I44/542
Under Archaeological Authority No. 2013/61**

Report Prepared for St Patrick's Development Committee
Authors: Sheryl Cawte, Eva Forster-Garbutt, Naomi Woods, Jeremy
Moyle and Peter Mitchell
Reviewed By: Dr Hayden Cawte
05/06/2018

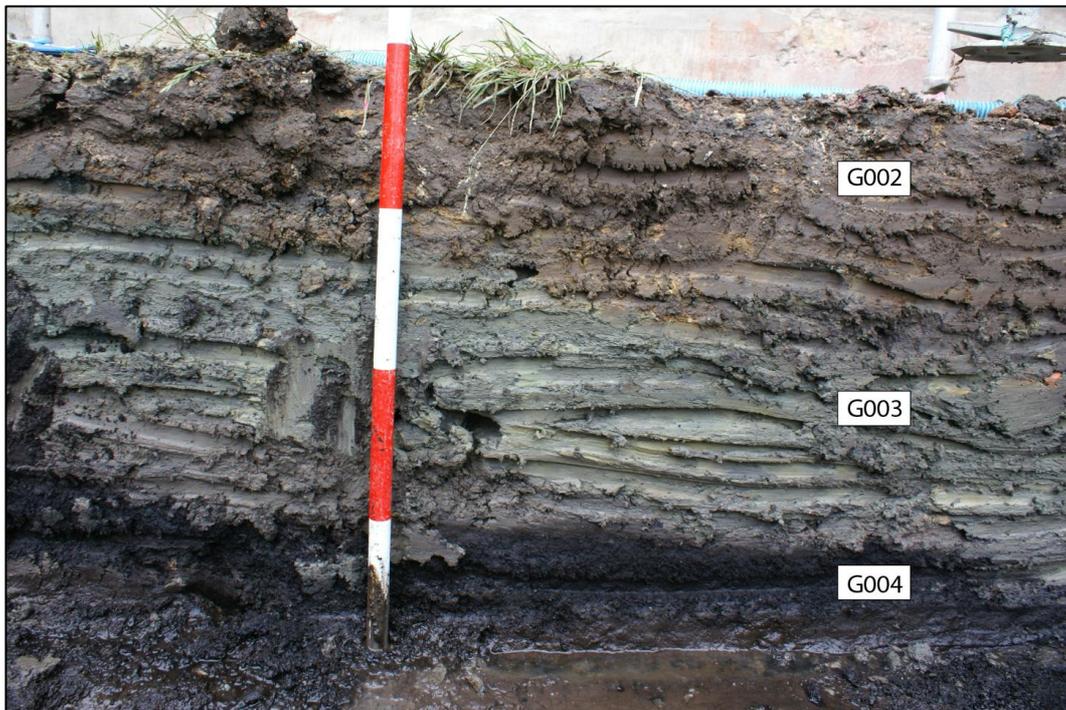
Figure 5-66 Stratigraphic Profile 1 adjacent to basilica.

Five distinct stratigraphic layers were identified, all of which had been previously recorded in EA3 (Figure 5-66):

- G001: mid-brown topsoil capping the site after clearance during Stage 2 (150 mm)
- G002: a yellow/orange/brown mixed fill layer comprised of rock, fine sediment (200 - 300 mm) (identical to A003, Stage 1, C005, Stage 2 and E005, EA5, Stage 3),
- G003: light grey natural clay subsoil (170 mm - 300 mm) (identical to A005, Stage 1, C007, Stage 2, and F004, EA6, Stage 3)
- G004: natural dark grey anaerobic layer where the water table fluctuates (200 mm – 400 mm) (identical to A004, Stage 1 and C006, Stage 2)

The stratigraphic profile varied in depth across the excavated area, getting deeper as ground works extended away from the basilica; G002 was 220 mm below the ground surface abutting the basilica and 740 mm at the western end of the scraped area. Excavations also identified that the layers within the site stratigraphy across EA7 varied in sequence. This indicated site disturbance had occurred over time, probably as a result of the various developments undertaken in the area associated with the construction and beautification in and around the presbytery, the outbuildings, the basilica and eventual clearance to establish the new green space (Figure 5-66 and Figure 5-67).

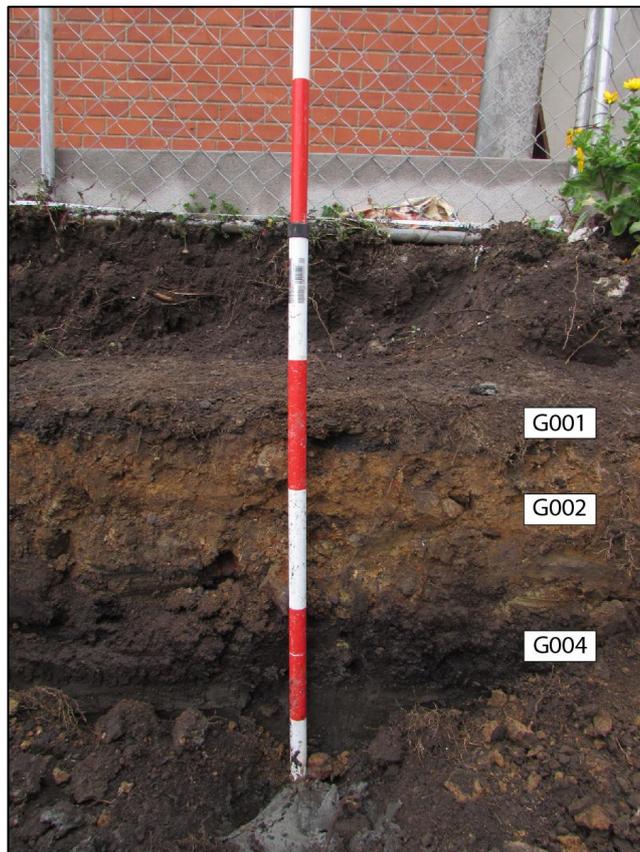
Figure 5-67 Stratigraphic Profile 2 in northern baulk of EA7.

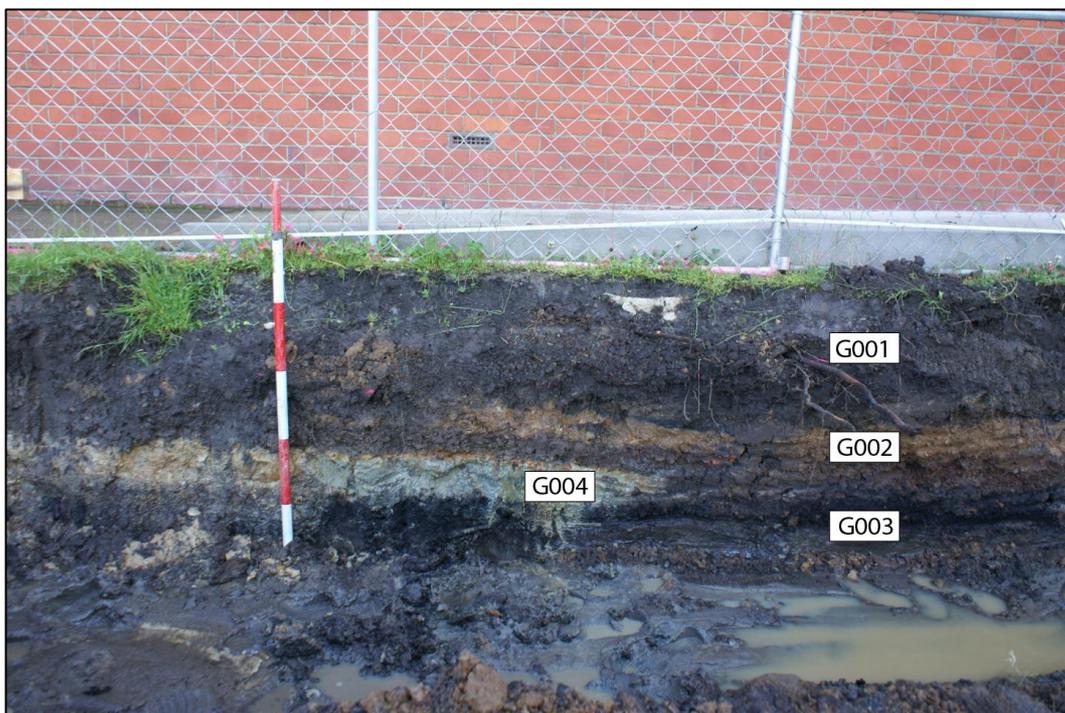
Figure 5-68 Stratigraphic Profile 3 in northern baulk of EA7.

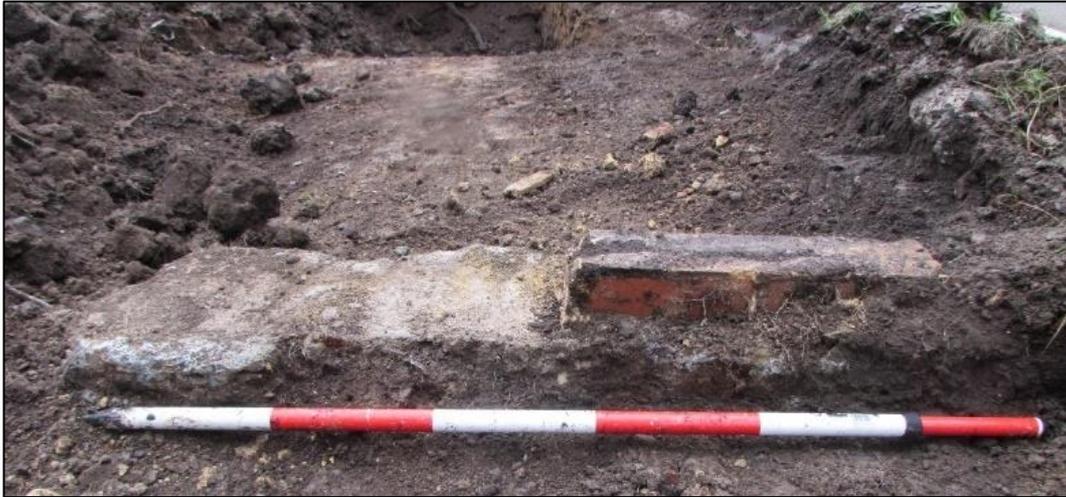
Linear brick feature on reinforced concrete encountered directly beneath G001. Orientated north to south measuring 71 mm long and 12 mm wide (Figure 5-69).

Figure 5-69 G005 looking west.

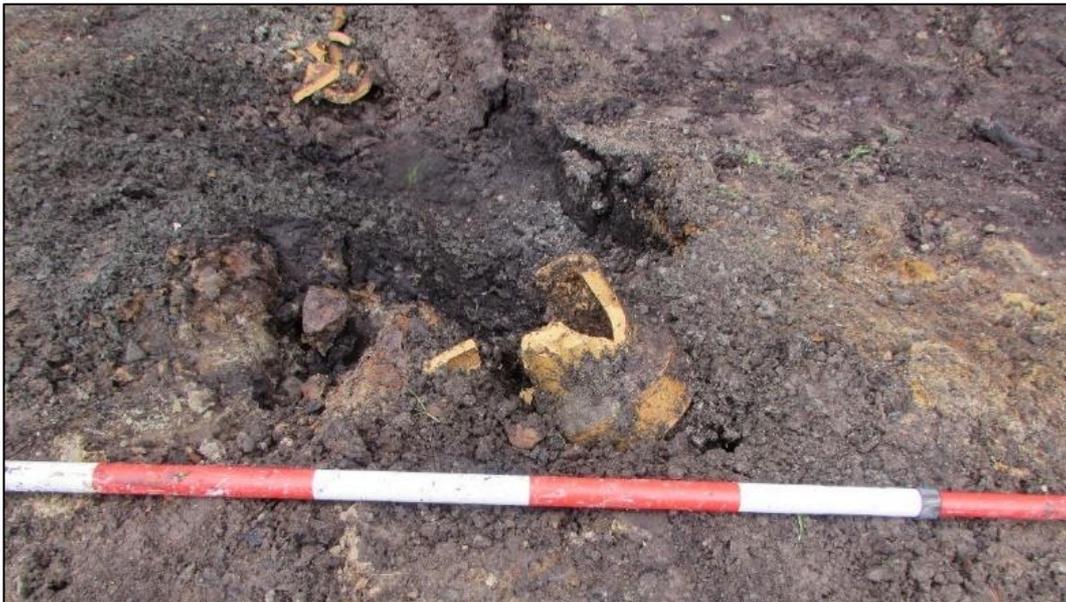
Portion of a clay drainage pipe orientated northeast to southwest encased in concrete. Within G002 measuring 1300 mm long and 600 mm wide (Figure 5-70).

Figure 5-70 Drainage feature (G006).

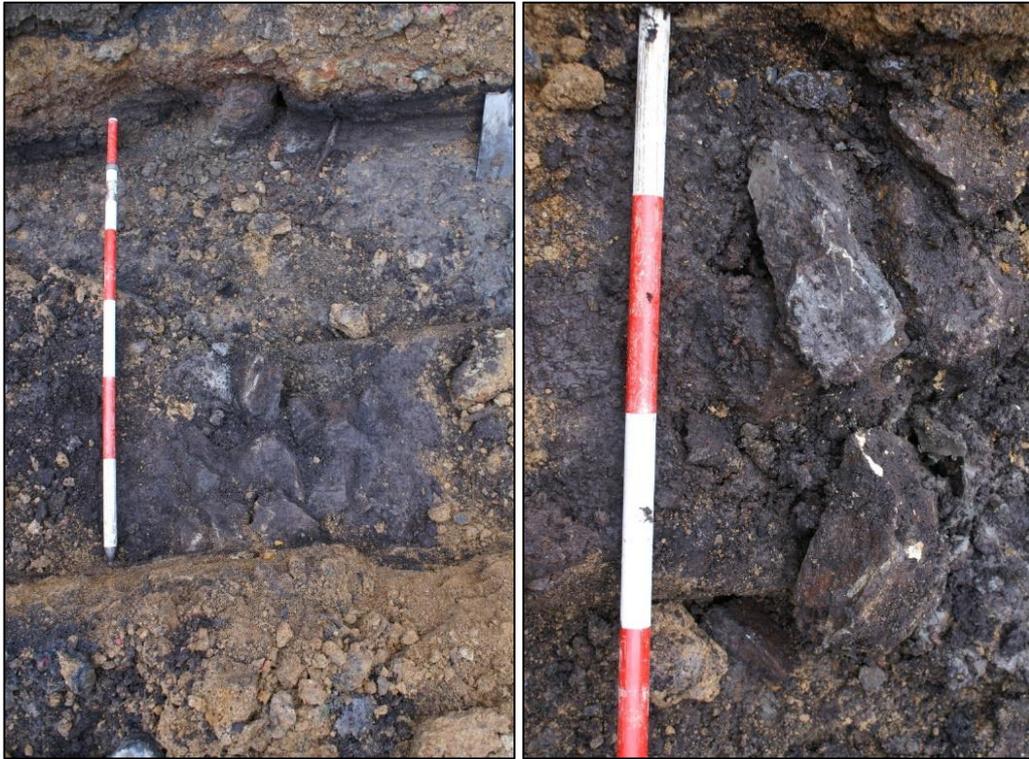
Stone wall section measuring 500 mm wide and 250 mm thick, orientated north to south coming out of the northern baulk. Uncovered 550 mm to 600 mm below the ground surface within G002 and G004 and sitting atop of G003. The wall is comprised of irregular shaped stones that have not been cut or faced, forming an apparent structural foundation. A fragment of a torpedo bottle, ceramic and glass was found associated with the feature. The feature was intersected three times across the excavated area during trenching.

Figure 5-71 G007 stone wall comprised of irregular shaped stones.

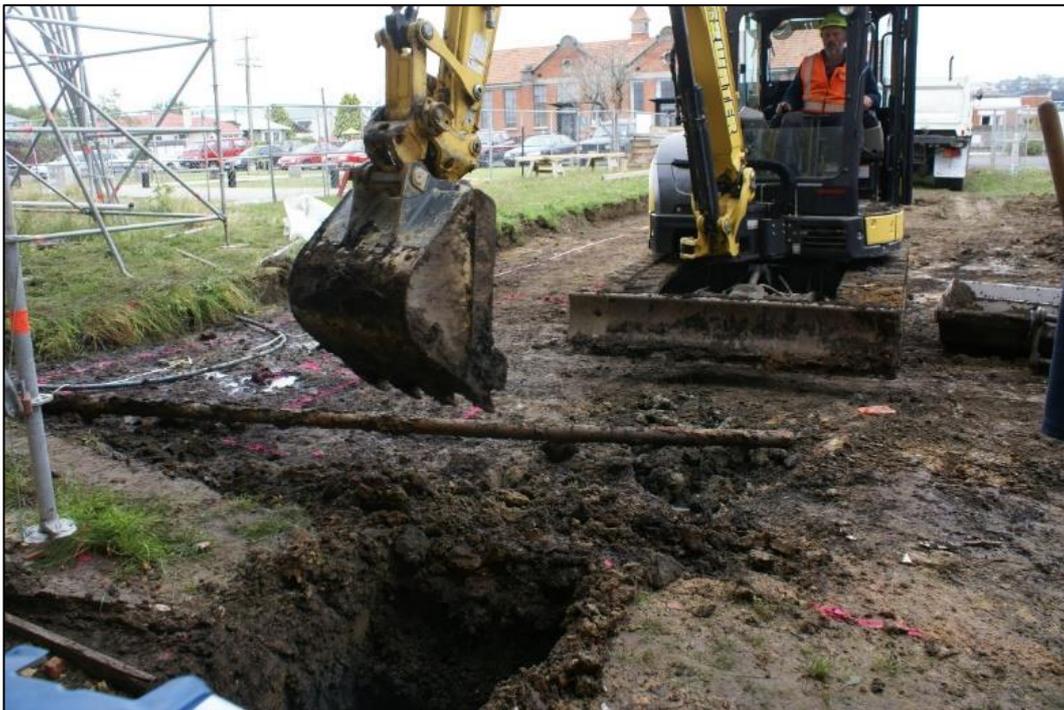
Modern service pipe beneath G001, oriented north to south.

Figure 5-72 G008.

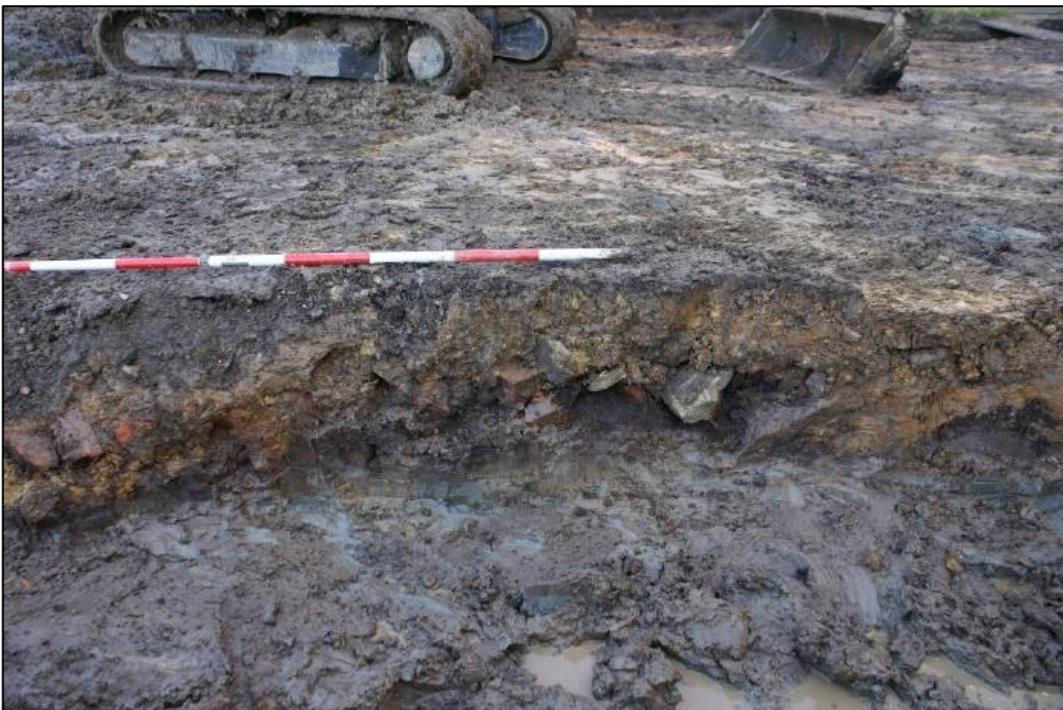
Cluster of large, irregular shaped stones 800 mm deep and beneath G002, within G004 and atop of G003.

Figure 5-74 G010 looking north.

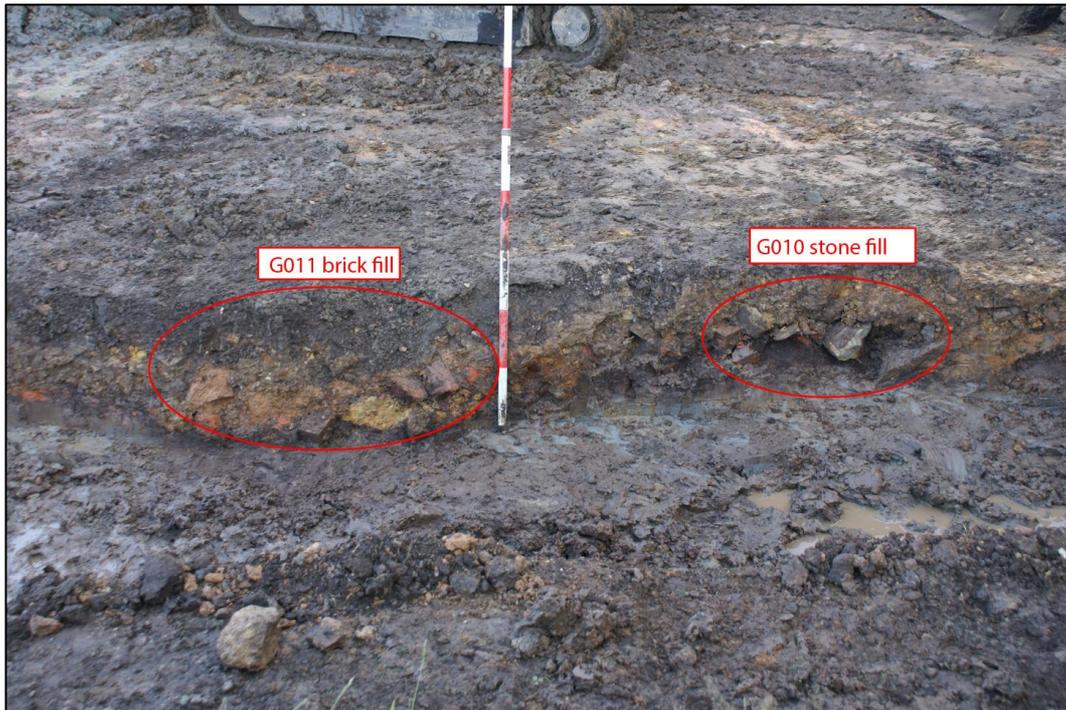
Cluster of bricks 800 mm deep and beneath G001, within G002 and G004 and, atop of G003. To the west of G010 (Figure 5-75).

Figure 5-75 G011 and G010 looking north.

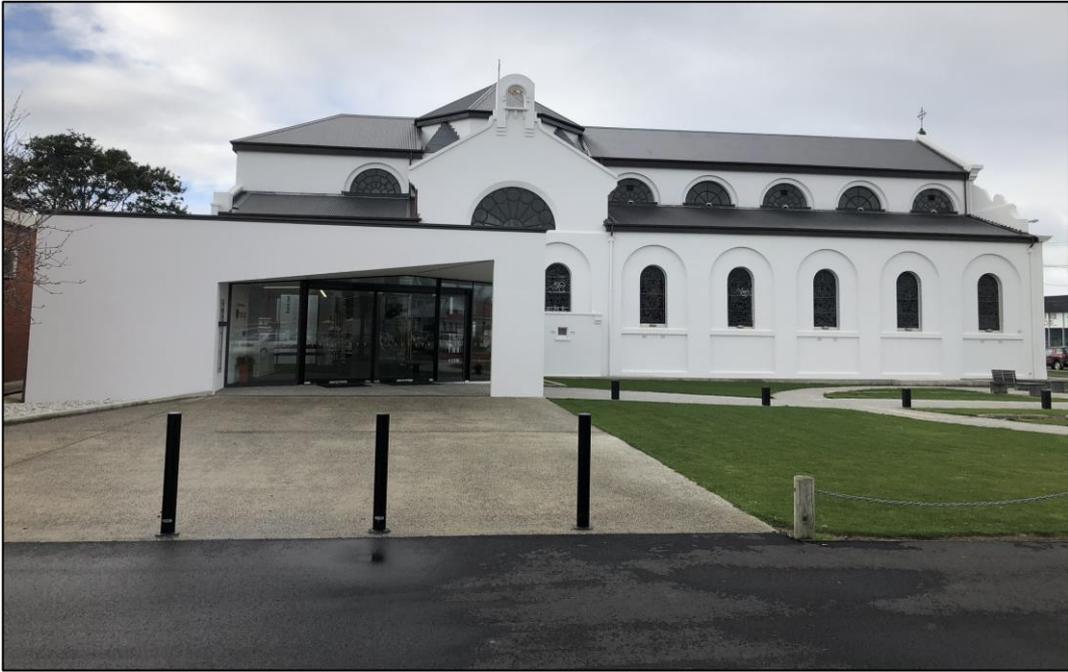
Figure 6-1 St Patricks Basilica with the new egress in 2017. Looking east.

The maintenance and redevelopment of the basilica over the last five years has successfully retained the key characteristics and purpose of the original structure to ensure it remains a central congregation hub for Dunedin Catholics (Figure 6-1 to Figure 6-3).

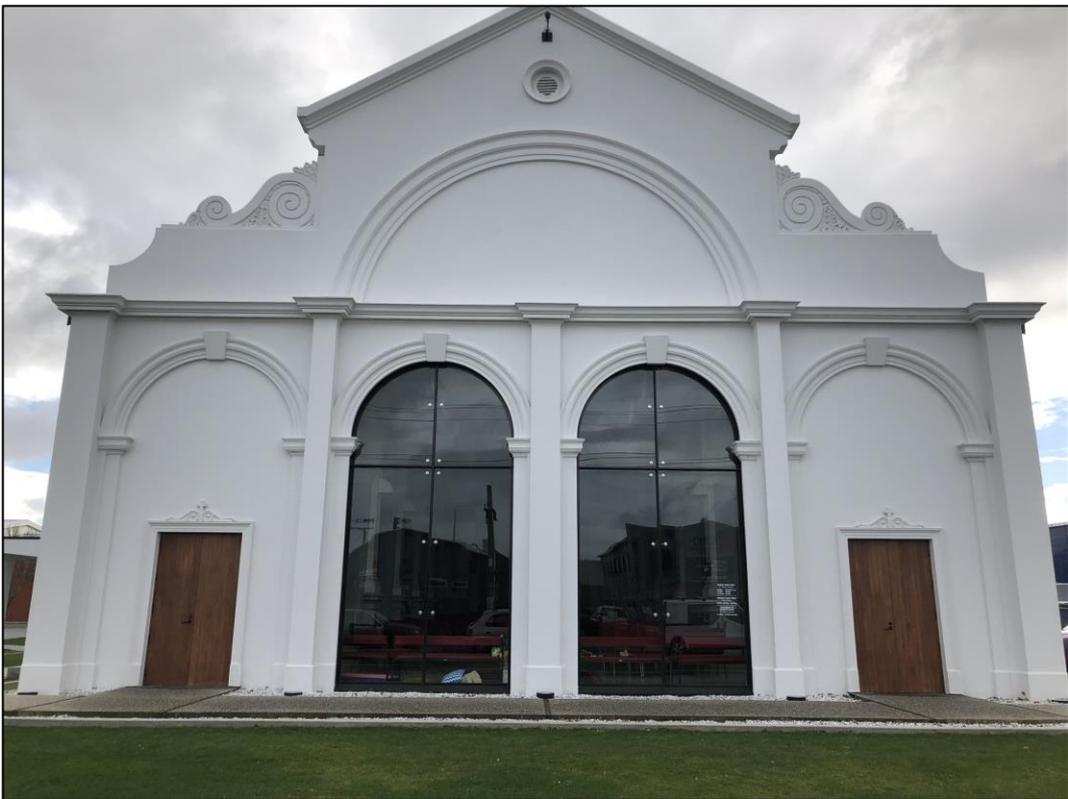
Figure 6-2 Front of the basilica facing MacAndrew Road in 2017.

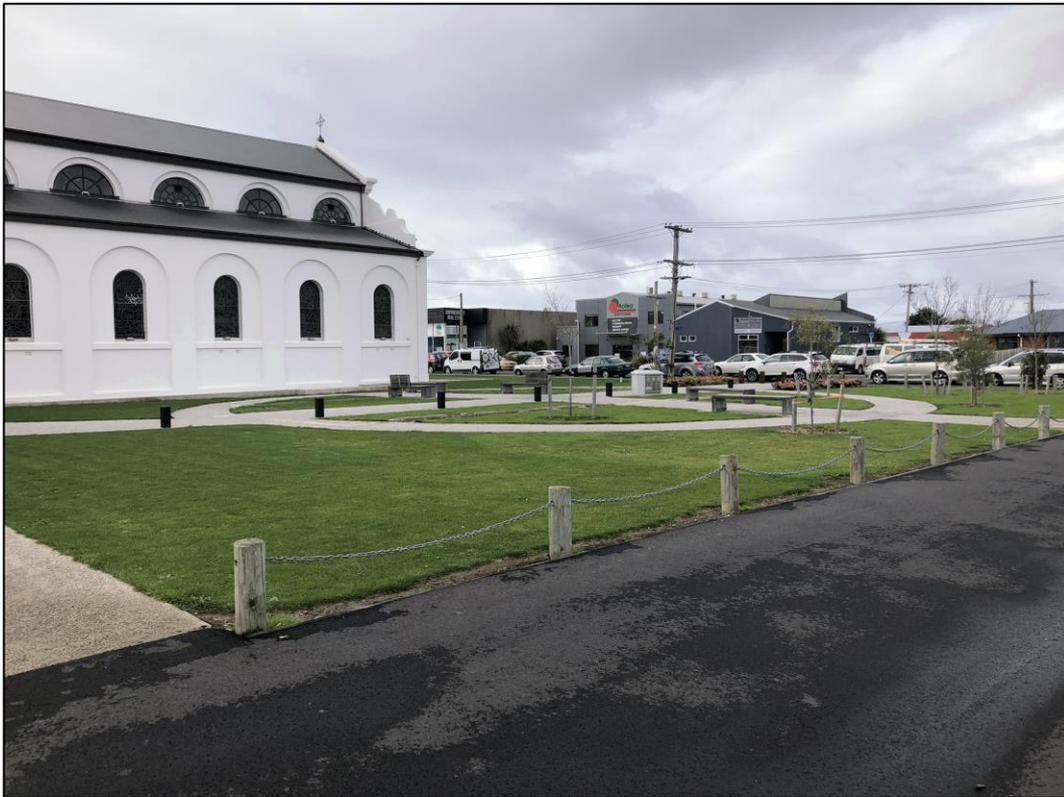
Figure 6-3 New public greenspace in 2017 where the presbytery once was located. Looking southeast.

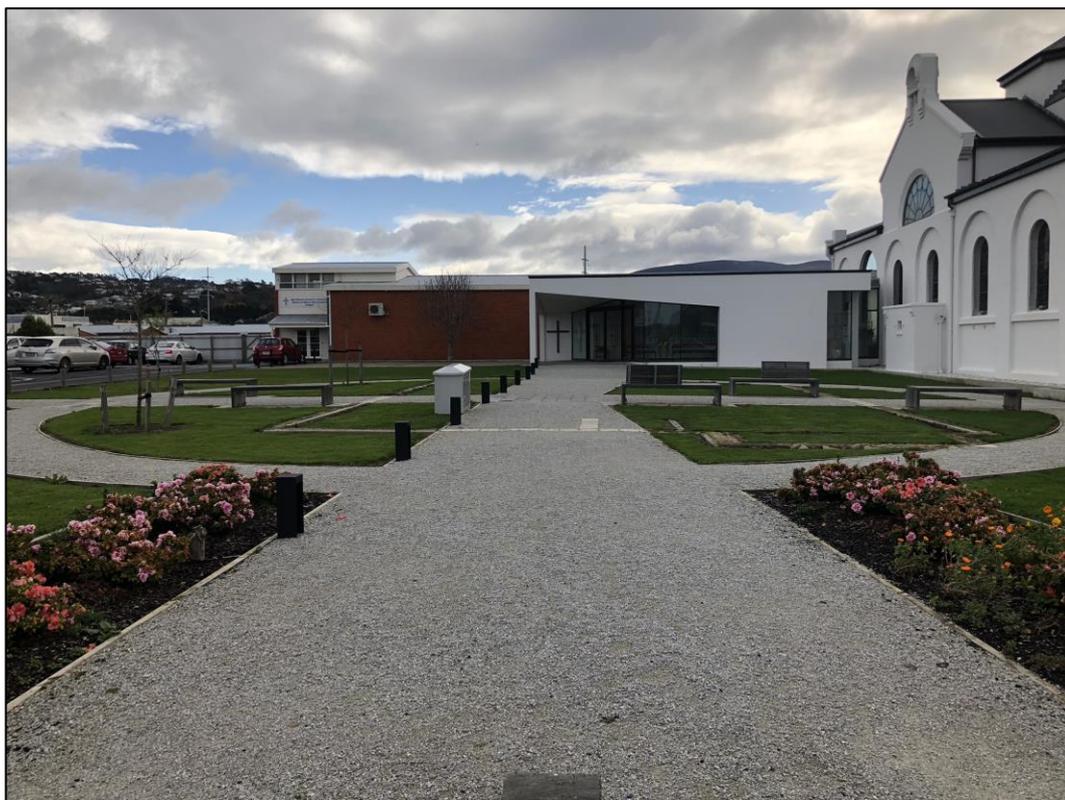
Figure 6-6 The new green space where the presbytery once was with the original founds clearly visible within the design. Photo taken in 2017.

The loss of this building has been outweighed by the money and time spent in maintaining and fixing the other two structures on site. Its removal has created a new kind of public space, relevant to the modern-day community; a green space for play and personal contemplation. However, keeping the foundations in-situ allows

the site to be interpreted as it once was, understanding the balance between the church and school with the clergy as the central element (Figure 6-6).
